**DEPARTMENT OF TRANSPORTATION**

Contract # : 04-0120S4  
 Cty SF/SF Rte 80 PM 1.6/2.7  
 File # 1.12

**QUALITY ASSURANCE – NONCONFORMANCE REPORT**

**Description of Incident:** The inorganic prime coating applied to the Seismic Expansion Joint Hinge E-East Bound has areas exhibiting high DFT (Dry Film Thickness) readings that exceed the required 200um (8mil) thickness and areas exhibiting “mud cracking” is present at multiple areas throughout the component.

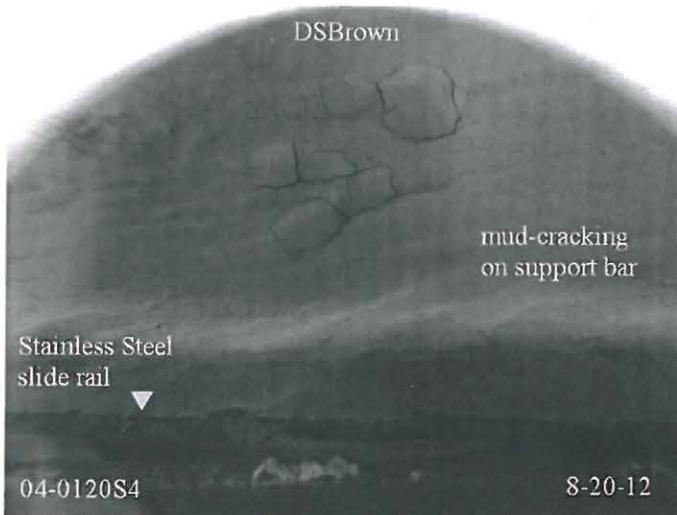
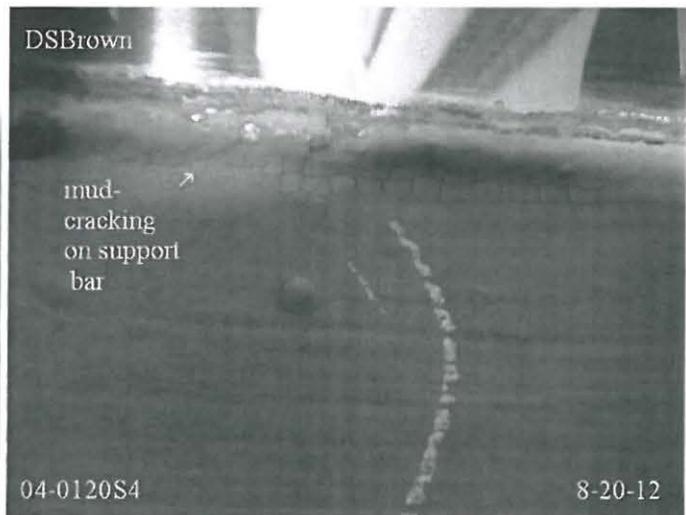
The group went to the paint shop to observe the coatings application area and then to the location of the hinge E-West Bound assembly in the shop. This assembly also has some areas with mud-cracking and after a visual inspection of the coating on this assembly, The QA NACE Inspector observed that there were areas that had another type of defect known as "orange peel", these areas were checked with a positex gauge by the QC and found the thickness of the coatings to be above the requirements of the contract documents. The QA NACE Inspector commented that these areas could lead to mud-cracking following the curing time and the transportation to the jobsite. The stresses from vibration and movement of the material while in transit, being the coating is applied to heavily, can result in a lower tensile strength of the coating.

The group of us moved to the support bars, where again by visual observation, mud-cracking was found to be present. The QA NACE Inspector relayed that the use of a brush to apply the inorganic zinc coating following the welding process could be causing this type of defect due to the heavy application. It was then discussed about options for repair to the assembly, it was suggested to DSB QC and QCM to review the CCO that this work is being performed under and if any questions they would need to contact the SMR along with reviewing the manufacturer's recommendations for repairs of these types.

The QA NACE Inspector also informed DSB QC and QCM that the proper way to test these assemblies would be to test in accordance to PA-2 specifications and contract documents, in lieu of testing random areas.

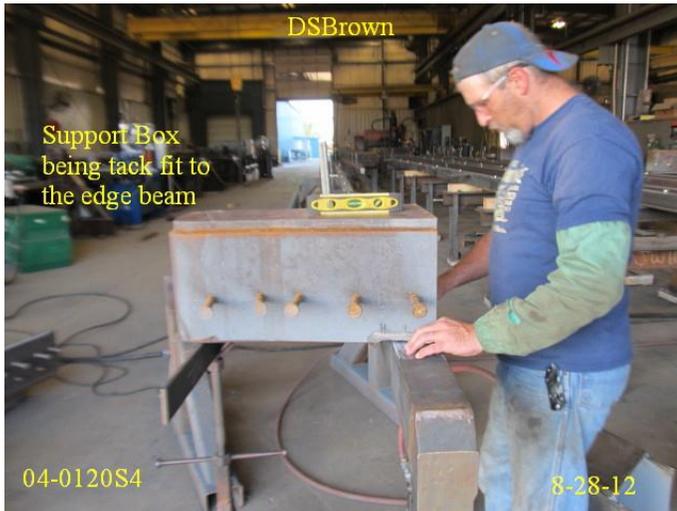
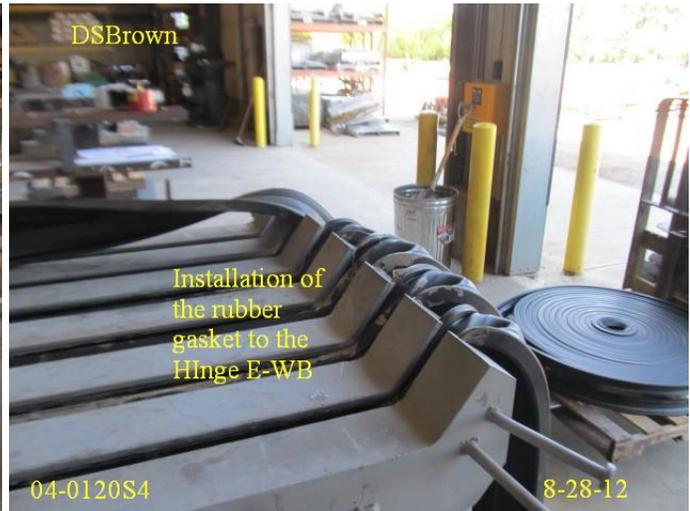
DSB operators were observed by this QAI installing the rubber bladder (seal) into the grooved areas on the Hinge E-WB (assembly 11A). The coating repairs to the mud-cracking issues on the insides of the center beams and the support bars have been completed using the approved method from the SMR (Aaron Prchlik). These areas have been repaired and the coated with organic zinc which was checked by the QC inspector. This QAI met with QC to discuss the remaining coating repairs on this assembly. The QC inspector informed this QAI that DS Brown would be performing the repair work to the special provisions, which allows blast cleaning of the areas where mud-cracking was identified by the QC inspector. The mud-cracking was identified at one center beam.

This QAI began reviews of the Material Testing Results (MTR's) for the Hinge E-WB assembly 11A, and upon review this QAI noticed in the MTR's included some lower grade material (A36) was used in the fabrication of this assembly that did not meet the special provisions requirements of 50 grade material. (Special provisions document page 222 identifies A572 gr 345). This QAI relayed these findings to DS Brown QC and Quality Administrator Patricia Kinne. She asked this QAI to which parts were affected with this lower grade of material to which the reply was the edge beam plate anchors and the support bar stops. Patricia relayed she would check into this matter and see if there were any Requests for Information (RFI's) in regards to this material issue. This QAI also relayed to Patricia that a proof testing release from SMR on this hinge assembly would be needed before it could be shipped. At the time of this report the items observed in fabrication appeared in general conformance with the contract documents and approved drawings.

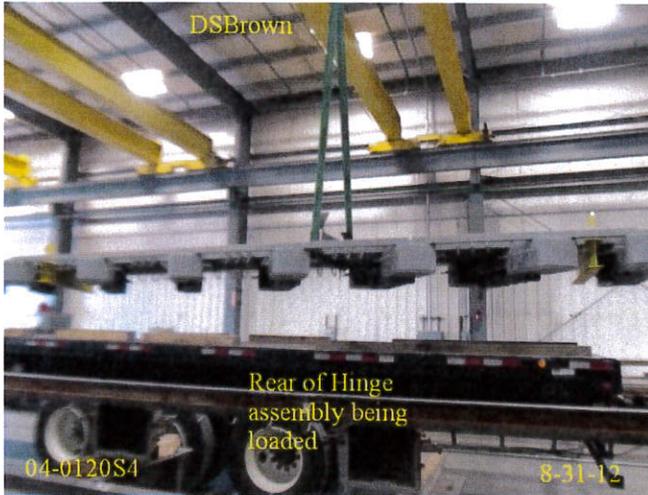
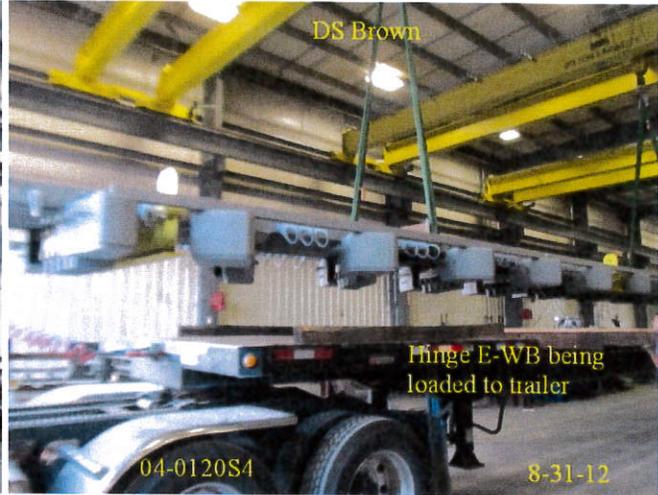
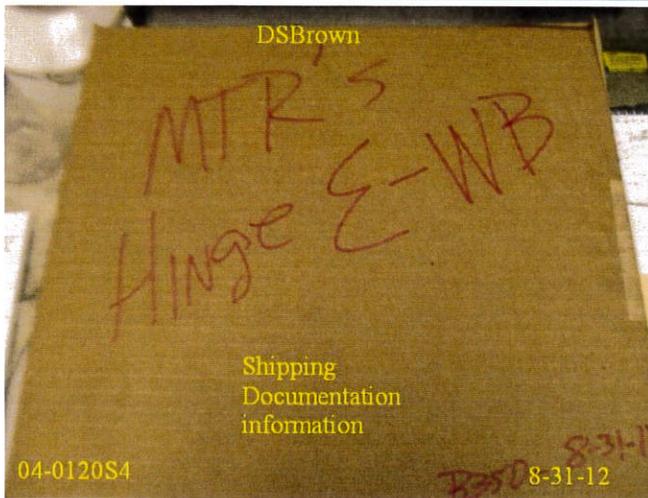
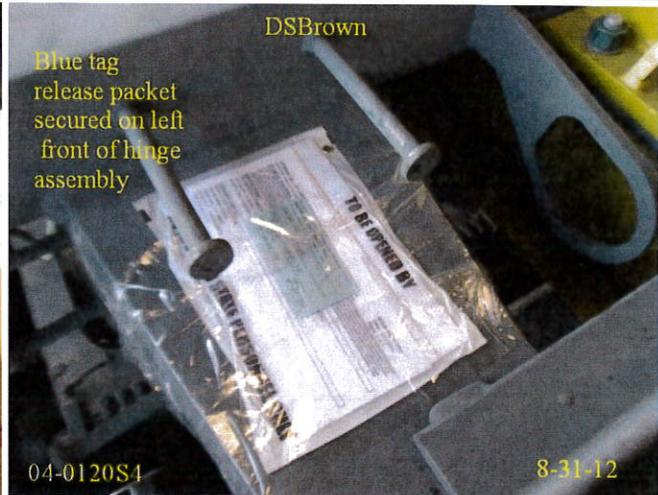
**Identification:** Shipping packet attached to left front of hinge assembly, Box of related paperwork to driver per Aaron
