DEPARTMENT OF TRANSPORTATION

Contract #: 04-0120F4Cty: SF/ALA Rte: 80 PM: 13.9/14.3,0.0/1.6File #: 69.28**WELDING INSPECTION REPORT****Resident Engineer:** Pursell, Gary**Address:** 333 Burma Road**City:** Oakland, CA 94607**Report No:** WIR-000842**Date Inspected:** 11-Nov-2007**Project Name:** SAS Superstructure**OSM Arrival Time:** 2300**Prime Contractor:** American Bridge/Fluor Enterprises, a JV**OSM Departure Time:** 730**Contractor:** Zhenhua Port Machinery Company, Ltd (ZPMC), Changxing Island **Location:** Shanghai, China**CWI Name:** Xu Lefeng & Li Gang**CWI Present:** Yes No**Inspected CWI report:** Yes No N/A**Rod Oven in Use:** Yes No N/A**Electrode to specification:** Yes No N/A**Weld Procedures Followed:** Yes No N/A**Qualified Welders:** Yes No N/A**Verified Joint Fit-up:** Yes No N/A**Approved Drawings:** Yes No N/A**Approved WPS:** Yes No N/A**Delayed / Cancelled:** Yes No N/A**Bridge No:** 34-0006**Component:** Caltrans Mock-Up**Summary of Items Observed:**

Caltrans Quality Assurance (QA) Inspector, Mike Hasler was present to observe the fitup, welding and related activities associated with the fabricating of Caltrans Mock-up, 77M, 89M, 114M and U-Rib Trial Asse

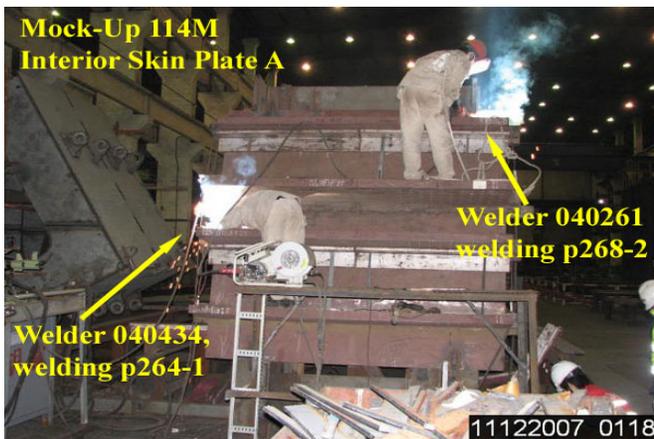
Mock-Up 114M, Interior Skin Plate A: Caltrans QA Inspector observed flux cored arc welding (FCAW), complete joint penetration (CJP) weld, longitudinal stiffeners (p264-1 & p268-2) joining skin plate A58, fill pass weld in the flat position. The welders are identified as Mr. Bai Wenming, welder stamp 040434 and Mr. Jang Zhou, welder stamp #040261. The welders are using welding procedure specification WPS-B-T-2231-TC-U5-F, Revision 1. Caltrans QA observed ZPMC Quality Control inspector, Mr. Xu Lefeng and Bureau Veritas (BV) inspector, Mr. Li Gang, monitoring welding activities at the workstation. Caltrans QA Inspector measured current welding parameters at approximately 300 amps, 31.1 volts and 302 millimeters per minute (mm/min) travel speed. Preheat and interpass temperatures were verified during welding activities. The preheat temperature prior to the start of welding measures more than 110 Celsius (230 degree Fahrenheit) but less than 232 Celsius (450 degrees Fahrenheit) during maximum interpass temperature verification. FCAW welding consumable is verified and identified as Supercored 71H, classification E71T-1, diameter 1.4 mm (.055 inches). The welding being performed appeared to be in conformance with contract specifications. The following digital picture illustrates welding in progress.

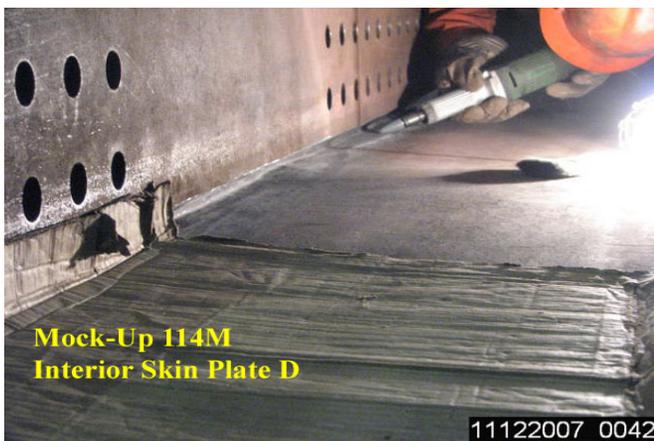
- 2 Skin Plate D NA NA Weld Joint Backgouge
- Mock-Up 114M, Interior Skin Plate D; Caltrans QA Inspector was informed by ZPMC QC inspector, Mr. Zhang Jiadi Ken that the weld backgouge, material preparation has been completed at stiffener plate p920-2, joining skin plate A75. Caltrans QA Inspector visual inspection and observed that the backgouged area is ground to bright metal, smooth and free of gouges. The weld joint material preparation appeared to be in conformance with contact specifications. The following digital picture illustrates ground backgouge.

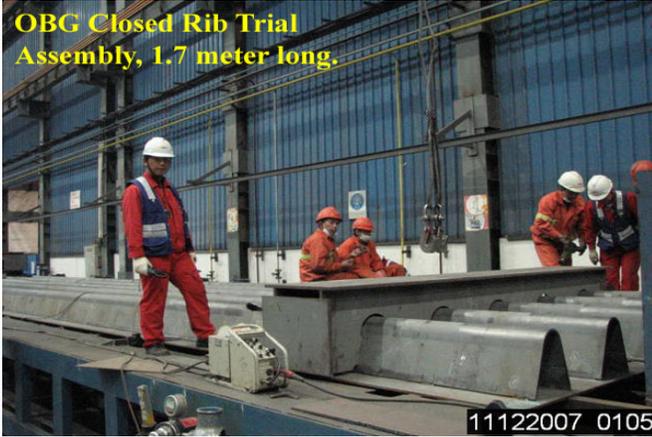
- 3 OBG Closed Rib NA NA Work in Progress
- OBG Closed Rib, Welding Trial Mock-Up: Caltrans QA Inspector observed ZPMC shop personnel performing fixture adjustments to the 1.7 meter long closed rib assembly in Building #1. No welding was performed. Caltrans QA Inspector asked ZPMC inspector, Mr. Zhang Jiadi Ken if he was aware that ZPMC was working on the closed rib assembly. Mr. Zhang Jiadi Ken stated that he was not informed that ZPMC would be working in Building #1 on the closed rib trial assembly. The following digital picture illustrates the 1.7 meter closed rib assembly.
