**DEPARTMENT OF TRANSPORTATION**

Contract #: 04-0120F4Cty: SF/ALA Rte: 80 PM: 13.2/13.9File #: 69.28**WELDING INSPECTION REPORT****Resident Engineer:** Pursell, Gary**Address:** 333 Burma Road**City:** Oakland, CA 94607**Report No:** WIR-000878**Date Inspected:** 12-Nov-2007**Project Name:** SAS Superstructure**OSM Arrival Time:** 630**Prime Contractor:** American Bridge/Fluor Enterprises, a JV**OSM Departure Time:** 1530**Contractor:** Zhenhua Port Machinery Company, Ltd (ZPMC), Changxing Island **Location:** Changxing Island**CWI Name:** Arthur Peterson**CWI Present:** Yes No**Inspected CWI report:** Yes No N/A**Rod Oven in Use:** Yes No N/A**Electrode to specification:** Yes No N/A**Weld Procedures Followed:** Yes No N/A**Qualified Welders:** Yes No N/A**Verified Joint Fit-up:** Yes No N/A**Approved Drawings:** Yes No N/A**Approved WPS:** Yes No N/A**Delayed / Cancelled:** Yes No N/A**Bridge No:** 34-0006**Component:** OBG Deck Plate Trial**Summary of Items Observed:**

Caltrans Quality Assurance (QA) Inspector, Larry Viars was present to observe the Welding and perform dimensional testing of the Caltrans Orthotropic Box Girder (OBG First Deck Plate Mock-up Weld Trial, for the

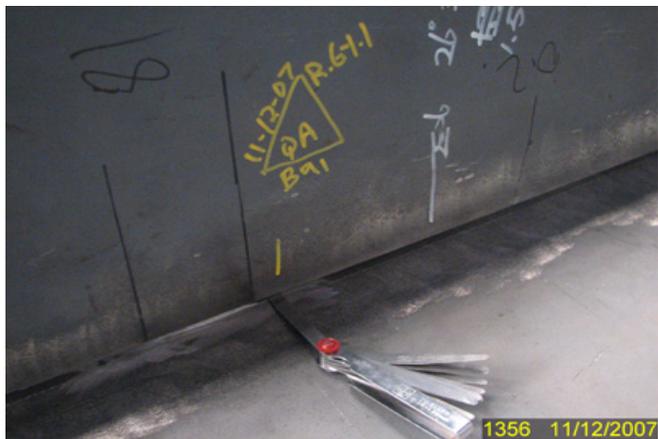
Caltrans QA Inspector Viars observed highest concentration of root gap readings that exceeded the limit of 0.5 mm were located 2.77 meters from the left end of the U ribs. The largest recorded reading root gap was located on rib U03 between tack welds 17 and 18 and measured 1.1 mm. The picture below shows the filler gauge inserted in the deck plate to U rib gap
