**DEPARTMENT OF TRANSPORTATION**

Contract #: 04-0120F4Cty: SF/ALA Rte: 80 PM: 13.2/13.9File #: 69.28**WELDING INSPECTION REPORT****Resident Engineer:** Pursell, Gary**Address:** 333 Burma Road**City:** Oakland, CA 94607**Report No:** WIR-000970**Date Inspected:** 04-Dec-2007**Project Name:** SAS Superstructure**OSM Arrival Time:** 730**Prime Contractor:** American Bridge/Fluor Enterprises, a JV**OSM Departure Time:** 1500**Contractor:** Zhenhua Port Machinery Company, Ltd (ZPMC), Changxing Island **Location:** Shanghai, China**CWI Name:** See Below**CWI Present:** Yes No**Inspected CWI report:** Yes No N/A**Rod Oven in Use:** Yes No N/A**Electrode to specification:** Yes No N/A**Weld Procedures Followed:** Yes No N/A**Qualified Welders:** Yes No N/A**Verified Joint Fit-up:** Yes No N/A**Approved Drawings:** Yes No N/A**Approved WPS:** Yes No N/A**Delayed / Cancelled:** Yes No N/A**Bridge No:** 34-0006**Component:** OBG**Summary of Items Observed:**

## WELDING INSPECTION REPORT

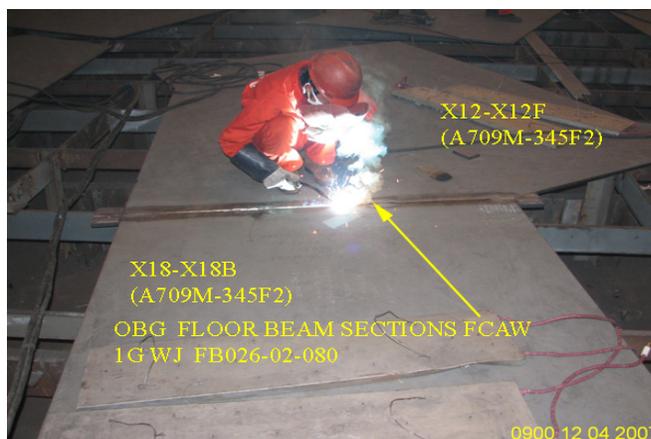
The QA Inspector randomly observed ZPMC welder Liu Kaige ID Number 044830, utilizing the FCAW Process with approved ZPMC WPS WPS-B-T-2231-B-U2-F-1 in the 1G position to weld the root pass in SPCM Floor Beam Section X18-X18B (A709M-345F2) to Floor Beam Section X12-X12F (A709M-345F2) at WJ FB026-01-080. The QA Inspector observed ZPMC CWI Cai Yiru monitoring weld parameters. The QA Inspector also performed random verification of the weld parameters and documented them as follows: welding amperage 280 amps, welding voltage 29.2 volts with a travel speed of 501 millimeters per minute. Weld parameters appeared to comply with the above approved ZPMC WPS. The attached photograph provides additional detail.
