DEPARTMENT OF TRANSPORTATION

Quality Assurance and Source Inspection

Contract #: 04-0120F4Cty: SF/ALA Rte: 80 PM: 13.2/13.9File #: 69.28**WELDING INSPECTION REPORT****Resident Engineer:** Pursell, Gary**Address:** 333 Burma Road**City:** Oakland, CA 94607**Report No:** WIR-000972**Date Inspected:** 07-Dec-2007**Project Name:** SAS Superstructure**OSM Arrival Time:** 730**Prime Contractor:** American Bridge/Fluor Enterprises, a JV**OSM Departure Time:** 1500**Contractor:** Zhenhua Port Machinery Company, Ltd (ZPMC), Changxing Island **Location:** Shanghai, China**CWI Name:** See Below**CWI Present:** Yes No**Inspected CWI report:** Yes No N/A**Rod Oven in Use:** Yes No N/A**Electrode to specification:** Yes No N/A**Weld Procedures Followed:** Yes No N/A**Qualified Welders:** Yes No N/A**Verified Joint Fit-up:** Yes No N/A**Approved Drawings:** Yes No N/A**Approved WPS:** Yes No N/A**Delayed / Cancelled:** Yes No N/A**Bridge No:** 34-0006**Component:** OBG**Summary of Items Observed:**

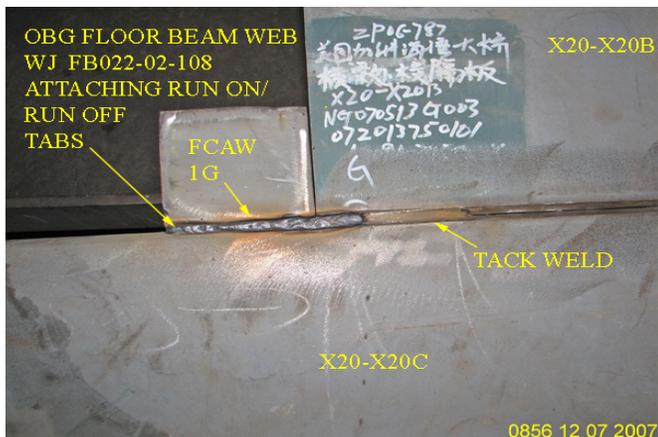
The QA Inspector randomly observed ZPMC welder Jin Cheng ID Number 058551, utilizing the Flux Cored Arc Welding (FCAW) Process with approved ZPMC Weld Procedure Specification (WPS) WPS-B-P-2211-3-U2 to attach run on/run off tabs to Floor Beam Web sections at Weld Joint (WJ) Numbers FB025-02-108, FB025-01-108, FB021-01-108, FB022-02-108, FB026-01-108, FB026-02-108, FB018-01-108, FB018-02-108, FB017-01-108 and FB017-02-108. The QA Inspector observed ZPMC CWI Zhang Zhong monitoring weld parameters. The QA Inspector randomly observed that the above Floor Beam Webs were covered in dirt and that the cleaning of the Floor Beam Webs prior to welding was minimal. The QA Inspector also observed that the preheat applied to the Floor Beam Webs prior to attaching the run on/run off tabs, produced a very defined mud line as a result of the condensing of moisture released during the preheating of the weld area. The QA Inspector picked up a nearby broom and swept the dirt off the Floor Beam Web at WJ FB022-01-108 to illustrate to ZPMC welding personnel that the weld area needed to be cleaned properly prior to welding. The ZPMC welding personnel cleaned off the dirt from the rest of the Floor Beam Webs prior to performing any welding. Weld parameters appeared to comply with the above approved ZPMC WPS. The attached photograph provides additional detail.
