Contract #: 04-0120F4Cty: SF/ALA Rte: 80 PM: 13.2/13.9File #: 69.28**WELDING INSPECTION REPORT****Resident Engineer:** Pursell, Gary**Address:** 333 Burma Road**City:** Oakland, CA 94607**Report No:** WIR-001005**Date Inspected:** 06-Dec-2007**Project Name:** SAS Superstructure**OSM Arrival Time:** 730**Prime Contractor:** American Bridge/Fluor Enterprises, a JV**OSM Departure Time:** 1500**Contractor:** Zhenhua Port Machinery Company, Ltd (ZPMC), Changxing Island **Location:** Shanghai, China**CWI Name:** See Below**CWI Present:** Yes No**Inspected CWI report:** Yes No N/A**Rod Oven in Use:** Yes No N/A**Electrode to specification:** Yes No N/A**Weld Procedures Followed:** Yes No N/A**Qualified Welders:** Yes No N/A**Verified Joint Fit-up:** Yes No N/A**Approved Drawings:** Yes No N/A**Approved WPS:** Yes No N/A**Delayed / Cancelled:** Yes No N/A**Bridge No:** 34-0006**Component:** OBG**Summary of Items Observed:**

Bay 7 OBG:

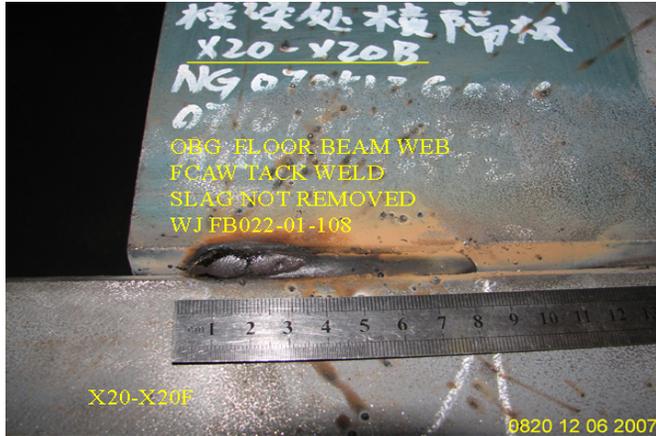
The QA Inspector randomly observed ZPMC welder Hu Ya Cheng ID Number 049339, utilizing the Flux Cored Arc Welding (FCAW) Process with approved ZPMC Weld Procedure Specification (WPS) WPS-B-P-2211-3-U2 to tack weld Floor Beam Web sections X20-X20F (T=12mm A709M-345T2) to X20-X20C (T=12mm A709M-345T2) at Weld Joint (WJ) FB022-01-108. The QA Inspector observed ZPMC CWI Zhang Zhong monitoring weld parameters. Weld parameters appeared to comply with the above approved ZPMC WPS. The attached photograph provides additional detail.

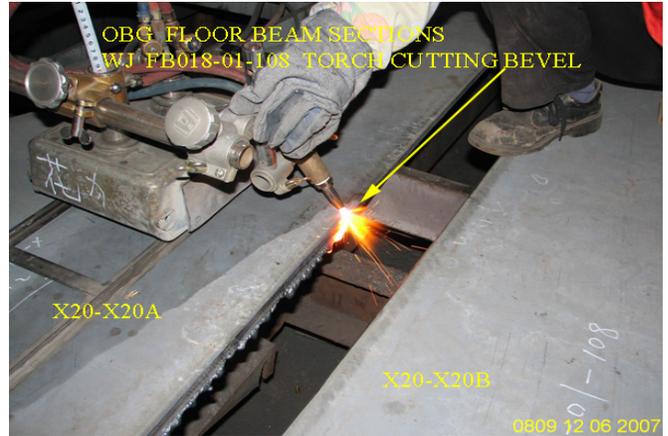
The QA Inspector randomly observed a ZPMC torch cutter utilizing a track mounted torch beveling apparatus, to cut the bevels on Floor Beam Web sections at WJ's FB018-01-108, FB026-01-108, FB021-01-108 and FB021-02-108. The attached photograph provides additional detail.
