Contract #: 04-0120F4Cty: SF/ALA Rte: 80 PM: 13.2/13.9File #: 69.28**WELDING INSPECTION REPORT****Resident Engineer:** Pursell, Gary**Address:** 333 Burma Road**City:** Oakland, CA 94607**Report No:** WIR-001038**Date Inspected:** 03-Dec-2007**Project Name:** SAS Superstructure**OSM Arrival Time:** 1400**Prime Contractor:** American Bridge/Fluor Enterprises, a JV**OSM Departure Time:** 2300**Contractor:** Zhenhua Port Machinery Company, Ltd (ZPMC), Changxing Island **Location:** Shanghai, China**CWI Name:** Zhang Zhong**CWI Present:** Yes No**Inspected CWI report:** Yes No N/A**Rod Oven in Use:** Yes No N/A**Electrode to specification:** Yes No N/A**Weld Procedures Followed:** Yes No N/A**Qualified Welders:** Yes No N/A**Verified Joint Fit-up:** Yes No N/A**Approved Drawings:** Yes No N/A**Approved WPS:** Yes No N/A**Delayed / Cancelled:** Yes No N/A**Bridge No:** 34-0006**Component:** Caltrans Mock-Up**Summary of Items Observed:**

WELDING INSPECTION REPORT

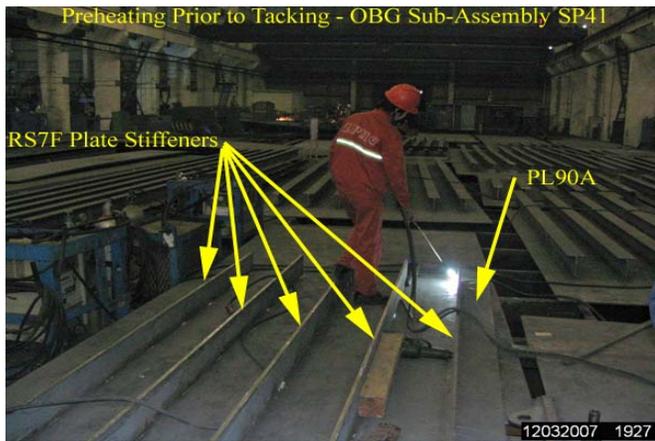
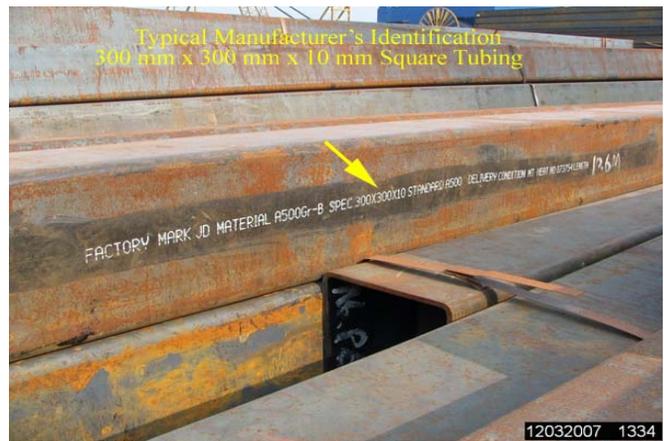
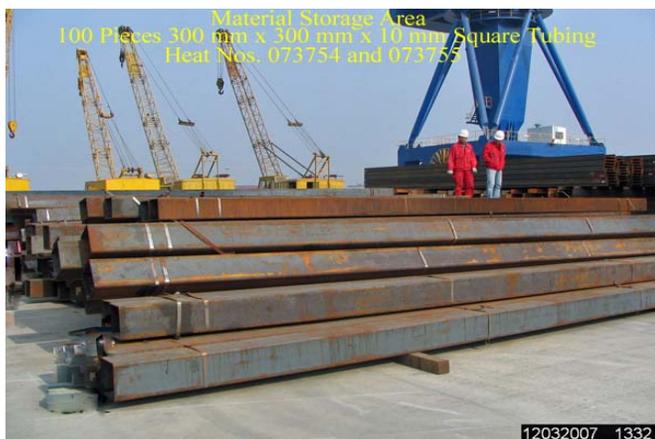
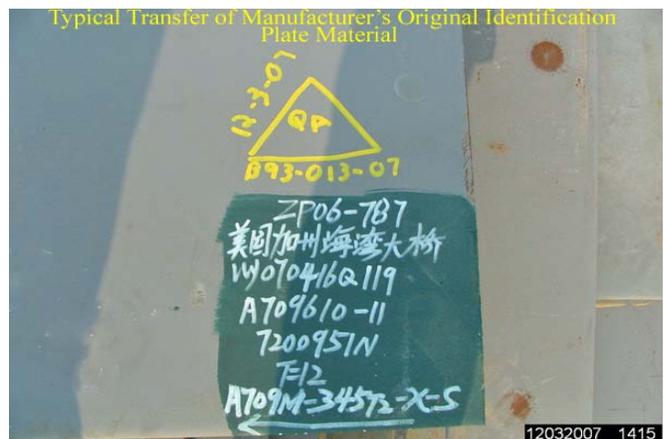
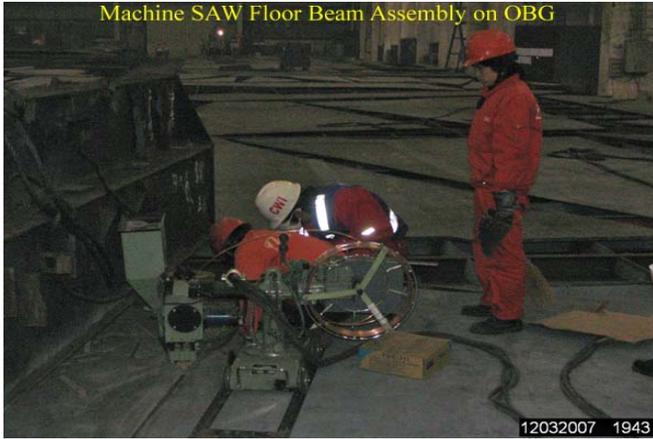
The Caltrans QA Inspector received the plate material list for Batch No. 43. The following thirty-two (32) plate Nos. from the production plate list were observed: 2814, 2815, 2816, 2818, 2819, 2820, 2821, 2826, 2838, 2839, 2840, 2841, 2843, 2844, 2846, 2847, 2848, 2851, 2875, 2877, 2882, 2888, 2894, 2895, 2896, 2897, 2898, 2899, 2900, 2913, 2914, 2915. The plates were observed for their general condition and identification marking, including accurate transfer of original manufacturer's required identification. The plates were designated as ASTM A709M-345T2-X and ASTM A709M-345F2-X and ranged in thickness from 12 mm to 35 mm. The QA Inspector assigned Lot No. B93-013-07 to these thirty-two plates on Batch No. 43.

The QA Inspector also observed one hundred (100) pieces of ASTM A500 Grade B, 300 mm x 300 mm x 10 mm square tubing for identification marking and general condition. There were fifty (50) pieces identified as Heat No. 073754 and fifty (50) pieces identified as Heat No. 073755. The QA Inspector observed that the original manufacturer's identification was still legible on each piece. In addition, this information had been transferred to the inside of each tube on one end. See attached picture showing typical identification. The QA Inspector assigned Lot No. B93-011-07 to Heat No. 073755 and Lot No. B93-012-07 to Heat No. 073754.

The QA Inspector observed the tacking of RS7F plate stiffeners to Piece Mark PL90A to make up Side Plate Sub-Assembly as shown on Drawing No. SP41. The QA Inspector observed that the material was being preheated and that the tack welder was Wang Zhonghua (I. D. No. 053753), whose qualifications for this welding are listed in ZPMC's Master List of Welders/Welding Operators/Tack Welders, Revision 6. The Welding Procedure Specification (WPS) was WPS-B-P-2212-SMAW, which specified the electrode as TL508 (E7018), which was being used for this tacking.

The QA Inspector also observed the machine Submerged Arc Welding (SAW) of Weld No. FB-001-02-021, which joins Piece Mark X14A to a sub-assembly of Piece Marks X46A and X46D (previously welded). This is on the OBG. The welding operator was Huang Xinian (I. D. 044780), whose qualifications for this welding are listed in ZPMC's Master List of Welders/Welding Operators/Tack Welders, Revision 6. ZPMC CWI, Zhang Zhong (AWS CWI No. 07051341) was present during this welding.

All observations appeared to meet the requirements of the job specifications.
