DEPARTMENT OF TRANSPORTATION

Quality Assurance and Source Inspection

Contract #: 04-0120F4Cty: SF/ALA Rte: 80 PM: 13.2/13.9File #: 69.28**WELDING INSPECTION REPORT****Resident Engineer:** Pursell, Gary**Address:** 333 Burma Road**City:** Oakland, CA 94607**Report No:** WIR-001045**Date Inspected:** 14-Dec-2007**Project Name:** SAS Superstructure**OSM Arrival Time:** 2300**Prime Contractor:** American Bridge/Fluor Enterprises, a JV**OSM Departure Time:** 730**Contractor:** Zhenhua Port Machinery Company, Ltd (ZPMC), Changxing Island **Location:** Shanghai, China**CWI Name:** Chen Xi**CWI Present:** Yes No**Inspected CWI report:** Yes No N/A**Rod Oven in Use:** Yes No N/A**Electrode to specification:** Yes No N/A**Weld Procedures Followed:** Yes No N/A**Qualified Welders:** Yes No N/A**Verified Joint Fit-up:** Yes No N/A**Approved Drawings:** Yes No N/A**Approved WPS:** Yes No N/A**Delayed / Cancelled:** Yes No N/A**Bridge No:** 34-0006**Component:** Caltrans Mock-Up**Summary of Items Observed:**

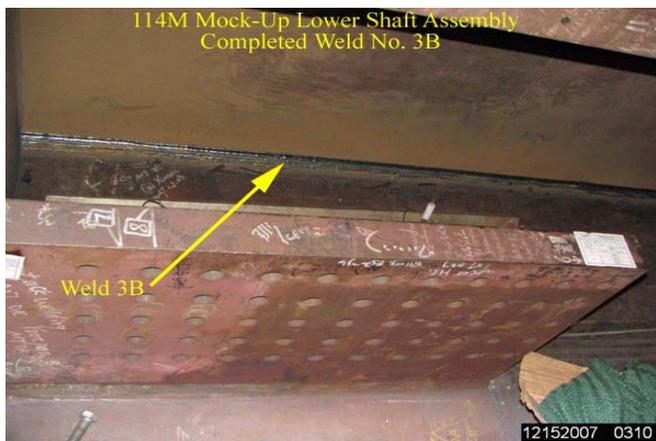
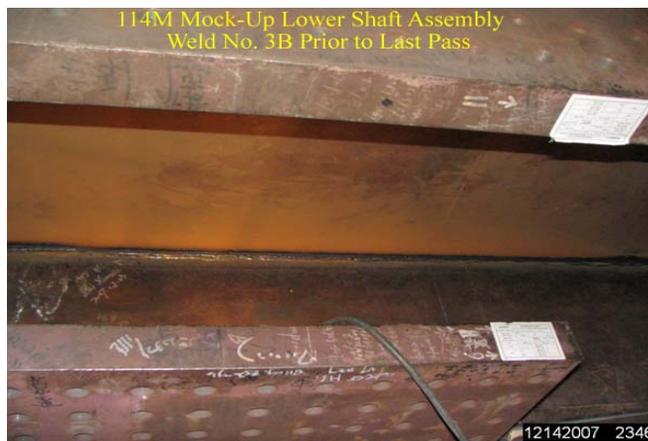
The Caltrans QA Inspector observed semi-automatic Flux Cored Arc Welding (FCAW) on the Lower Shaft Assembly on the 114M Mock-Up, Weld No. 3B. This is the inside weld of Skin B to Skin C. This is a complete joint penetration (CJP) groove weld and was being welded in the horizontal groove (2G) welding position. The welder was Jiang Zhou (I.D. No. 040261), whose qualifications for this welding are listed in ZPMC's Master List of Welders/Welding Operators/Tack Welders, Revision 6. Welding Procedure Specification (WPS) WPS-B-T-2232-TC-U4b-F was being used for this weld. ZPMC's documentation originally showed WPS-B-T-2232-B-U4b-F, which is for a butt joint. This joint is a corner joint. The QA Inspector brought this to the attention of ZPMC CWI, Chen Xi (CWI No. 07072021), who made the correction on the documentation. The QA Inspector verified that the amperage and voltage were within the ranges of the correct WPS for the pass being welded. This was accomplished using a calibrated Fluke amp/volt meter. The QA Inspector also noted that ZPMC's documentation of minimum/maximum preheat/interpass temperatures, voltage, amperage and travel speed by Wang Xipang Pin were within the specified ranges of the WPS for the first three passes. The CWI also measured and documented these parameters separately and the QA Inspector observed that they were also within the ranges of the applicable WPS.

There is a discrepancy as to which of two drawings applies to this work. ZPMC Drawing No. MUSC-MA107 B/C says the following in the title block: "114 Mock-Up Lower Shaft Assembly." It shows the Piece Marks for this

weld to be MUSC-MA102 for Skin B and MUSC-MA111 for Skin C. However, ZPMC references their Drawing No. MUSC-MA106 C/C for this work. The title block says, "114M Mock-Up Upper Shaft Assembly." There is a handwritten note at the bottom of this drawing that says "Down Tower." The note is not signed or dated. The Piece Marks on this drawing are MUSC-MA101 for Skin B and MUSC-112 for Skin C. These are the piece marks referenced on ZPMC's documentation for the welding of this joint. This discrepancy was brought to the attention of Zhang Jiadi on December, 13, 2007, night shift. Mr. Jiadi informed us tonight that ZPMC had submitted a request today, December 14, 2007, to ABF for clarification/approval of Drawing No. MUSC-MA106 C/C for this work. This discrepancy concerning the applicable drawing does not appear to meet the requirements of the job specifications. All other observations do appear to such requirements.
