Quality Assurance and Source Inspection

Contract #: 04-0120F4Cty: SF/ALA Rte: 80 PM: 13.2/13.9File #: 69.28**WELDING INSPECTION REPORT****Resident Engineer:** Pursell, Gary**Address:** 333 Burma Road**City:** Oakland, CA 94607**Report No:** WIR-001056**Date Inspected:** 18-Dec-2007**Project Name:** SAS Superstructure**OSM Arrival Time:** 730**Prime Contractor:** American Bridge/Fluor Enterprises, a JV**OSM Departure Time:** 1500**Contractor:** Zhenhua Port Machinery Company, Ltd (ZPMC), Changxing Island **Location:** Shanghai, China

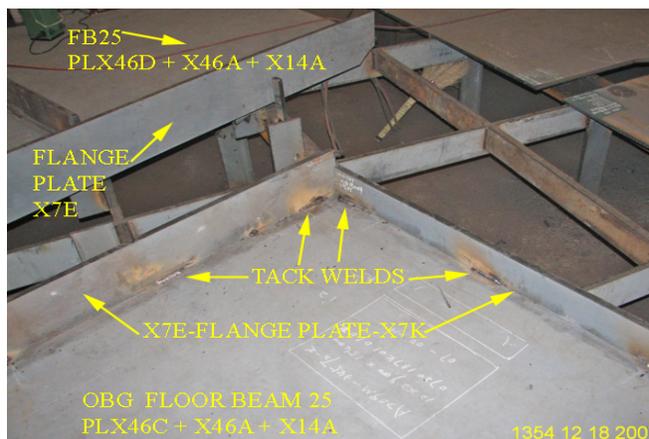
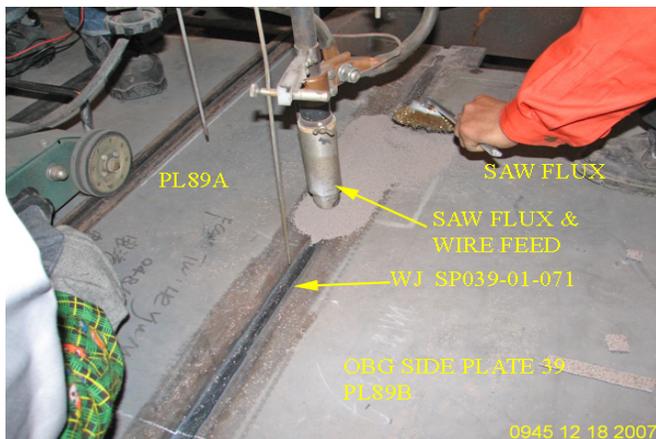
WPS-B-T-2221-B-Lc2-S-1 in the 1G position to weld the fill and cover passes in a butt splice between Side Plate SP39 Sub-Assembly Sections piece marks PL89A and PL89B at WJ SP039-01-071. The QA Inspector randomly observed a 4.8 metric ton weight placed on PL89B with dunnage under PL89A approximately 300mm from the WJ. The QA Inspector also randomly observed that the far end of PL89A was being held down by Side Plate SP25/PL80, which had been placed over the far end of PL89A. WJ SP039-01-071 was in positive deflection as a result of the configuration of the weight and dunnage placement. ZPMC Quality Representative Fu Yuhong informed the QA Inspector that the plate would be flipped over and back gouged, and that the WJ would be in negative deflection for welding on that side. The QA Inspector randomly observed ZPMC CWI Wu Ming Kai, monitoring weld parameters. The QA Inspector also randomly monitored weld parameters and recorded them as follows: welding amperage 490 amps, welding voltage 31 volts with a travel speed of 412 mm per minute. The weld parameters appeared to comply with contract requirements. The attached photographs provide additional detail.
