Quality Assurance and Source Inspection

Contract #: 04-0120F4Cty: SF/ALA Rte: 80 PM: 13.2/13.9File #: 69.28**WELDING INSPECTION REPORT****Resident Engineer:** Pursell, Gary**Address:** 333 Burma Road**City:** Oakland, CA 94607**Report No:** WIR-001058**Date Inspected:** 30-Nov-2007**Project Name:** SAS Superstructure**OSM Arrival Time:** 1400**Prime Contractor:** American Bridge/Fluor Enterprises, a JV**OSM Departure Time:** 2300**Contractor:** Zhenhua Port Machinery Company, Ltd (ZPMC), Changxing Island **Location:** Shanghai, China**CWI Name:** Lee Chan Woo**CWI Present:** Yes No**Inspected CWI report:** Yes No N/A**Rod Oven in Use:** Yes No N/A**Electrode to specification:** Yes No N/A**Weld Procedures Followed:** Yes No N/A**Qualified Welders:** Yes No N/A**Verified Joint Fit-up:** Yes No N/A**Approved Drawings:** Yes No N/A**Approved WPS:** Yes No N/A**Delayed / Cancelled:** Yes No N/A**Bridge No:** 34-0006**Component:** OBG**Summary of Items Observed:**

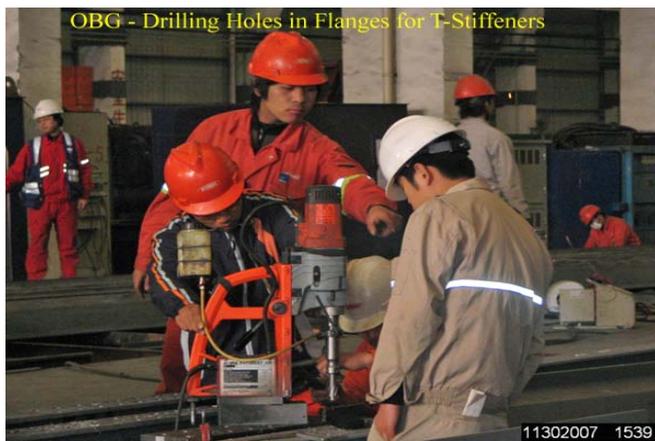
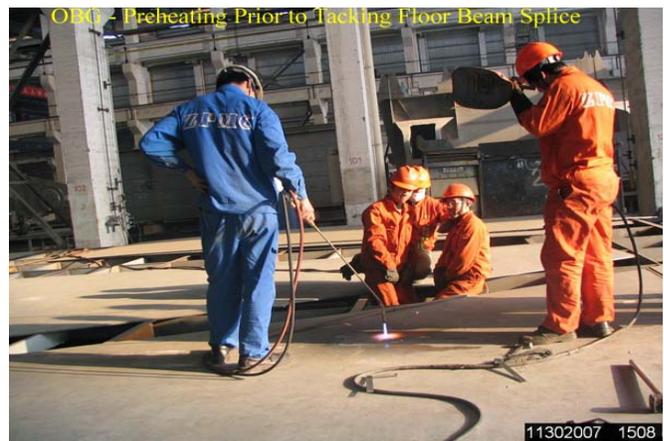
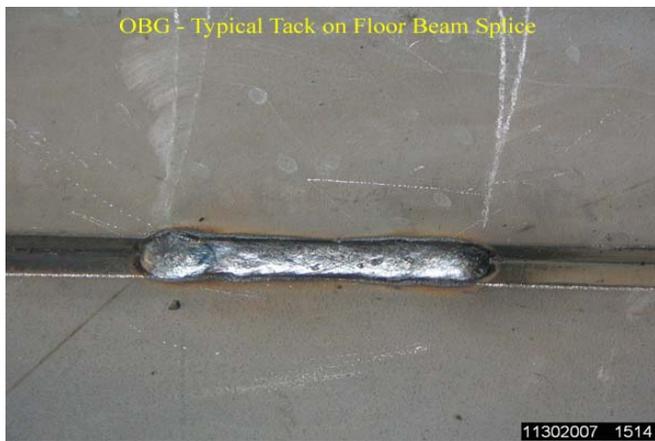
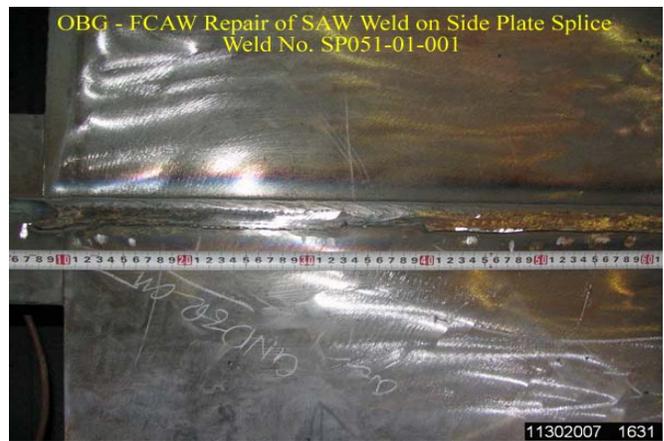
The Caltrans QA Inspector observed fitting and tacking of OBG Floor Beam Weld No. FB002-01-023, utilizing the semi-automatic Flux Cored Arc Welding (FCAW) process in the flat groove (1G) welding position. Both members being tacked were 12 mm thick, ASTM A709-345-T2 base material. Welding Procedure No. WPS-B-T-2231-U2-F-1 was being used. The QA Inspector observed that the minimum specified preheat of 10° C was being applied.

The QA Inspector observed the drilling of holes in beams for WT stiffeners using Template No. WT265Y. The QA Inspector verified the hole spacing on one of several members. The member verified was Piece Mark RS17D, shown on Drawing No. RS17D. Other reference drawings are BP5 and BP005.

The QA Inspector observed the fitting and tacking of WT stiffeners to Bottom Plate BP006 using the semi-automatic FCAW welding process in the horizontal fillet (2F) welding position. Two of the Weld Nos. were BP006-01-008 and BP006-01-009. The stiffener base material was ASTM A709-345 and the plate base material (Piece Mark PL37A) was 20 mm thick ASTM A709-345-T2-X. The welding procedure No. being used was WPS-B-T-2132-1, which required a minimum preheat of 10° C. The QA Inspector noted that preheat was being applied, although it did not appear that the temperature was being measured. The tack welder was Li Shuliang (I. D. No. 048801). The closest CWI, Lee Chan Woo was working approximately fifty meters from this work and the

The QA Inspector also observed the semi-automatic FCAW repair of a machine Submerged Arc Weld (SAW) of a splice on Side Plate 051. The Weld No. was SP051-01-001. The welding operator for the SAW was recorded as Jang Jingteng (I.D. No. 046830) and the welding procedure No. was WPS-B-T-2221-B-L2c-S-1. The QA Inspector did not observe the Submerged Arc Welding of this joint. The FCAW repair was made by Li Zhaoqian (I. D. 048810) using WPS-345-FCAW-1G(1F)-Repair. The repair was documented as being for undercut. The QA Inspector observed that ZPMC CWI Lee Chan Woo was present during the repair welding.

All observations appeared to meet the requirements of the job specifications.
