DEPARTMENT OF TRANSPORTATION

Contract #: 04-0120F4Cty: SF/ALA Rte: 80 PM: 13.2/13.9File #: 69.28**WELDING INSPECTION REPORT****Resident Engineer:** Pursell, Gary**Address:** 333 Burma Road**City:** Oakland, CA 94607**Report No:** WIR-001061**Date Inspected:** 17-Dec-2007**Project Name:** SAS Superstructure**OSM Arrival Time:** 730**Prime Contractor:** American Bridge/Fluor Enterprises, a JV**OSM Departure Time:** 1500**Contractor:** Zhenhua Port Machinery Company, Ltd (ZPMC), Changxing Island **Location:** Shanghai, China**CWI Name:** Ji Jianjiang & Cui Yi Ru**CWI Present:** Yes No**Inspected CWI report:** Yes No N/A**Rod Oven in Use:** Yes No N/A**Electrode to specification:** Yes No N/A**Weld Procedures Followed:** Yes No N/A**Qualified Welders:** Yes No N/A**Verified Joint Fit-up:** Yes No N/A**Approved Drawings:** Yes No N/A**Approved WPS:** Yes No N/A**Delayed / Cancelled:** Yes No N/A**Bridge No:** 34-0006**Component:** OBG**Summary of Items Observed:**

WELDING INSPECTION REPORT

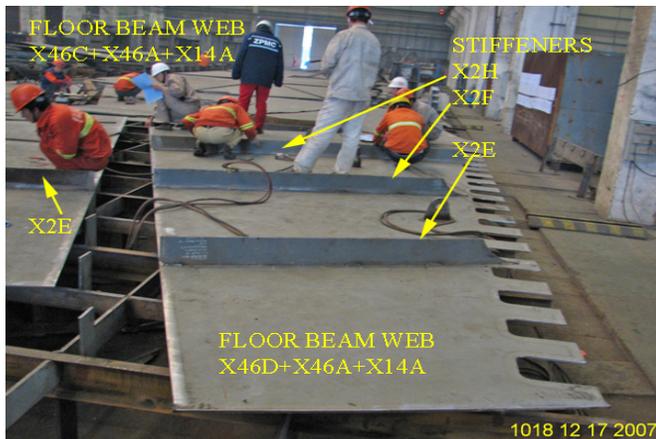
The QA Inspector randomly observed a ZPMC torch cutter utilizing a track mounted torch cutting apparatus to remove lifting lugs from the edges of Floor Beam Webs X46D+X46A+X14A (WJ's FB001-01-021, 026) and X46C+X46A+X14A (FB007-01-021, 026). The attached photograph provides additional detail.

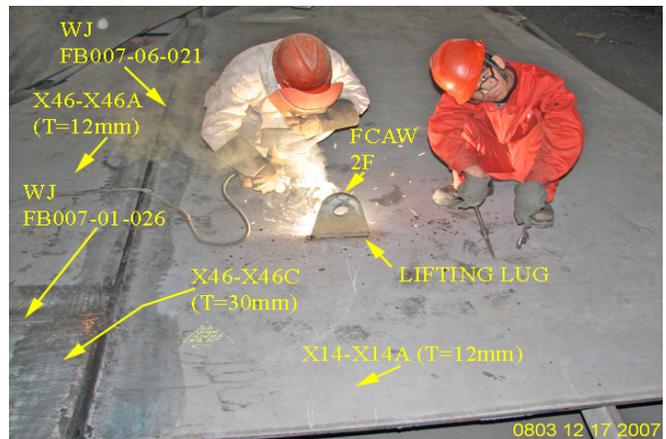
The QA Inspector randomly observed ZPMC welder Wang Changfu ID Number 058102, utilizing the Shielded Metal Arc Welding (SMAW) Process with ZPMC approved Weld Procedure Specification (WPS) WPS-B-P-2112 in the 2F position to weld lifting lugs to Floor Beam Sub-Assemblies X46C+X46A+X14A (WJ's FB007-06-021, 026), X94A+X47A+X15A (WJ's FB008-04-023, 026), X46C+X46A+X14A (WJ's FB007-05-021, 026) and X94A+X47A+X15A (WJ's FB008-05-023, 026). The QA Inspector randomly observed ZPMC CWI Li Jianjiang, monitoring weld parameters for the welding of the lifting lugs on Floor Beam Sub-Assembly X46C+X46A+X14A (WJ's FB007-05-021, 026). The QA Inspector also randomly monitored weld parameters and documented them as follows: 160 amps and 24 volts. The weld parameters appeared to comply with contract requirements. The attached photograph provides additional detail.

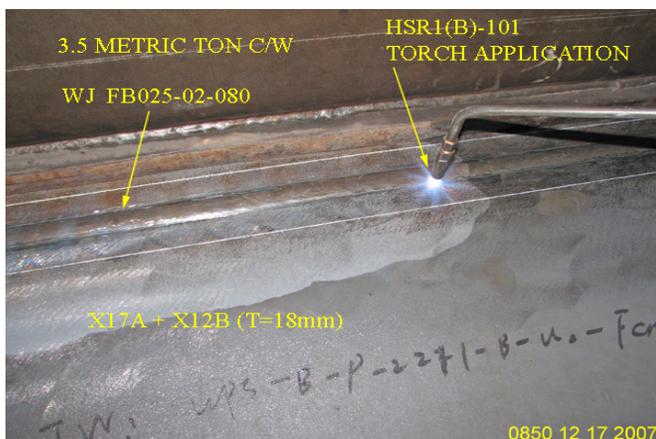
The QA Inspector observed ZPMC personnel performing heat straightening operations with a rose bud on Floor Beam Sub-Assemblies per ZPMC Heat Straightening Request (HSR) HSR1(B)-101, X17A + X12B (WJ FB025-02-080), HSR1(B)-098, X18A + X12F (WJ018-02-080), HSR1(B)-100, X17B + X12B (WJ FB025-01-080) and HSR1(B)-097, X18A + X12E (WJ FB018-01-080). The attached photograph provides additional detail.

The QA Inspector randomly observed ZPMC welder Ren Jinzhu ID Number 0544837, utilizing the Shielded Metal Arc Welding (SMAW) Process with ZPMC approved Weld Procedure Specification (WPS) WPS-B-P-2112 in the 2F position to weld tack weld gusset stiffeners piece marks X3K and X3L to Floor Beam Webs X46D+X46A+X14A (WJ's FB001-01-021, 026) and X46C+X46A+X14A (WJ's FB007-01-021, 023). The WJ's identify the Floor Beam Webs and are not the I-Stiffener to Floor Beam Web WJ's. The attached photographs provide additional detail.
