DEPARTMENT OF TRANSPORTATION

Quality Assurance and Source Inspection

Contract #: 04-0120F4Cty: SF/ALA Rte: 80 PM: 13.2/13.9File #: 69.28**WELDING INSPECTION REPORT****Resident Engineer:** Pursell, Gary**Address:** 333 Burma Road**City:** Oakland, CA 94607**Report No:** WIR-001064**Date Inspected:** 12-Dec-2007**Project Name:** SAS Superstructure**OSM Arrival Time:** 730**Prime Contractor:** American Bridge/Fluor Enterprises, a JV**OSM Departure Time:** 1500**Contractor:** Zhenhua Port Machinery Company, Ltd (ZPMC), Changxing Island **Location:** Shanghai, China**CWI Name:** See Below**CWI Present:** Yes No**Inspected CWI report:** Yes No N/A**Rod Oven in Use:** Yes No N/A**Electrode to specification:** Yes No N/A**Weld Procedures Followed:** Yes No N/A**Qualified Welders:** Yes No N/A**Verified Joint Fit-up:** Yes No N/A**Approved Drawings:** Yes No N/A**Approved WPS:** Yes No N/A**Delayed / Cancelled:** Yes No N/A**Bridge No:** 34-0006**Component:** OBG**Summary of Items Observed:**

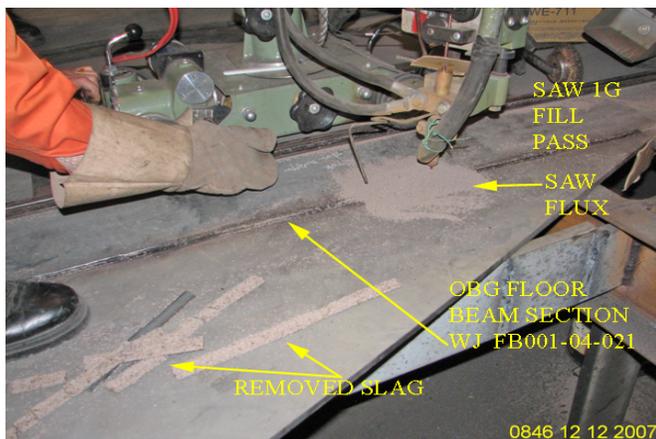
The QA Inspector randomly observed ZPMC welder Wang Min ID Number 048296, utilizing the SAW Process with approved ZPMC WPS WPS-B-P-2221-B-L2c-S-1 in the 1G position to weld the fill and cover passes on Floor Beam Sections at Weld Joint (WJ) FB008-04-023. The QA Inspector observed ZPMC CWI Zhang Zhong monitoring weld parameters. The QA Inspector also performed random verification of the weld parameters and documented them as follows: welding amperage 506 amps, welding voltage 31.4 volts with a travel speed of 446 millimeters (mm) per minute. Weld parameters appeared to comply with the above approved ZPMC WPS. The attached photograph provides additional detail.

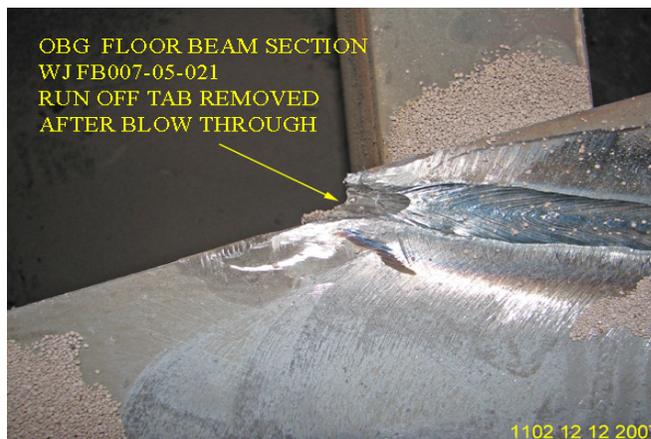
The QA Inspector randomly observed ZPMC welder Huang Xin Lan ID Number 044780, utilizing the SAW Process with approved ZPMC WPS WPS-B-P-2221-B-L2c-S-1 in the 1G position to weld the fill and cover passes on Floor Beam Sections at WJ FB001-04-021. The QA Inspector observed ZPMC CWI Cui Yi Ru monitoring weld parameters. The QA Inspector also performed random verification of the weld parameters and documented them as follows: welding amperage 504 amps, welding voltage 31.2 volts with a travel speed of 412 mm per minute. Weld parameters appeared to comply with the above approved ZPMC WPS. The attached photograph provides additional detail.

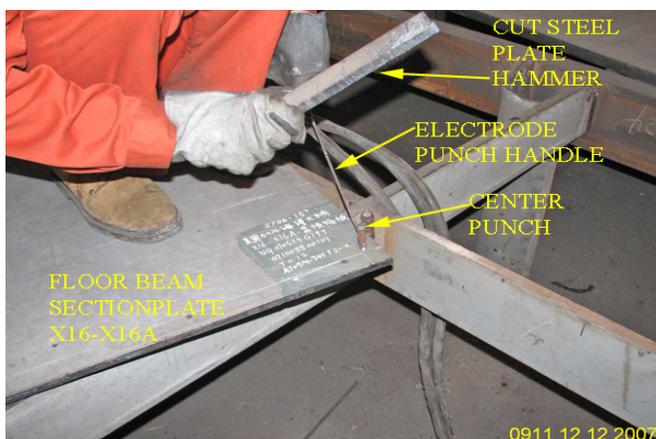
The QA Inspector randomly observed ZPMC welder Wang Min ID Number 048296, utilizing the SAW Process with approved ZPMC WPS WPS-B-P-2221-B-L2c-S-1 in the 1G position to weld the fill and cover passes on Floor Beam Sections at WJ FB007-06-021. The QA Inspector observed ZPMC CWI Zhang Zhong monitoring weld parameters. The QA Inspector also performed random verification of the weld parameters and documented them as follows: 520 amps, 31.3 volts with a travel speed of 422mm per minute. The QA Inspector randomly observed that the run on tab fell off right at the start of the welding. The run on tab was re-attached and welding resumed. Weld parameters appeared to comply with the above approved ZPMC WPS. The attached photograph provides additional information.
