Contract #: 04-0120F4Cty: SF/ALA Rte: 80 PM: 13.2/13.9File #: 69.28**WELDING INSPECTION REPORT****Resident Engineer:** Pursell, Gary**Address:** 333 Burma Road**City:** Oakland, CA 94607**Report No:** WIR-001065**Date Inspected:** 11-Dec-2007**Project Name:** SAS Superstructure**OSM Arrival Time:** 730**Prime Contractor:** American Bridge/Fluor Enterprises, a JV**OSM Departure Time:** 1500**Contractor:** Zhenhua Port Machinery Company, Ltd (ZPMC), Changxing Island **Location:** Shanghai, China**CWI Name:** See Below**CWI Present:** Yes No**Inspected CWI report:** Yes No N/A**Rod Oven in Use:** Yes No N/A**Electrode to specification:** Yes No N/A**Weld Procedures Followed:** Yes No N/A**Qualified Welders:** Yes No N/A**Verified Joint Fit-up:** Yes No N/A**Approved Drawings:** Yes No N/A**Approved WPS:** Yes No N/A**Delayed / Cancelled:** Yes No N/A**Bridge No:** 34-0006**Component:** OBG**Summary of Items Observed:**

WELDING INSPECTION REPORT

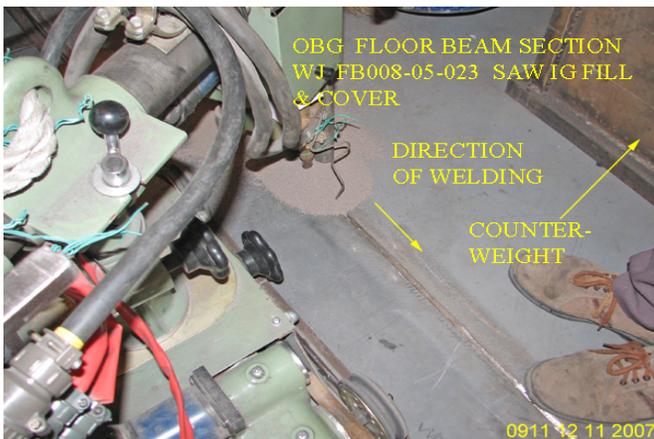
Process with approved ZPMC WPS WPS-B-P-2221-B-L2c-S-1 in the 1G position to weld the fill and cover passes on Floor Beam Sections at WJ FB007-04-021. The QA Inspector observed ZPMC CWI Cui Yi Ru monitoring weld parameters. The QA Inspector also performed random verification of the weld parameters and documented them as follows: welding amperage 507 amps, welding voltage 31.2 volts with a travel speed of 457 mm per minute. Weld parameters appeared to comply with the above approved ZPMC WPS. The attached photograph provides additional detail.

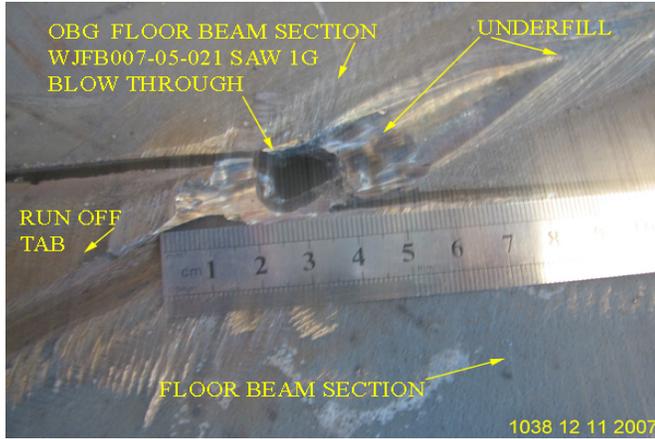
The QA Inspector randomly observed ZPMC welder Wang Min ID Number 048296, utilizing the SAW Process with approved ZPMC WPS WPS-B-P-2221-B-L2c-S-1 in the 1G position to weld the fill and cover passes on Floor Beam Sections at WJ FB007-05-021. The QA Inspector observed ZPMC CWI Zhang Zhong monitoring weld parameters. The QA Inspector also performed random verification of the weld parameters and documented them as follows: welding amperage 531 amps, welding voltage 31.6 volts with a travel speed of 390mm per minute. The QA Inspector randomly observed that at the end of one of the fill passes, the SAW welding apparatus blew through the the tip of the run off tab and that there was an area of underfill prior to the blow through. Welding was discontinued at that point to allow for the removal and replacement of the blown through run off tab. Weld parameters appeared to comply with the above approved ZPMC WPS. The attached photograph provides additional information.
