Contract #: 04-0120F4Cty: SF/ALA Rte: 80 PM: 13.2/13.9File #: 69.28**WELDING INSPECTION REPORT****Resident Engineer:** Pursell, Gary**Address:** 333 Burma Road**City:** Oakland, CA 94607**Report No:** WIR-001066**Date Inspected:** 10-Dec-2007**Project Name:** SAS Superstructure**OSM Arrival Time:** 730**Prime Contractor:** American Bridge/Fluor Enterprises, a JV**OSM Departure Time:** 1500**Contractor:** Zhenhua Port Machinery Company, Ltd (ZPMC), Changxing Island **Location:** Shanghai, China**CWI Name:** See Below**CWI Present:** Yes No**Inspected CWI report:** Yes No N/A**Rod Oven in Use:** Yes No N/A**Electrode to specification:** Yes No N/A**Weld Procedures Followed:** Yes No N/A**Qualified Welders:** Yes No N/A**Verified Joint Fit-up:** Yes No N/A**Approved Drawings:** Yes No N/A**Approved WPS:** Yes No N/A**Delayed / Cancelled:** Yes No N/A**Bridge No:** 34-0006**Component:** OBG**Summary of Items Observed:**

Bay 7 OBG:

WELDING INSPECTION REPORT

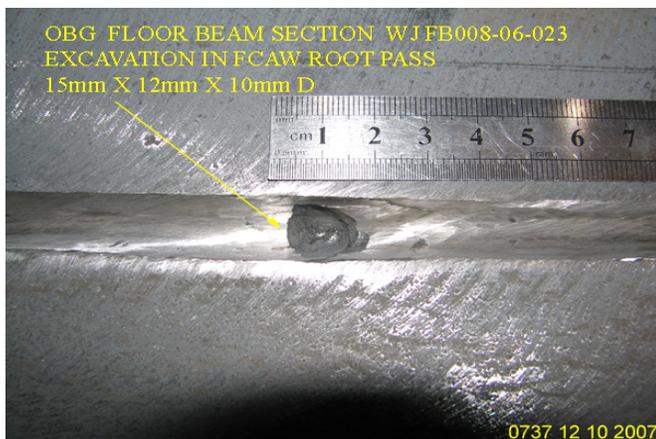
The QA Inspector randomly observed ZPMC welder Chen Chuanzong ID Number 044824, utilizing the Flux Cored Arc Welding (FCAW) Process with approved ZPMC Weld Procedure Specification (WPS) WPS-B-T-2231-B-U2-F-1, to fill small excavations in the root passes in Floor Beam Sections at Weld Joint (WJ) Numbers FB008-06-023, FB015-04-023 and FB001-04-021 prior to the Submerged Arc Welding (SAW) of the fill and cover passes. The attached photograph provides additional detail.

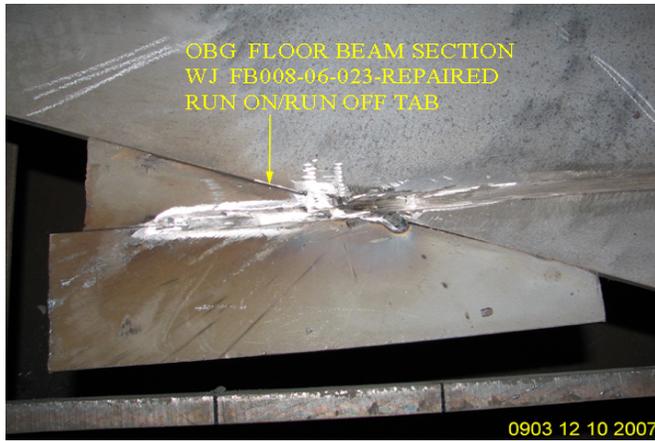
The QA Inspector randomly observed that run on/run off tabs were being bent over almost at right angles to the Floor Beam Section WJ's that they were attached to during the handling of the Floor Beam Sections. The attached photographs provide additional detail.
