**DEPARTMENT OF TRANSPORTATION**

Contract #: 04-0120F4Cty: SF/ALA Rte: 80 PM: 13.2/13.9File #: 69.28**WELDING INSPECTION REPORT****Resident Engineer:** Pursell, Gary**Address:** 333 Burma Road**City:** Oakland, CA 94607**Report No:** WIR-001073**Date Inspected:** 25-Dec-2007**Project Name:** SAS Superstructure**OSM Arrival Time:** 2300**Prime Contractor:** American Bridge/Fluor Enterprises, a JV**OSM Departure Time:** 730**Contractor:** Zhenhua Port Machinery Company, Ltd (ZPMC), Changxing Island **Location:** Shanghai, China**CWI Name:** Sha Zhi, Xu Lefeng**CWI Present:** Yes No**Inspected CWI report:** Yes No N/A**Rod Oven in Use:** Yes No N/A**Electrode to specification:** Yes No N/A**Weld Procedures Followed:** Yes No N/A**Qualified Welders:** Yes No N/A**Verified Joint Fit-up:** Yes No N/A**Approved Drawings:** Yes No N/A**Approved WPS:** Yes No N/A**Delayed / Cancelled:** Yes No N/A**Bridge No:** 34-0006**Component:** Caltrans Mock-Up**Summary of Items Observed:**

# WELDING INSPECTION REPORT

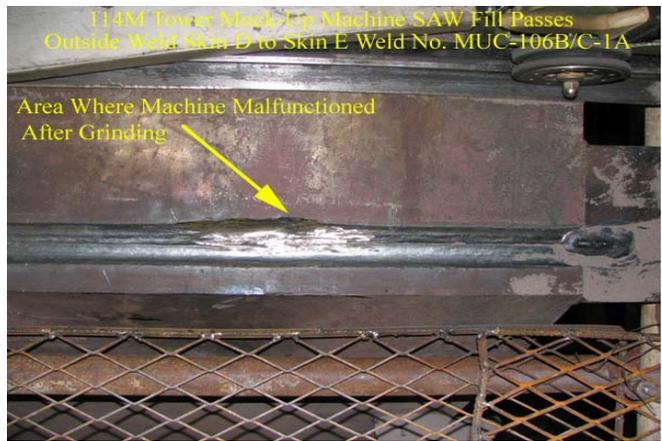
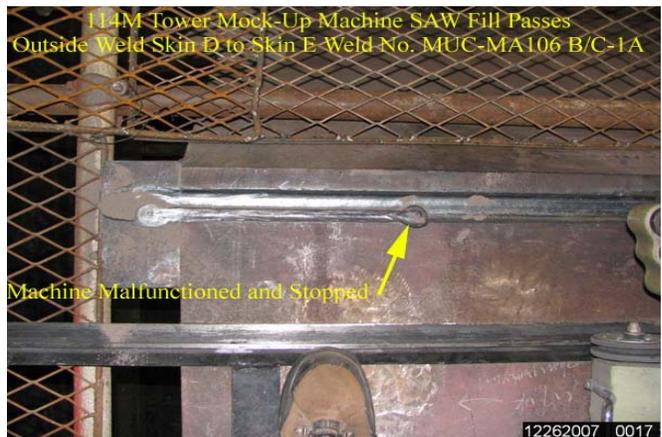
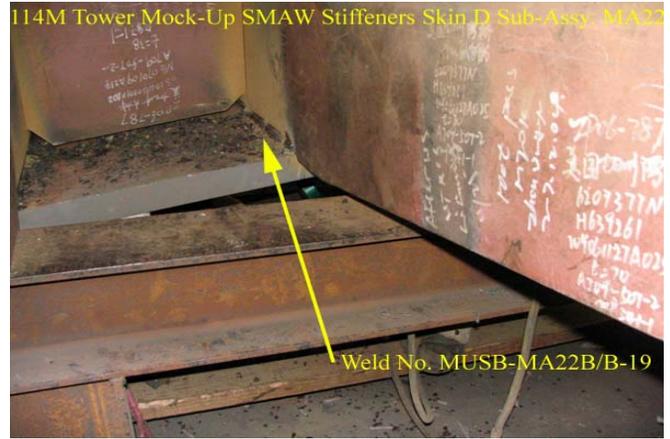
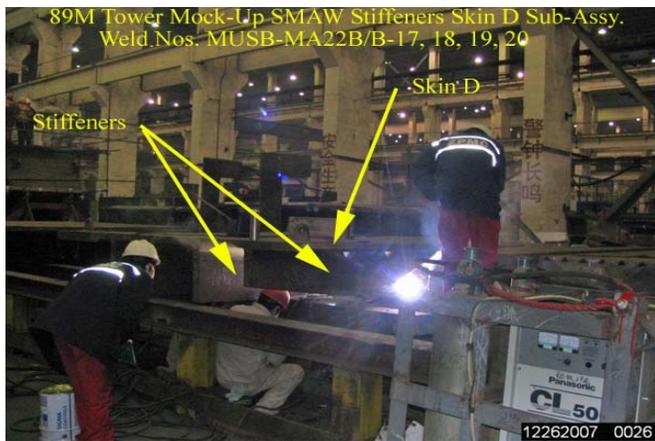
The Caltrans QA Inspector randomly observed machine Submerged Arc Welding (SAW) of fill passes on the Upper Shaft Assembly of the 114M Tower Mock-Up, Weld No. MUC-MA106 B/C-1A. This is the outside weld of Skin D to Skin E. This is a complete joint penetration (CJP) groove weld and was being welded in the flat groove (1G) welding position. The welding operator was Yun Chaunjin (I.D. No. 0503060), whose qualifications for this welding are listed in ZPMC's Master List of Welders/Welding Operators/Tack Welders, Revision 7. Welding Procedure Specification (WPS) No. WPS-B-T-2221-C-U2b-S was being used for this weld. ZPMC CWI, Xu Lefeng (CWI No. 07031411) was present during this welding. The QA Inspector also noted that documentation of minimum/maximum preheat/interpass temperatures, voltage, amperage and travel speed by the CWI were within the specified ranges of the WPS up until the time of random observation. The QA Inspector observed that, during the welding of the first pass of his observation, that the machine malfunctioned and stopped, and did not resume for the rest of the observation, nor was it in operation during a later observation, approximately two hours later.

The Caltrans QA Inspector also randomly observed the manual Shielded Metal Arc Welding (SMAW) on the 89M Tower Mock-Up, Weld Nos. MUSB-MA22 B/B-17 thru 20. These welds join stiffener Piece Marks mp535b and mp536b to Piece Mark p1009.

This is part of Skin D Sub-Assembly MA22 shown on Drawing MUSB-MA22B/B. These are partial joint

penetration (PJP) groove weld and were being welded in the horizontal groove (2G) welding position. The four welders were Yang Shui Wei (I.D. No. 066280), Cao Tao (I.D. No. 066163), Liang Yanhai (I.D. No. 066457), and Tan Xiang (I. D. No. 066459; all of whose qualifications for this welding are listed in ZPMC's Master List of Welders/Welding Operators/Tack Welders, Revision 7. Welding Procedure Specification (WPS) WPS-B-T-4312-TC-P5-1-S was being used for this welding. The specified electrode, THJ506-Fe-1 (E7018-1) was being used and portable electrode ovens were in use. It was observed that preheating was being utilized. ZPMC CWI, Sha Zhi (CWI No. 07081551) was present during this welding as was Bureau Veritas Inspector, Zhang Xu Wang. The QA Inspector also noted that ZPMC's documentation of minimum/maximum preheat/interpass temperatures, voltage, amperage and travel speed by the CWI were within the specified ranges of the WPS for the passes welded during the time of observation. The QA Inspector also randomly measured the amperage and voltage by use of a calibrated Fluke amp/volt meter.

The Caltrans QA Inspector also randomly observed the arc gouging and grinding on the inside of the joint between Skin A and Skin B on the 77M Tower Mock-Up in order to increase the groove angle from 30° to 45°. The outside of this joint was tacked during this operation and no preheat was applied.

All observations appeared to meet the requirements of the job specifications.
