Contract #: 04-0120F4Cty: SF/ALA Rte: 80 PM: 13.2/13.9File #: 69.28**WELDING INSPECTION REPORT****Resident Engineer:** Pursell, Gary**Address:** 333 Burma Road**City:** Oakland, CA 94607**Report No:** WIR-001076**Date Inspected:** 04-Dec-2007**Project Name:** SAS Superstructure**OSM Arrival Time:** 630**Prime Contractor:** American Bridge/Fluor Enterprises, a JV**OSM Departure Time:** 1530**Contractor:** Zhenhua Port Machinery Company, Ltd (ZPMC), Changxing Island **Location:** Shanghai, China**CWI Name:** Mr. Sha Zhi**CWI Present:** Yes No**Inspected CWI report:** Yes No N/A**Rod Oven in Use:** Yes No N/A**Electrode to specification:** Yes No N/A**Weld Procedures Followed:** Yes No N/A**Qualified Welders:** Yes No N/A**Verified Joint Fit-up:** Yes No N/A**Approved Drawings:** Yes No N/A**Approved WPS:** Yes No N/A**Delayed / Cancelled:** Yes No N/A**Bridge No:** 34-0006**Component:** Tower Fabrication**Summary of Items Observed:**

Tower Mock Up:

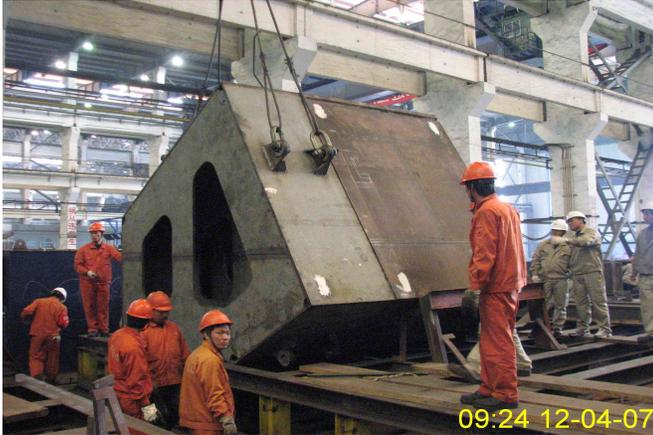
The Caltrans Quality Assurance (QA) Inspector observed ZPMC personnel removing scaffolding from 114 M elevation tower mockup assembly. This tower mockup has been tack welded together, and final welding has not been started. Per discussion with American Bridge/Fluor Enterprises, joint venture (ABF) fabrication supervisor Mr. John Hamer, ZPMC Quality Control personnel will perform weld joint inspections as detailed in the "Dimensional Control Plan" hold point step #7 reference drawing FP-MUA-24 after the 114 M tower mockup assembly dimensions are verified using a tower mockup jig. Below is a photograph showing the tower mockup dimensional jig being positioned along side the 114M tower mockup assembly.
