Contract #: 04-0120F4Cty: SF/ALA Rte: 80 PM: 13.2/13.9File #: 69.28**WELDING INSPECTION REPORT****Resident Engineer:** Pursell, Gary**Address:** 333 Burma Road**City:** Oakland, CA 94607**Report No:** WIR-001125**Date Inspected:** 07-Dec-2007**Project Name:** SAS Superstructure**OSM Arrival Time:** 1400**Prime Contractor:** American Bridge/Fluor Enterprises, a JV**OSM Departure Time:** 2330**Contractor:** Zhenhua Port Machinery Company, Ltd (ZPMC), Changxing Island **Location:** Shanghai, China**CWI Name:** Zhu Zhong Hai**CWI Present:** Yes No**Inspected CWI report:** Yes No N/A**Rod Oven in Use:** Yes No N/A**Electrode to specification:** Yes No N/A**Weld Procedures Followed:** Yes No N/A**Qualified Welders:** Yes No N/A**Verified Joint Fit-up:** Yes No N/A**Approved Drawings:** Yes No N/A**Approved WPS:** Yes No N/A**Delayed / Cancelled:** Yes No N/A**Bridge No:** 34-0006**Component:** 114 meter mock up assembly**Summary of Items Observed:**

WELDING INSPECTION REPORT

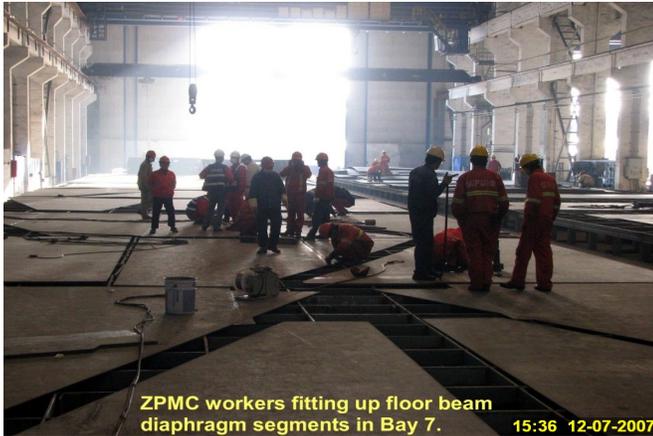
Bay 7: The QA inspector observed ZPMC workers fitting floor beam diaphragm (FB) components together and preparing to tack weld the assembly. The QA inspector randomly observed weld joint 004 of several floor beam assemblies. The fit up preparations that were observed by the QA inspector appeared to be conforming to the contract requirements. The QA inspector did not observe the final fit-up of these parts. The QA inspector observed a ZPMC crew checking the flatness of weld 026 and their associated plates on FB008-01. The QA inspector noted that the plates appear to have significant distortion but there was no immediate access to measure these observations.
