DEPARTMENT OF TRANSPORTATION

Quality Assurance and Source Inspection

Contract #: 04-0120F4Cty: SF/ALA Rte: 80 PM: 13.2/13.9File #: 69.28**WELDING INSPECTION REPORT****Resident Engineer:** Pursell, Gary**Address:** 333 Burma Road**City:** Oakland, CA 94607**Report No:** WIR-001130**Date Inspected:** 02-Jan-2008**Project Name:** SAS Superstructure**OSM Arrival Time:** 630**Prime Contractor:** American Bridge/Fluor Enterprises, a JV**OSM Departure Time:** 1530**Contractor:** Zhenhua Port Machinery Company, Ltd (ZPMC), Changxing Island **Location:** Shanghai, China**CWI Name:** ZPMC- Fu Gua Gang**CWI Present:** Yes No**Inspected CWI report:** Yes No N/A**Rod Oven in Use:** Yes No N/A**Electrode to specification:** Yes No N/A**Weld Procedures Followed:** Yes No N/A**Qualified Welders:** Yes No N/A**Verified Joint Fit-up:** Yes No N/A**Approved Drawings:** Yes No N/A**Approved WPS:** Yes No N/A**Delayed / Cancelled:** Yes No N/A**Bridge No:** 34-0006**Component:** 77m, 89m, 114m and #1 deck mock-ups**Summary of Items Observed:**

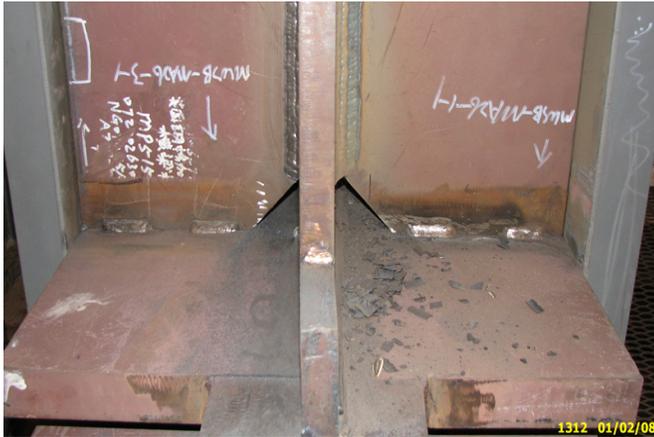
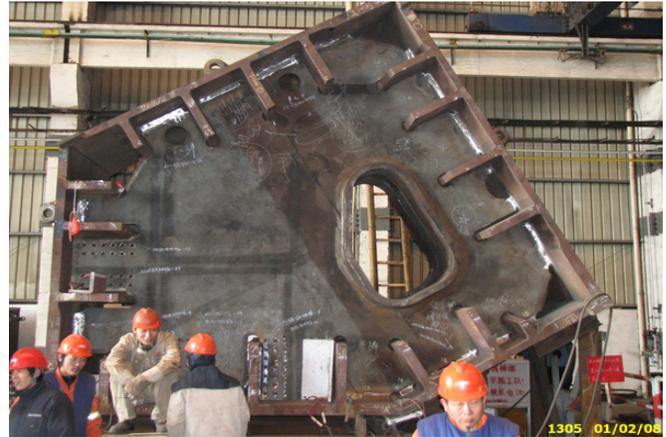
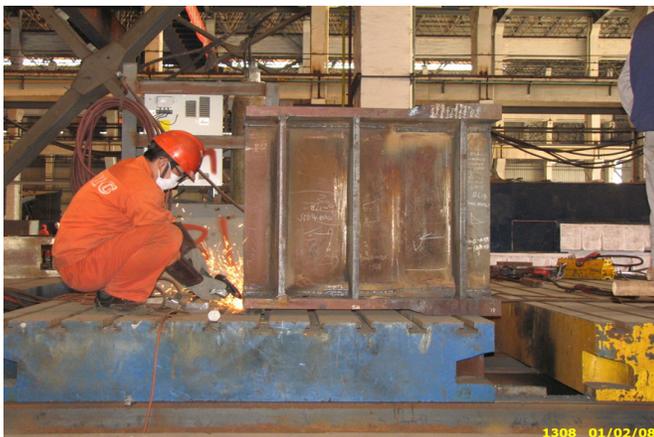
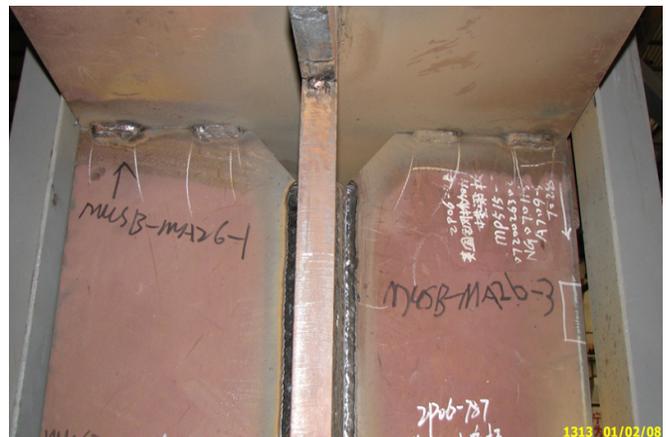
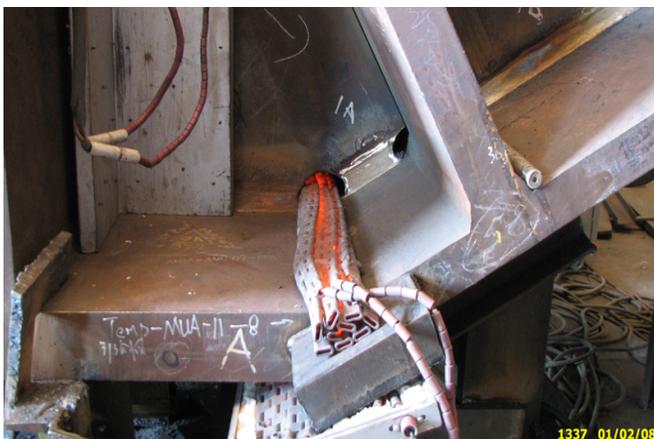
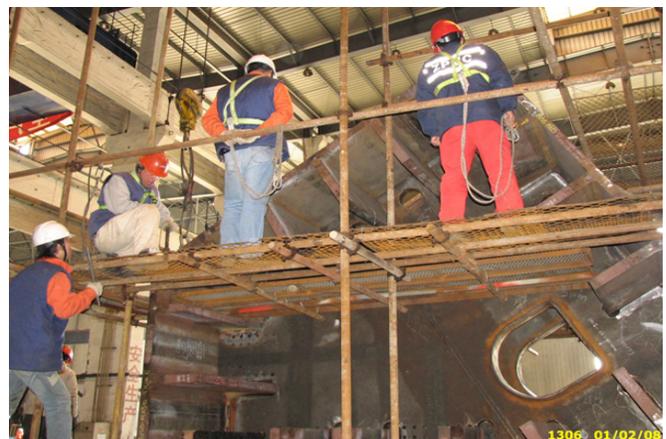
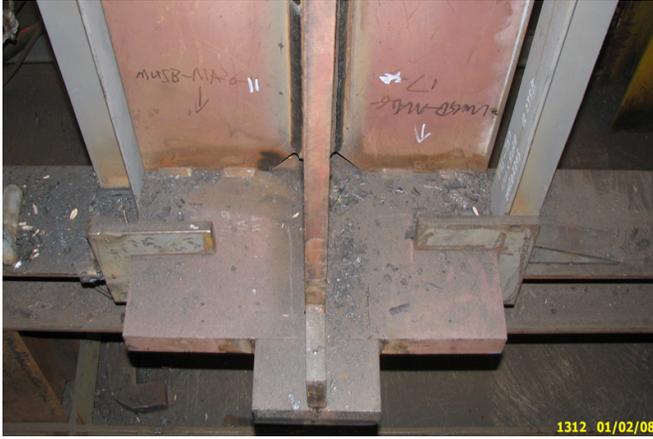
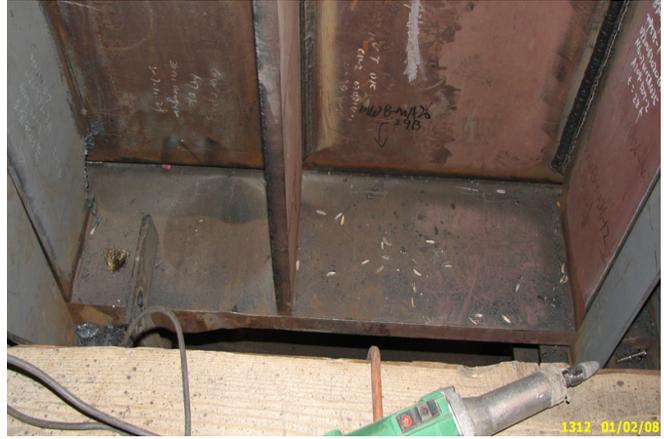
Bay 1: Submerged Arc Weld (SAW) gantry welder is inactive. Caltrans representatives, Mr. Alfredo Acuna and Mr. Larry Viars, were present on the #1 Deck mock-up where they were capturing weld profile data that corresponded with Ultrasonic Testing (UT) inspection data from days previous. The Caltrans representative assisted these representatives by photographing diaphragm to closed U-rib attachment welds and significant weld discrepancies on various weld joints. Photographs were transferred to Mr. Acuna for reporting purposes.

Bay 2 operations: The 77m mock-up has ongoing thermal operations with multiple ceramic heating pads being placed on diaphragm to plate attachment welds. A to B attachment weld for joint MUA-MA1 D/F -14A under WPS-B-T-2232-B-U4b-F is also being heated for ZPMC welders Zhang Binghua (053316) and Wang Bing (048696) with ZPMC Certified Welding Inspector (CWI) Fu Gua Gang being present. MUSA-SA104 A/B-10 has root pass completed. Preheat was active and joint was in process for additional fill passes with ZPMC welder Jiang Xiaohu (066155) performing Shielded Metal Arc Weld (SMAW) process. No welding parameters were noted.

MUSB-MA25 and MUSB-MA26-1 and -2 shear links are idle and awaiting web to flange weld out.

89m MUSB-MA29 Cross Brace has had heat straightening operations performed and stiffener components that

have been tack welded and have root passes already in place however, the component remains incomplete and inactive.

114m upper and lower mock-up sections are idle while awaiting the approved repair procedures.

Included below are digital pictures that support the observations recorded within this report.
