**DEPARTMENT OF TRANSPORTATION**

Contract #: 04-0120F4Cty: SF/ALA Rte: 80 PM: 13.2/13.9File #: 69.28**WELDING INSPECTION REPORT****Resident Engineer:** Pursell, Gary**Address:** 333 Burma Road**City:** Oakland, CA 94607**Report No:** WIR-001136**Date Inspected:** 26-Nov-2007**Project Name:** SAS Superstructure**OSM Arrival Time:** 630**Prime Contractor:** American Bridge/Fluor Enterprises, a JV**OSM Departure Time:** 1530**Contractor:** Zhenhua Port Machinery Company, Ltd (ZPMC), Changxing Island **Location:** Shanghai, China**CWI Name:** Lu Jian Ping**CWI Present:** Yes No**Inspected CWI report:** Yes No N/A**Rod Oven in Use:** Yes No N/A**Electrode to specification:** Yes No N/A**Weld Procedures Followed:** Yes No N/A**Qualified Welders:** Yes No N/A**Verified Joint Fit-up:** Yes No N/A**Approved Drawings:** Yes No N/A**Approved WPS:** Yes No N/A**Delayed / Cancelled:** Yes No N/A**Bridge No:** 34-0006**Component:** Tower Mock-up and OBG**Summary of Items Observed:**

CALTRANS Quality Assurance (QA) Inspector, Alfredo Acuna was present for the fabrication scheduled for this project at the ZPMC facility in Shanghai, China for the San Francisco Oakland Bay Self Anchored Suspension

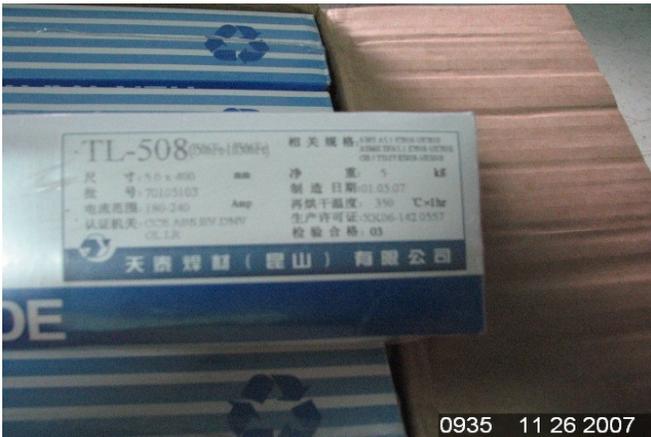
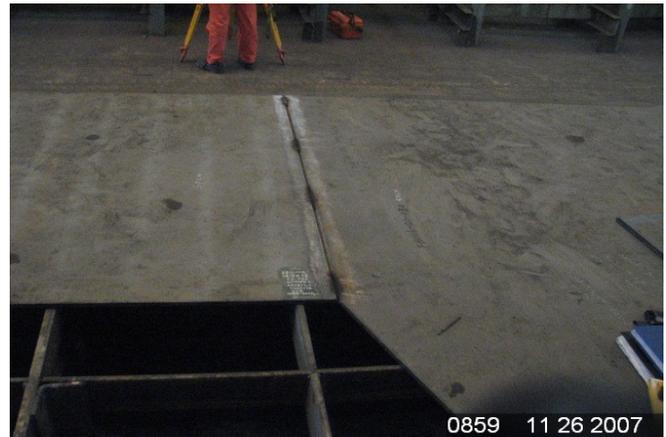
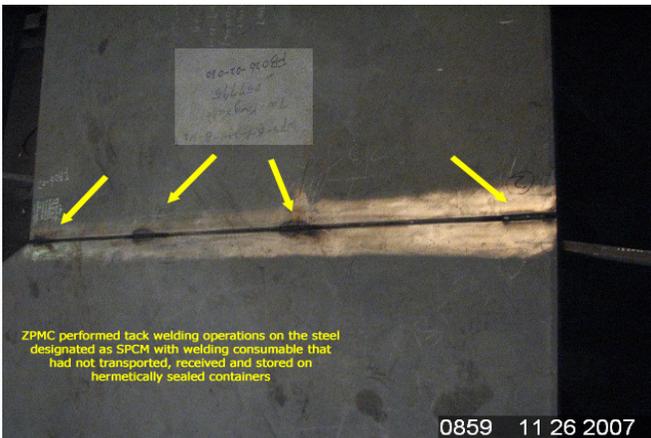
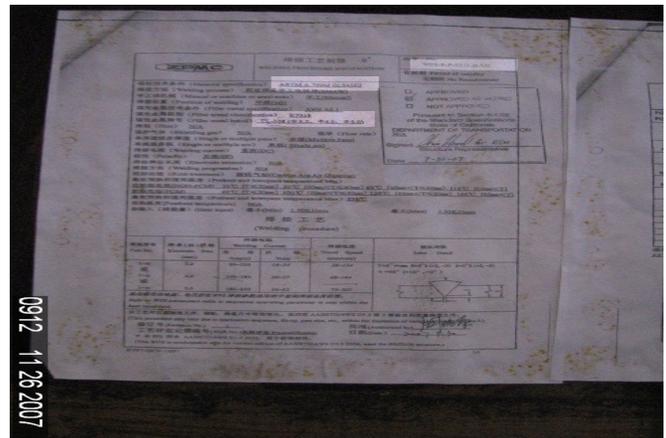
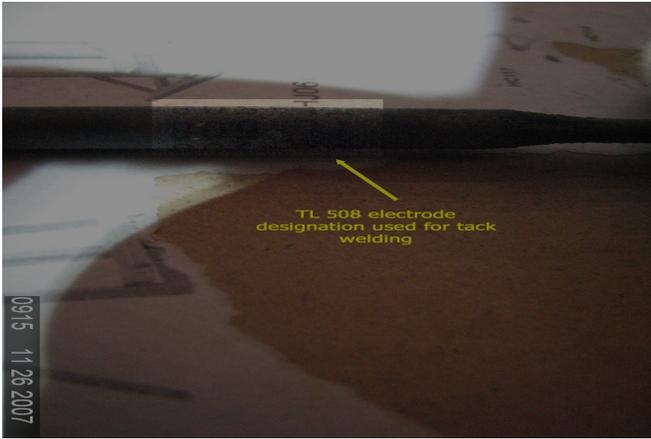
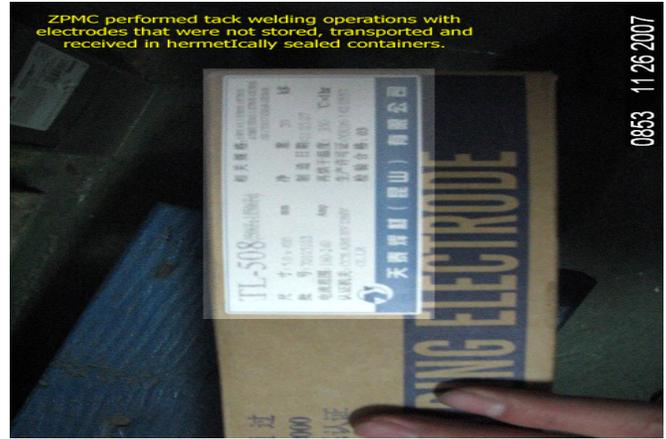
## 1 Floor Beams SPCM Tack Welding

The QA inspector observed ZPMC setting up the welding machine before starting the tack welding operations on a Seismic Performance Critical Member (SPCM) with the shielded metal arc welding with 4.0 diameter brand name TL-508 electrode using the Welding Procedure Specification WPS-B-P-2211-B-U2 as shown on the photograph below. The QA inspector had a conversation with ZPMC representative Lay Tao. The QA inspector asked Mr. Lay Tao if the electrodes (TL-508) that ZPMC were going to use were transported, delivered and stored in hermetically sealed containers. Mr. Lay Tao informed to the QA inspector that he did not know at this time. Mr. Lay Tao and the QA inspector went to the electrode storage and verified that the welding consumable that ZPMC was going to use were not storage in hermetically sealed containers. The QA inspector asked Mr. Lay Tao if ZPMC had already used these electrodes to perform tack welding operations on another locations. After Mr. Lay Tao inquired to the ZPMC welding supervisors on the Bay 7 shop, Mr. Lay Tao said to the QA inspector that ZPMC had already tack welded two plates with the TL-508 electrodes. The floor beams joints designations FB026-02-080 and FB26-01-080 as shown on the photographs below.

Smith. The QA inspector brought to the attention of ABF representatives that ZPMC tack welded SPCM material with electrodes that were not transported, delivered and stored in hermetically sealed containers. The QA inspector added that ZPMC had other electrodes with AWS designation E-7018-1 TL-506 that ZPMC could use for tack welding SPCM material.

ZPMC representative, ABF representatives and the QA inspector went to the ZPMC electrode storage. ABF representative agreed that ZPMC was using electrodes(TL-508) that were transported, delivered and had stored the electrode directly on carton boxes in lieu of hermetically sealed containers. ABF representatives said that the tack welds were going to be removed and the tacks would be rewelded. The QA inspector had a conversation with Task Leader Jimmy Cochran. The QA inspector brought to the attention of the resolution of ABF representatives. The photos below shows the electrode use and the locations were ZPMC performed tack welding operations.

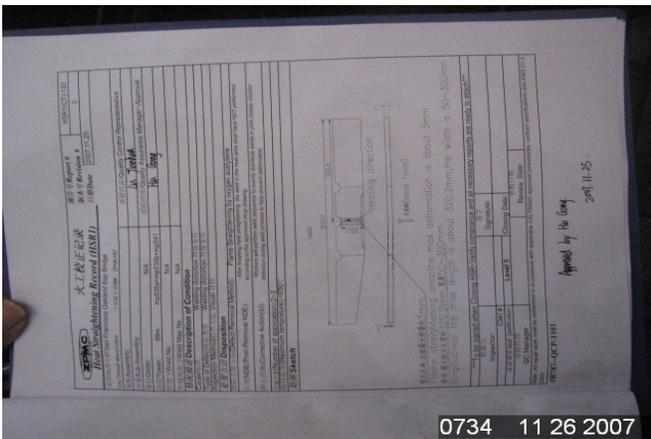
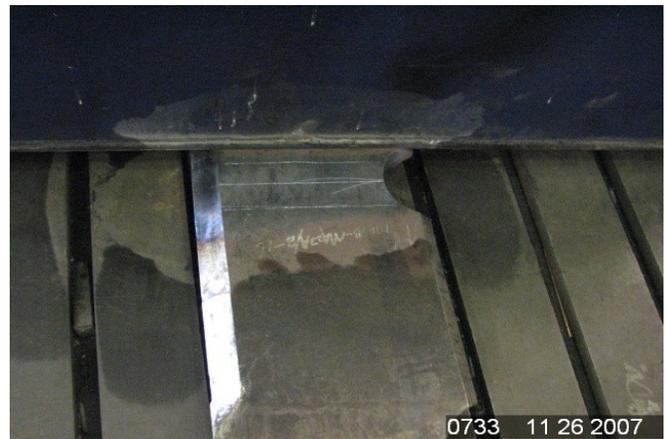
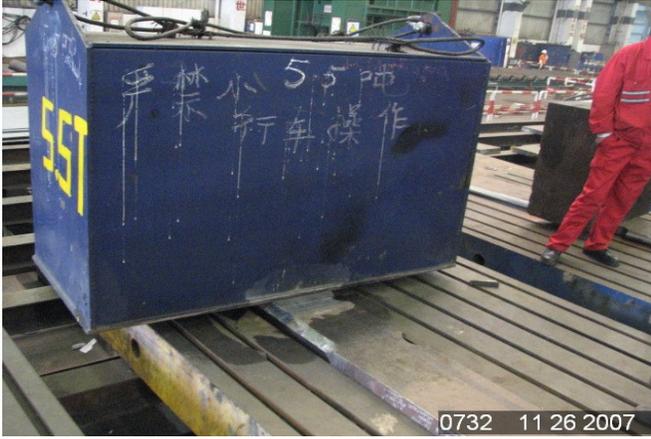
2 Tower Mock-up 89 M Heat straightening

The QA inspector observed ZPMC performing heat straightening operation on the longitudinal stiffeners from the skin panel D. ZPMC was applying heat by the weld area while ZPMC set a 5.5 Tons at the other side. ZPMC was heat straightening at the junction of the plate mp535a and 535b, weld joint # 16. The QA inspector arrived when ZPMC was completing the heat straightening operations at approximately 0734 hours. The QA inspector touch the steel on other longitudinal stiffener and found that the longitudinal stiffener was warm even though the atmosphere temperature was approximately below 50 degrees Fahrenheit temperature. The QA inspector asked to ZPMC supervisor on the shop, what time ZPMC had performed the heat straightening operations because the steel was still warm. ZPMC said that ZPMC did not heat straightened the steel. ZPMC just removed the moisture of the steel before tack welding. The QA inspector had a conversation with the Caltrans Task Leader Jimmy Cochran. The QA inspector informed Mr. Jimmy Cochran that ZPMC was performing heat straightening operations on the longitudinal stiffener that was not per the Heat straightening request and that it was questionable when ZPMC started the heat straightening operations.
