DEPARTMENT OF TRANSPORTATION

Quality Assurance and Source Inspection

Contract #: 04-0120F4Cty: SF/ALA Rte: 80 PM: 13.2/13.9File #: 69.28**WELDING INSPECTION REPORT****Resident Engineer:** Pursell, Gary**Address:** 333 Burma Road**City:** Oakland, CA 94607**Report No:** WIR-001144**Date Inspected:** 02-Jan-2008**Project Name:** SAS Superstructure**OSM Arrival Time:** 2300**Prime Contractor:** American Bridge/Fluor Enterprises, a JV**OSM Departure Time:** 730**Contractor:** Zhenhua Port Machinery Company, Ltd (ZPMC), Changxing Island **Location:** Shanghai, China**CWI Name:** Chen Xi**CWI Present:** Yes No**Inspected CWI report:** Yes No N/A**Rod Oven in Use:** Yes No N/A**Electrode to specification:** Yes No N/A**Weld Procedures Followed:** Yes No N/A**Qualified Welders:** Yes No N/A**Verified Joint Fit-up:** Yes No N/A**Approved Drawings:** Yes No N/A**Approved WPS:** Yes No N/A**Delayed / Cancelled:** Yes No N/A**Bridge No:** 34-0006**Component:** Caltrans Mock-Up**Summary of Items Observed:**

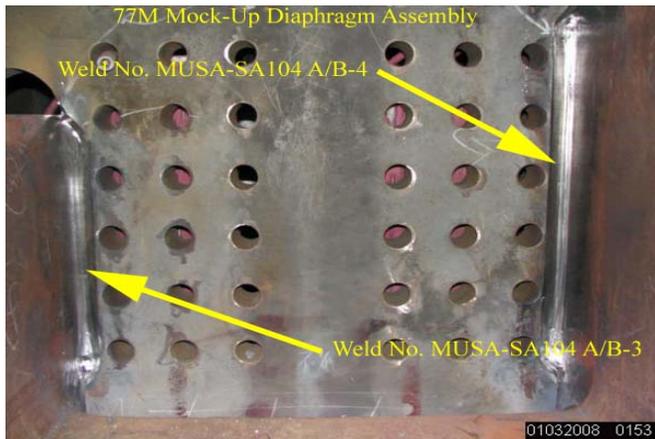
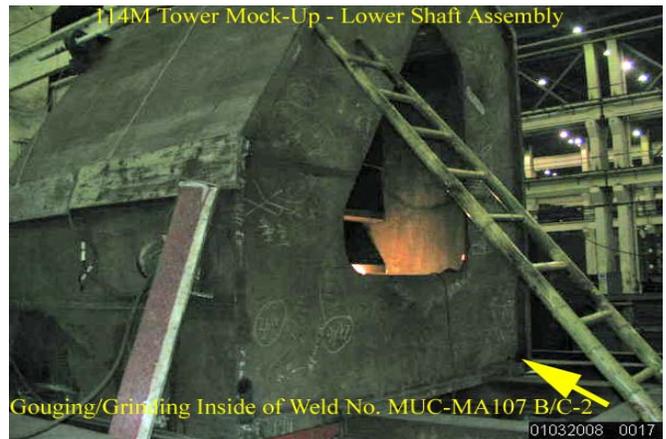
The Caltrans QA Inspector randomly observed the manual Shielded Metal Arc Welding (SMAW) on the 89M Tower Mock-Up, Weld No. MUSB-MA26-30A-1. Welder, Wang Zhong Hua (I. D. 053753), welded the first pass of the shift and Dai Lu (I. D. 048659) had welded two additional passes. Both welders' qualifications for this welding are listed in ZPMC's Master List of Welders/Welding Operators/Tack Welders, Revision 7. ZPMC CWI, Chen Xi (CWI No. 07072021), as well as Bureau Veritas Inspector, Huang Li, were present during this welding. Welding Procedure Specification (WPS) WPS-B-T -3212-TC-U5b was used for this weld being made in the horizontal groove (2G) welding position. The QA Inspector noted that documentation of preheat/interpass temperatures, voltage, amperage and travel speed by the CWI were within the specified ranges of the WPS up until the time of the random observation. The QA Inspector also randomly measured the amperage and voltage by use of a calibrated Fluke amp/volt meter. The specified electrode, Excalibur 9018M H4R, 4.0 mm diameter, was being used and a portable electrode oven was in use and warm to the touch.

The QA Inspector also observed the finishing of Weld Nos. MUSA-SA104-A/B-3 and 4 using a burring tool.

The QA Inspector also observed the arc gouging and grinding of Weld No. MUC-MA107 B/C-2B. This is the inside weld of Skin C to Skin D on the Lower Shaft Assembly on the 114M Tower Mock-Up. All but approximately 10" to 12" had been excavated all the way to the weld root for Critical Weld Repair (CWR) No.

032. Grinding had just commenced at the end of this observation.

All observations appeared to meet the requirements of the job specifications.
