**DEPARTMENT OF TRANSPORTATION**

Contract #: 04-0120F4Cty: SF/ALA Rte: 80 PM: 13.2/13.9File #: 69.28**WELDING INSPECTION REPORT****Resident Engineer:** Pursell, Gary**Address:** 333 Burma Road**City:** Oakland, CA 94607**Report No:** WIR-001169**Date Inspected:** 04-Jan-2008**Project Name:** SAS Superstructure**OSM Arrival Time:** 830**Prime Contractor:** American Bridge/Fluor Enterprises, a JV**OSM Departure Time:** 1730**Contractor:** Zhenhua Port Machinery Company, Ltd (ZPMC), Changxing Island **Location:** Shanghai, China**CWI Name:** See Below**CWI Present:** Yes No**Inspected CWI report:** Yes No N/A**Rod Oven in Use:** Yes No N/A**Electrode to specification:** Yes No N/A**Weld Procedures Followed:** Yes No N/A**Qualified Welders:** Yes No N/A**Verified Joint Fit-up:** Yes No N/A**Approved Drawings:** Yes No N/A**Approved WPS:** Yes No N/A**Delayed / Cancelled:** Yes No N/A**Bridge No:** 34-0006**Component:** Tower and OBG Fabrication**Summary of Items Observed:**

Orthotropic Box Girder (OBG) and Tower Mock Up:

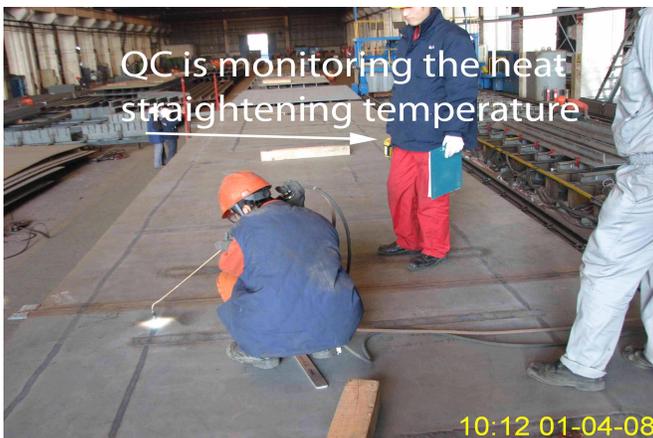
The QA Inspector observed ZPMC personnel perform heat straightening of OBG base plate BP001 as directed by HSR1(B)-107. This HSR has been approved by Mr. Hu Gang on 01-02-2008. The QA inspector observed Quality Control Inspector Mr. Zhang Qizang monitoring the heat temperature using a laser indicating device. The QA Inspector observed the laser device display indicates the battery is almost dead. The QA Inspector observed the temperature display is visible for approximately one second and then the temperature display goes blank. The QA Inspector asked ZPMC CWI Mr. Hu Wei Qing if he was aware that the laser temperature measurement device was not functioning properly. Mr. Qing said he will have Mr. Qizang obtain a new battery before any additional heat straightening takes place. The QA Inspector observed Mr. Qizang did obtain a new battery prior to ZPMC personnel performing additional heat straightening and the laser temperature indicating device appeared to be functioning normally. Items observed by the QA Inspector do not appear to fully comply with project specifications. See the photograph below showing this heat straightening process.
