**DEPARTMENT OF TRANSPORTATION**

Contract #: 04-0120F4Cty: SF/ALA Rte: 80 PM: 13.2/13.9File #: 69.28**WELDING INSPECTION REPORT****Resident Engineer:** Pursell, Gary**Address:** 333 Burma Road**City:** Oakland, CA 94607**Report No:** WIR-001199**Date Inspected:** 12-Jan-2008**Project Name:** SAS Superstructure**OSM Arrival Time:** 1500**Prime Contractor:** American Bridge/Fluor Enterprises, a JV**OSM Departure Time:** 100**Contractor:** Zhenhua Port Machinery Company, Ltd (ZPMC), Changxing Island **Location:** Shanghai, China**CWI Name:** See Below**CWI Present:** Yes No**Inspected CWI report:** Yes No N/A**Rod Oven in Use:** Yes No N/A**Electrode to specification:** Yes No N/A**Weld Procedures Followed:** Yes No N/A**Qualified Welders:** Yes No N/A**Verified Joint Fit-up:** Yes No N/A**Approved Drawings:** Yes No N/A**Approved WPS:** Yes No N/A**Delayed / Cancelled:** Yes No N/A**Bridge No:** 34-0006**Component:** Tower and OBG Fabrication**Summary of Items Observed:**

# WELDING INSPECTION REPORT

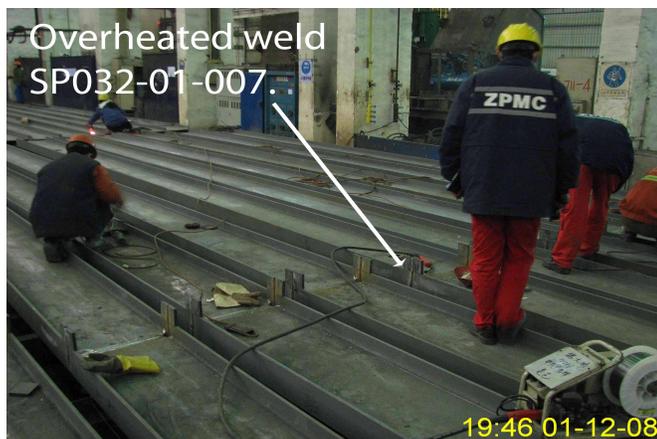
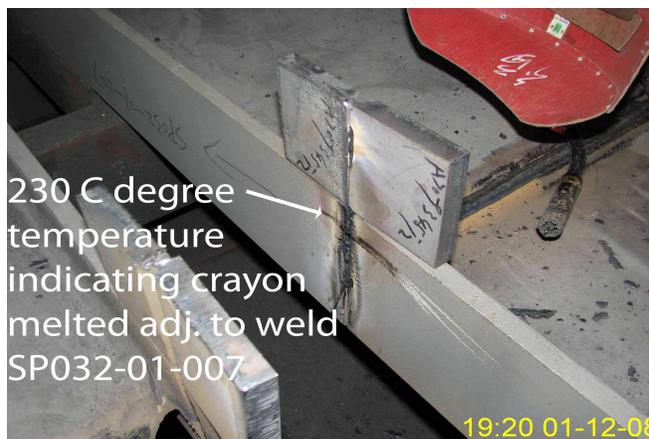
The QA Inspector observed ZPMC welder Mr. Wei Da Shuai stencil 51246 is using welding procedure specification WPS-B-T-2233-B-U2-F using the flux cored welding process to make groove weld SP032-01-007 that joins two OBG stiffener plates. The QA Inspector observed a welding current of approximately 220 amps 24.5 volts and the base material where Mr. Wei Da Shuai is welding has a temperature of approximately 250°C. The welding procedure specification lists a maximum interpass temperature of 230°C and this maximum temperature has been exceeded. The QA Inspector informed ZPMC QC/CWI Inspector Mr. Wang Nan that the base material temperature where Mr. Wei Da Shuai is welding has a base material temperature that exceeds the maximum allowed by the WPS. Mr. Wang Nan said Mr. Wei Da Shuai will stop welding until the plate cools down and ZPMC QC Inspectors will be more careful to monitor interpass temperatures in the future. Items observed by the QA Inspector do not appear to fully comply with project specifications and a Quality Assurance Incident Report was issued to document this procedure violation. See the photographs below for additional information.
