DEPARTMENT OF TRANSPORTATION

Quality Assurance and Source Inspection

Bridge No: 34-0006**Component:** Bay 2-witness Quality Control-MT inspection**Summary of Items Observed:**

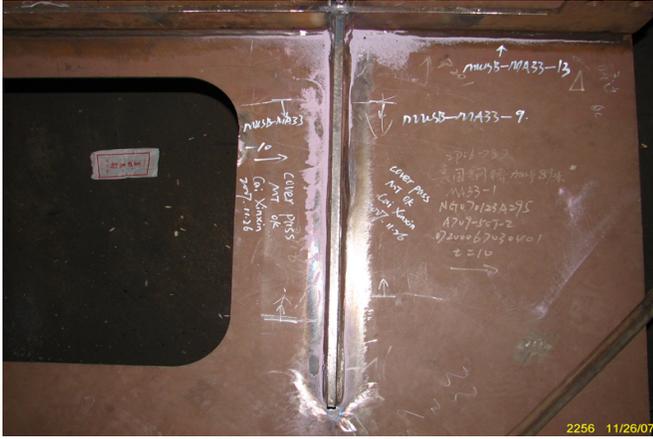
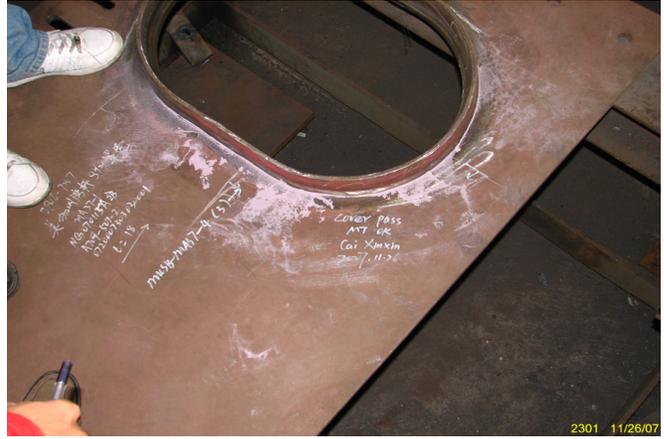
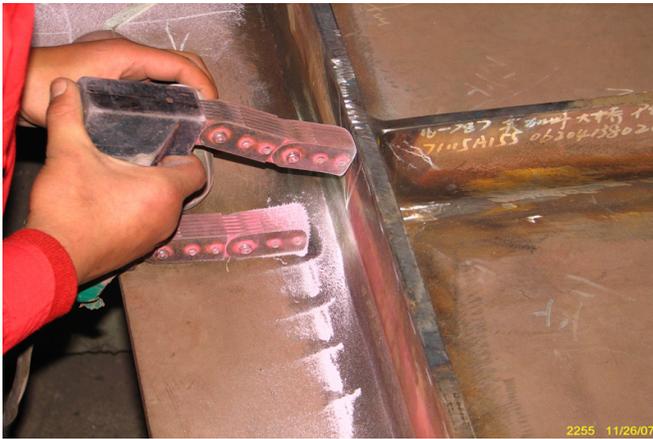
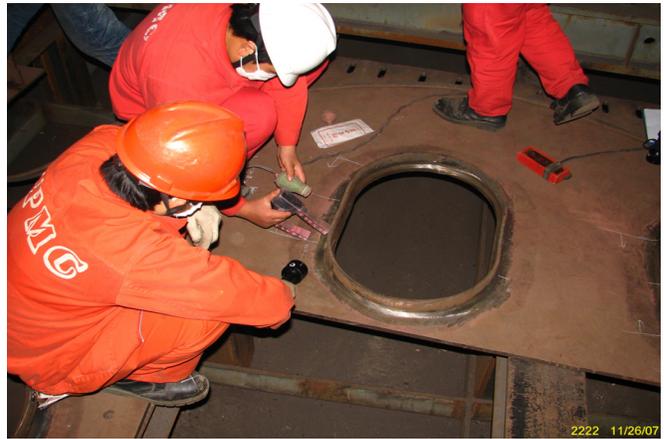
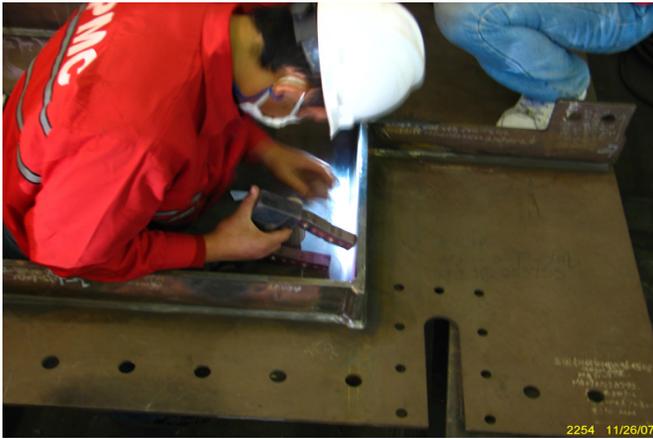
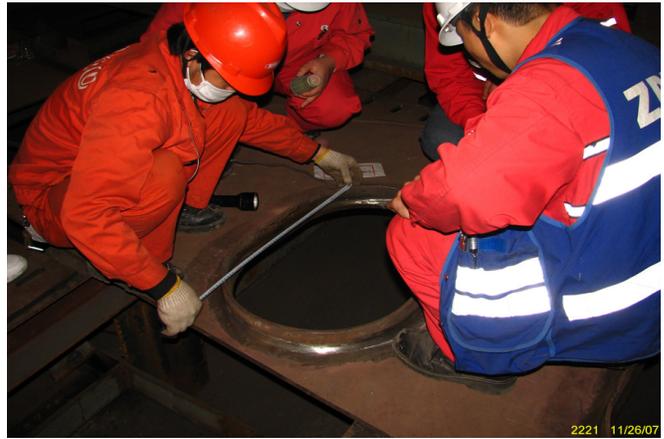
Bay 2: 89m mock-up has the following components are being Dry Magnetic Particle Testing (DMT) inspected: MUSB-MA36 for weld numbers -5, -6, -13 and -14, MUSB-MA33-9, MUSB-MA37-3 and -4 plus MUSB-MA30-21 and -26. All welds examined were in the final cover pass.

On component MUSB-MA36, the ZPMC DMT inspectors, Zhou Dong Yun and Cai Xin Xin, noted linear indications at the toes of the welds so ZPMC personnel took a mechanical grinder and performed light blend grinding. Inspectors reexamined the areas and accepted the welds. The inspections that were observed appeared to be in accordance with the criteria set forth within the contractual documents
