Contract #: 04-0120F4Cty: SF/ALA Rte: 80 PM: 13.2/13.9File #: 69.28**WELDING INSPECTION REPORT****Resident Engineer:** Pursell, Gary**Address:** 333 Burma Road**City:** Oakland, CA 94607**Report No:** WIR-001245**Date Inspected:** 13-Dec-2007**Project Name:** SAS Superstructure**OSM Arrival Time:** 630**Prime Contractor:** American Bridge/Fluor Enterprises, a JV**OSM Departure Time:** 1530**Contractor:** Zhenhua Port Machinery Company, Ltd (ZPMC), Changxing Island **Location:** Shanghai, China**CWI Name:** Xu Lefeng**CWI Present:** Yes No**Inspected CWI report:** Yes No N/A**Rod Oven in Use:** Yes No N/A**Electrode to specification:** Yes No N/A**Weld Procedures Followed:** Yes No N/A**Qualified Welders:** Yes No N/A**Verified Joint Fit-up:** Yes No N/A**Approved Drawings:** Yes No N/A**Approved WPS:** Yes No N/A**Delayed / Cancelled:** Yes No N/A**Bridge No:** 34-0006**Component:** OBG and Tower Mock-up**Summary of Items Observed:**

CALTRANS Quality Assurance (QA) Inspector, Alfredo Acuna was present for the fabrication scheduled for this project at the ZPMC facility in Shanghai, China for the San Francisco Oakland Bay Self Anchored Suspension Bridge.

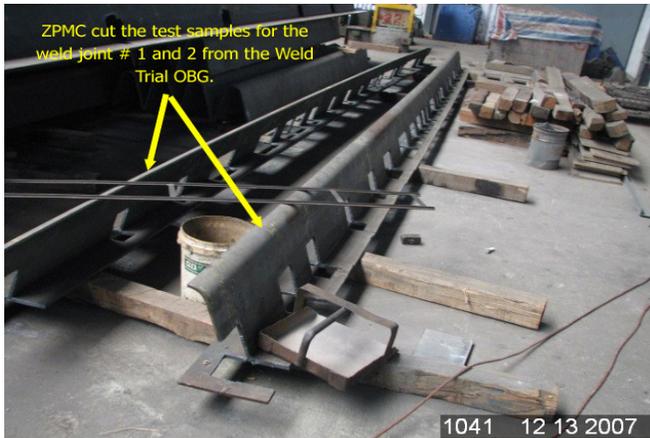
Item Description	WBS	Dwg No.	Status
1 Witnessing UT at the interior splice MA-58 Tower Mock-up 114 M			
The QA inspector witnessed ZPMC Quality Control inspector E Shuiqin and Xue Hai Rong performing preliminary ultrasonic testing (UT) after second time repair and before heat straightening operations at the junction of the interior splice MA-58 and longitudinal stiffeners weld joints # 1, 2, 3 and 4 scanning from sides A, B and C. The QA inspector observed that Ms. E and Mr. Xue recorded on the steel that the welds were acceptable before heat straightening.

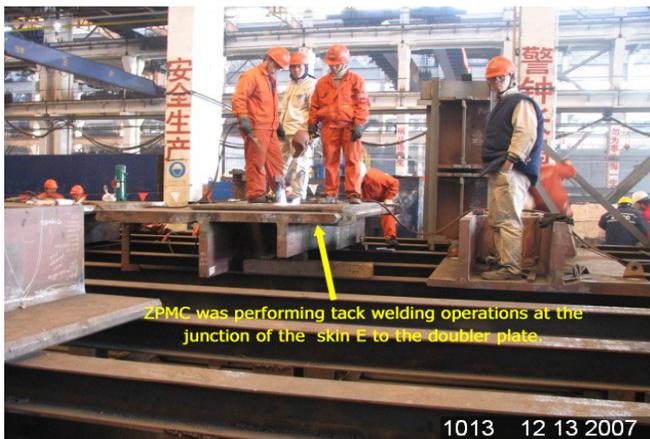
4 Tower Mock-up 89 M Skin E

The QA inspector observed ZPMC welding personnel performing tack welding operations at the junction of skin E to doubler plate MA-21 weld joint # 1 thru 4. See photograph below.
