**DEPARTMENT OF TRANSPORTATION**

Contract #: 04-0120F4Cty: SF/ALA Rte: 80 PM: 13.2/13.9File #: 69.28**WELDING INSPECTION REPORT****Resident Engineer:** Pursell, Gary**Address:** 333 Burma Road**City:** Oakland, CA 94607**Report No:** WIR-001253**Date Inspected:** 31-Dec-2007**Project Name:** SAS Superstructure**OSM Arrival Time:** 630**Prime Contractor:** American Bridge/Fluor Enterprises, a JV**OSM Departure Time:** 1530**Contractor:** Zhenhua Port Machinery Company, Ltd (ZPMC), Changxing Island **Location:** Changxing Island**CWI Name:** Ye Yong Jun**CWI Present:** Yes No**Inspected CWI report:** Yes No N/A**Rod Oven in Use:** Yes No N/A**Electrode to specification:** Yes No N/A**Weld Procedures Followed:** Yes No N/A**Qualified Welders:** Yes No N/A**Verified Joint Fit-up:** Yes No N/A**Approved Drawings:** Yes No N/A**Approved WPS:** Yes No N/A**Delayed / Cancelled:** Yes No N/A**Bridge No:** 34-0006**Component:** OBG and 89 Mock-up**Summary of Items Observed:**

# WELDING INSPECTION REPORT

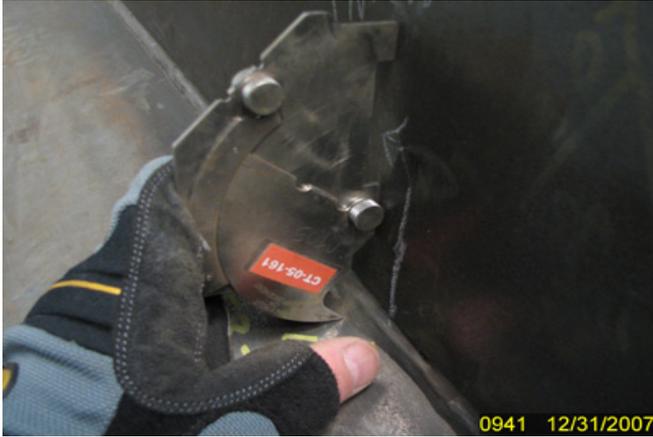
Caltrans QA Inspector Viars performed recorded dimensions of undersized and excessive convexity of the Orthotropic Box Girders (OBG) deck plate trial closed rib welds. Measurements were input into an excel spreadsheet with the length, location in relation to the Y side of rib and reinforcement dimension.
