Contract #: 04-0120F4Cty: SF/ALA Rte: 80 PM: 13.2/13.9File #: 69.28**WELDING INSPECTION REPORT****Resident Engineer:** Pursell, Gary**Address:** 333 Burma Road**City:** Oakland, CA 94607**Report No:** WIR-001304**Date Inspected:** 27-Dec-2007**Project Name:** SAS Superstructure**OSM Arrival Time:** 700**Prime Contractor:** American Bridge/Fluor Enterprises, a JV**OSM Departure Time:** 1500**Contractor:** Zhenhua Port Machinery Company, Ltd (ZPMC), Changxing Island **Location:** Shanghai, China

CWI Name:	Wu Ming Kai	CWI Present:	Yes	No
Inspected CWI report:	Yes No N/A	Rod Oven in Use:	Yes	No N/A
Electrode to specification:	Yes No N/A	Weld Procedures Followed:	Yes	No N/A
Qualified Welders:	Yes No N/A	Verified Joint Fit-up:	Yes	No N/A
Approved Drawings:	Yes No N/A	Approved WPS:	Yes	No N/A
		Delayed / Cancelled:	Yes	No N/A
Bridge No:	34-0006	Component:	OBG/89M Mockup

WELDING INSPECTION REPORT

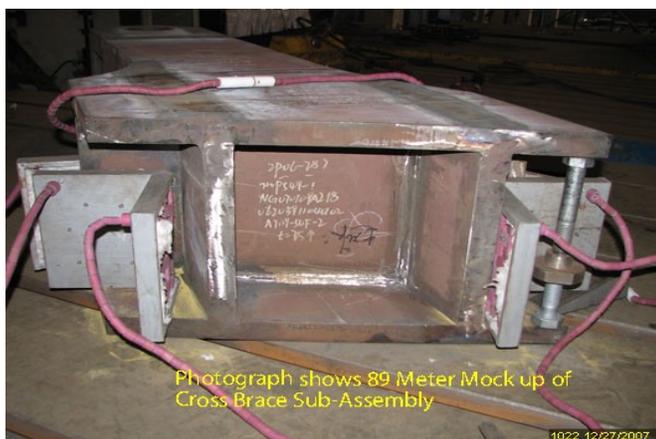
Photograph shows 89 Meter Mock up of Cross Brace Sub-Assembly

Bay 2- QA Inspector observed that tack welding was completed on the Cross Brace Sub-Assembly for the 89 Meter Mockup. Quality Control Inspector (QC) Zhoa Chen Sun informed QA Inspector that the tack weld are completed and have been inspected by the Magnetic Particle Inspection Method (MT). QA Inspector observed that the weld map for the Sub-Assembly did not properly identify one of the four fillet welds. QA Inspector reviewed the drawings with QC Inspector Xu Jun and QC Inspector Zhoa Chen Sun and the QA Inspector was informed that the drawing will be presented to the Technical Department for clarification.

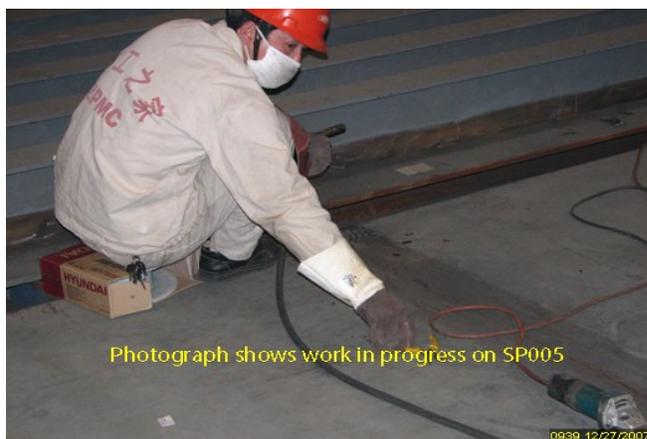
Photograph shows work in progress on SP005

Bay 3- QA Inspector randomly observed ZPMC qualified welder Zhang Feng, Identification (ID) #049769, utilizing the Shielded Metal Arc Welding (SMAW) process per the approved Welding Procedure Specification (WPS) WPS-B-P-2112-FCM while performing tack welding on Side Plate SP005 weld joints SP005-01-003/004 and SP005-01-014/015 to PL68A and P68B plates. The QA Inspector observed ZPMC Certified Weld Inspector (CWI) Wu Ming Kai monitoring welding and preheating parameters. The QA Inspector also randomly monitored weld parameters and recorded them as follows: welding amperage 175 amps, welding voltage 26 volts. The weld parameters appeared to comply with contract requirements and the approved WPS.

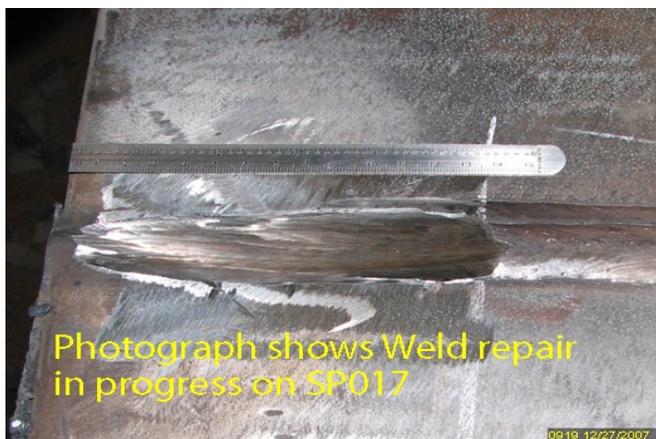
Photograph shows Weld repair in progress on SP017

Bay 3- QA Inspector randomly observed ZPMC qualified welder Li Mengqian, ID #054460 performing weld repairs to Side Plate SP017 at weld joint SP017-01-001 joining plates PL76A and PL76B. QA Inspector observed that preheating and welding current was monitored by QC Inspector Wu Ming Kai. QA observed the Flux Core Metal Arc Welding (FCAW) process is used per WPS-345-FCAW-1G(1F)-FCM-Repair. QA Inspector observed welding parameters of 295 amps and 29.5 volts were used during the weld repair. Welding and welding parameters observed by QA Inspector appear to be in general compliance with the approved WPS and contract requirements.

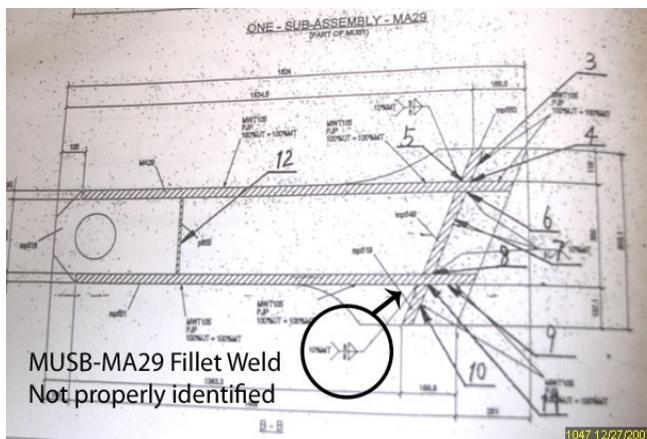
MUSB-MA29 Fillet Weld Not properly identified

General communications took place between the QA and QC Inspector. QC Inspector Li Xiu Yang acted as a translator for the QA Inspector during the review of the Cross Brace Sub Assembly. Li Xiu Yang informed the QA Inspector that he will contact a representative of Caltrans with any information or revisions regarding the fillet weld that is not properly identified.
