Contract #: 04-0120F4Cty: SF/ALA Rte: 80 PM: 13.2/13.9File #: 69.28**WELDING INSPECTION REPORT****Resident Engineer:** Pursell, Gary**Address:** 333 Burma Road**City:** Oakland, CA 94607**Report No:** WIR-001306**Date Inspected:** 24-Dec-2007**Project Name:** SAS Superstructure**OSM Arrival Time:** 700**Prime Contractor:** American Bridge/Fluor Enterprises, a JV**OSM Departure Time:** 1530**Contractor:** Zhenhua Port Machinery Company, Ltd (ZPMC), Changxing Island **Location:** Shanghai, China

Bridge No: 34-0006**Component:** 89 Meter Mockup**Summary of Items Observed:**

WELDING INSPECTION REPORT

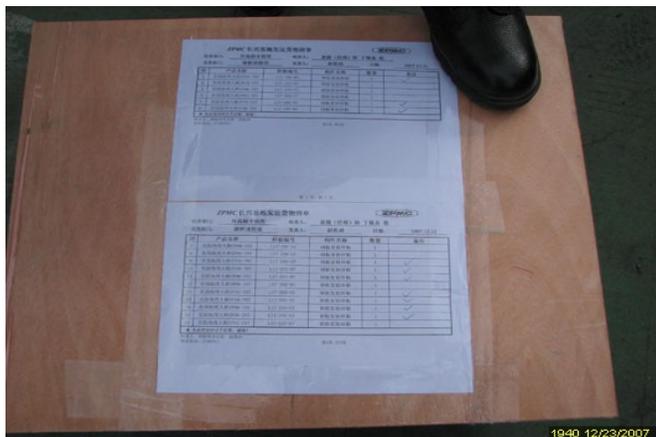
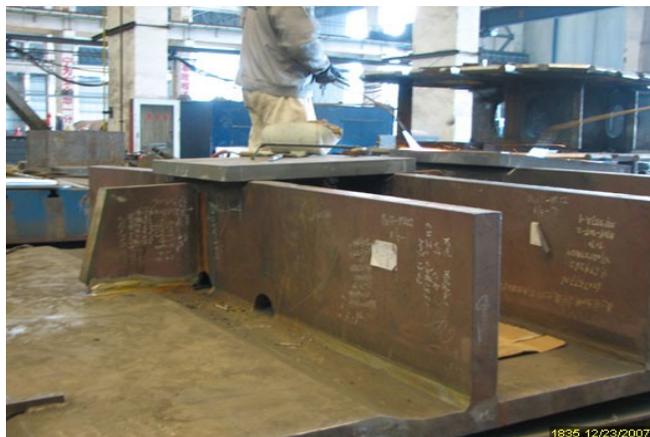
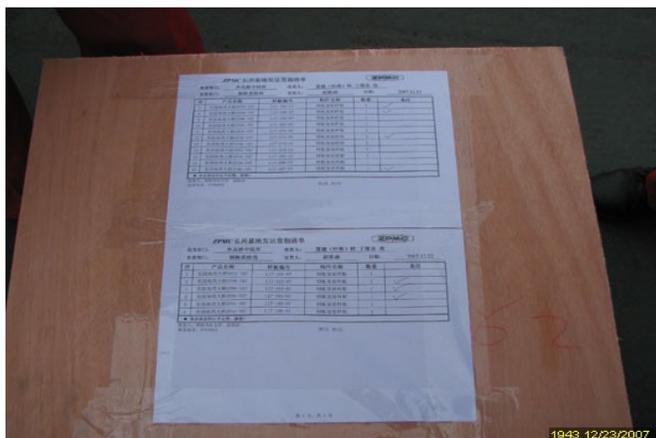
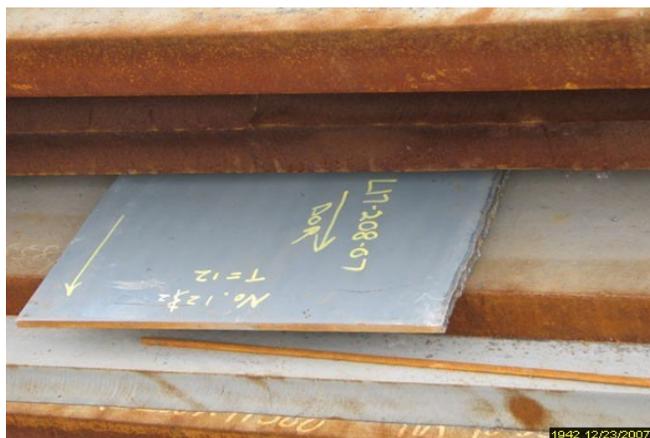
Bay 7- Qualified welders Wang Jian #067081 and Dai Lu #048659 performed tack welding of piece mp957 to mp537 and mp538 on the 89 Meter Skin Plate Sub assembly drawing MUSB-MA22B/B. Weld Map identifies the locations as weld joint #13, #14, #15 and #16. QA Inspector observed that preheating and welding current was performed and monitored during tack welding per the Welding Procedure Specification (WPS) WPS-B-T-43(1)14.

Caltrans Check Samples - QA Inspector verified a list of material for Caltrans Check Test Samples for batch number six (6) and seven (7) were properly identified and prepared for shipping. QA Inspector observed ZPMC QC Inspector Sun Bo witness and perform an inventory check list as each sample was placed in a box in preparation for shipping the samples to the testing facility.

QA Inspector observed that Caltrans Check Sample Batch nine (9), Lot# L17-208-07 was not prepared for shipping. The following information is provided to identify the Check Sample for Batch nine (9):

Items observed by QA Inspector described above appear to comply with project specifications. See the photographs below which show material described above. Date and time that appears in the photographs is Pacific Standard time zone.
