**DEPARTMENT OF TRANSPORTATION**

Contract #: 04-0120F4Cty: SF/ALA Rte: 80 PM: 13.2/13.9File #: 69.28**WELDING INSPECTION REPORT****Resident Engineer:** Pursell, Gary**Address:** 333 Burma Road**City:** Oakland, CA 94607**Report No:** WIR-001348**Date Inspected:** 25-Jan-2008**Project Name:** SAS Superstructure**OSM Arrival Time:** 600**Prime Contractor:** American Bridge/Fluor Enterprises, a JV**OSM Departure Time:** 1530**Contractor:** Zhenhua Port Machinery Company, Ltd (ZPMC), Changxing Island **Location:** Changxing Island**CWI Name:** Huwei Qing**CWI Present:** Yes No**Inspected CWI report:** Yes No N/A**Rod Oven in Use:** Yes No N/A**Electrode to specification:** Yes No N/A**Weld Procedures Followed:** Yes No N/A**Qualified Welders:** Yes No N/A**Verified Joint Fit-up:** Yes No N/A**Approved Drawings:** Yes No N/A**Approved WPS:** Yes No N/A**Delayed / Cancelled:** Yes No N/A**Bridge No:** 34-0006**Component:** OBG**Summary of Items Observed:**

# WELDING INSPECTION REPORT

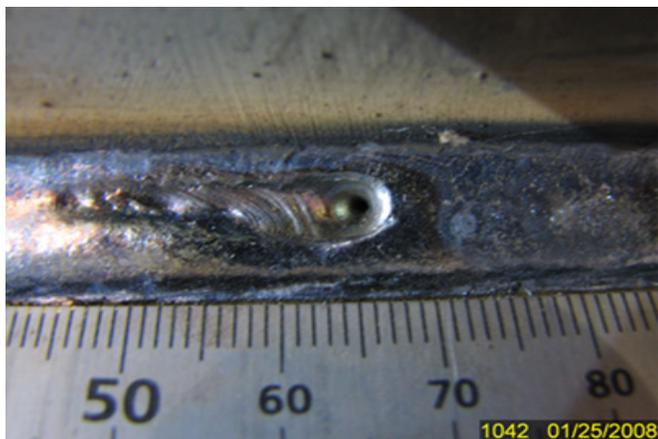
Caltrans QA Inspector Viars performed random visual inspection of OBG Side plate 038 fillet welds. Welding was performed with a semi automated gantry machine with the Flux Cored Arc Welding (FCAW) process. ZPMC QC Mr. Huwei Qing monitored welding operations. During visual observations areas of piping porosity, overlap and lack of fusion on the stiffener toe of the weld were noted on the root pass of SP038 fillet welds. Mr. Huwei stated areas of nonconformance would be excavated and repaired prior to the cover pass of the root pass. Please see the attached photo of piping porosity found on weld joint # SP038-01-020 below.
