Contract #: 04-0120F4Cty: SF/ALA Rte: 80 PM: 13.2/13.9File #: 69.28**WELDING INSPECTION REPORT****Resident Engineer:** Pursell, Gary**Address:** 333 Burma Road**City:** Oakland, CA 94607**Report No:** WIR-001405**Date Inspected:** 12-Feb-2008**Project Name:** SAS Superstructure**OSM Arrival Time:** 700**Prime Contractor:** American Bridge/Fluor Enterprises, a JV**OSM Departure Time:** 1530**Contractor:** Zhenhua Port Machinery Company, Ltd (ZPMC), Changxing Island **Location:** Shanghai, China

Orthotropic Box Girder (OBG) and Tower Mock Up:

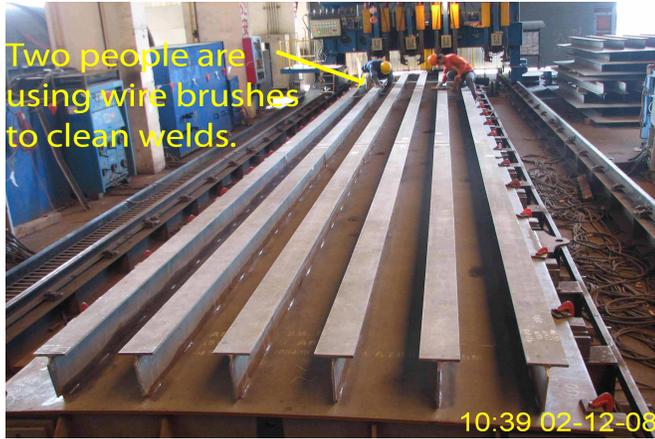
The QA Inspector observed two ZPMC personnel using electric powered wire brushes to clean the weld joint surfaces of OBG PL85A side plate SP032 stiffener plate welds SP032-001-013 through SP032-001-024. Several of these weld joint surfaces appear to have light rust coatings as a result of the weld surfaces having become wet.
