**DEPARTMENT OF TRANSPORTATION**

Contract #: 04-0120F4Cty: SF/ALA Rte: 80 PM: 13.2/13.9File #: 69.28**WELDING INSPECTION REPORT****Resident Engineer:** Pursell, Gary**Address:** 333 Burma Road**City:** Oakland, CA 94607**Report No:** WIR-001408**Date Inspected:** 05-Feb-2008**Project Name:** SAS Superstructure**OSM Arrival Time:** 700**Prime Contractor:** American Bridge/Fluor Enterprises, a JV**OSM Departure Time:** 1530**Contractor:** Zhenhua Port Machinery Company, Ltd (ZPMC), Changxing Island **Location:** Shanghai, China**CWI Name:** See Below**CWI Present:** Yes No**Inspected CWI report:** Yes No N/A**Rod Oven in Use:** Yes No N/A**Electrode to specification:** Yes No N/A**Weld Procedures Followed:** Yes No N/A**Qualified Welders:** Yes No N/A**Verified Joint Fit-up:** Yes No N/A**Approved Drawings:** Yes No N/A**Approved WPS:** Yes No N/A**Delayed / Cancelled:** Yes No N/A**Bridge No:** 34-0006**Component:** Tower and OBG Fabrication**Summary of Items Observed:**

Orthotropic Box Girder (OBG) and Tower Mock Up:

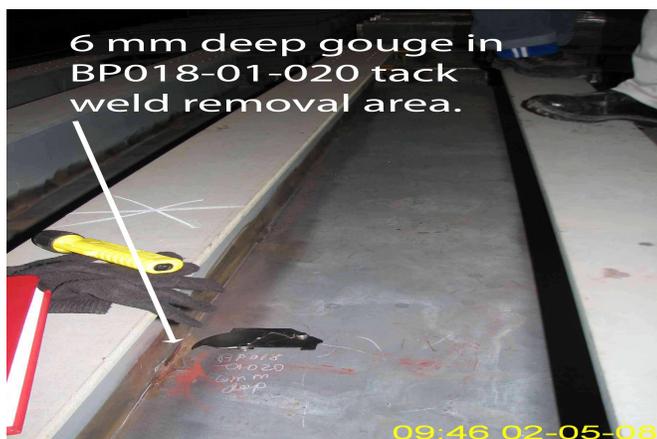
The QA Inspector observed ZPMC personnel installing base material heating elements on bottom plate BP018 to preheat stiffener plate welds BP018-01-013 through BP018-01-024. ZPMC usually installs these heaters prior to making stiffener plate fillet welds. The QA Inspector visually observed welds BP018-01-018 and BP018-01-015 both have locations where the tack welds have been totally removed resulting in 3 mm to 6 mm deep gouges in the base material. The QA Inspector asked ZPMC QC Inspector Mr. Liz Hijiang if ZPMC has issued critical weld repair (CWR) documents to obtain Engineering approval to repair these base material gouges. Mr. Lizjiang said ZPMC needs to issue CWR documents and that ZPMC will not be welding this bottom plate today. The QA inspector observed ZPMC removing heating elements from BP018 welds. The QA inspector observed paint material in area where a fillet weld is to be made on stiffener plate weld BP018-01-014. The QA Inspector informed American Bridge / Fluor Quality Assurance Inspector Mr. David LaRue that base plate BP018 has welds

with base material gouges and paint material adjacent to where various welds are to be made. Mr. LaRue said he will discuss these issues with ZPMC personnel. See the photographs below showing the gouge location in weld BP018-01-018 and the paint material adjacent to weld where BP018-01-014 is to be made). This QA Inspector issued an incident report to document these base material gouges.

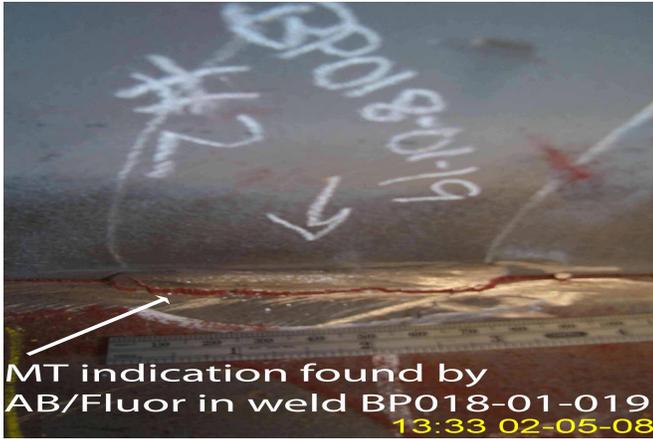
Later in the day Mr. LaRue informed the QA Inspector he has completed informational magnetic particle (MT) inspections of base plate BP018 fillet tack welds and several linear indications have been observed. See the photograph below showing weld BP018-01-019 that has a MT linear indication along the entire length of the fillet tack weld and the bottom plate.

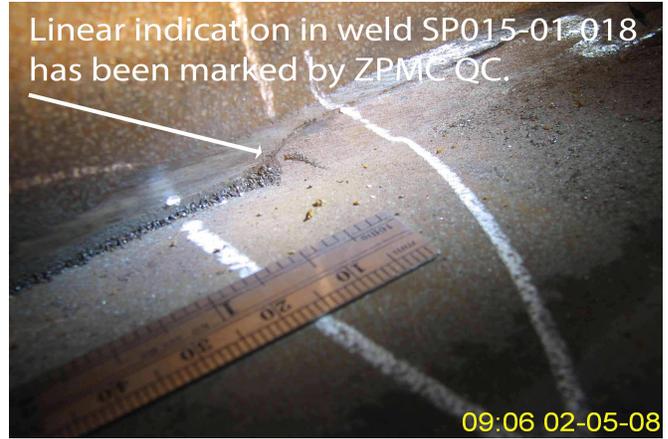
The QA Inspector observed ZPMC QC Inspector Mr. Li Peng Fei performing visual inspections of the tack welds on side plate SP015. Mr. Fei has marked several of the tack welds as needing to be ground. The QA Inspector observed several of these locations have metal chips that had formed linear indications on portions of the tack welds in a similar manner as when magnetic particle inspection powder is attracted to magnetic particle fields. See the photograph below showing a linear indication in weld SP015-01-018. ZPMC QC Inspector Mr. Liz Hijiang said ZPMC is going to grind plate SP015 fillet tack welds where QC observed linear indications and if the linear indications extend into the base material ZPMC will process critical weld repair (CWR) documents prior to making repairs of these base material gouges.
