Contract #: 04-0120F4Cty: SF/ALA Rte: 80 PM: 13.2/13.9File #: 69.28**WELDING INSPECTION REPORT****Resident Engineer:** Pursell, Gary**Address:** 333 Burma Road**City:** Oakland, CA 94607**Report No:** WIR-001414**Date Inspected:** 28-Jan-2008**Project Name:** SAS Superstructure**OSM Arrival Time:** 900**Prime Contractor:** American Bridge/Fluor Enterprises, a JV**OSM Departure Time:** 1630**Contractor:** Zhenhua Port Machinery Company, Ltd (ZPMC), Changxing Island **Location:** Shanghai, China**CWI Name:** See Below**CWI Present:** Yes No**Inspected CWI report:** Yes No N/A**Rod Oven in Use:** Yes No N/A**Electrode to specification:** Yes No N/A**Weld Procedures Followed:** Yes No N/A**Qualified Welders:** Yes No N/A**Verified Joint Fit-up:** Yes No N/A**Approved Drawings:** Yes No N/A**Approved WPS:** Yes No N/A**Delayed / Cancelled:** Yes No N/A**Bridge No:** 34-0006**Component:** Tower and OBG Fabrication**Summary of Items Observed:**

Orthotropic Box Girder (OBG) and Tower Mock Up:

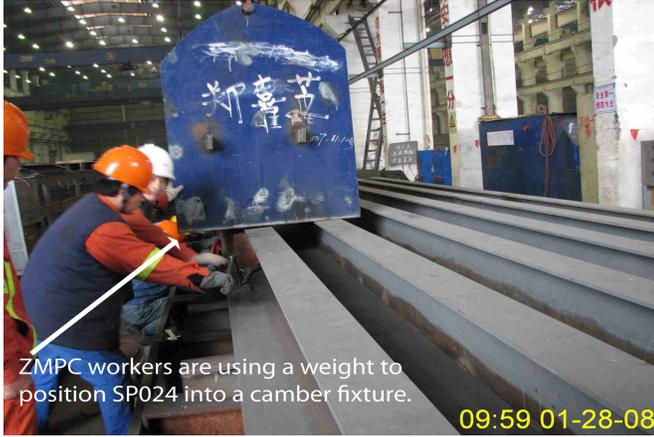
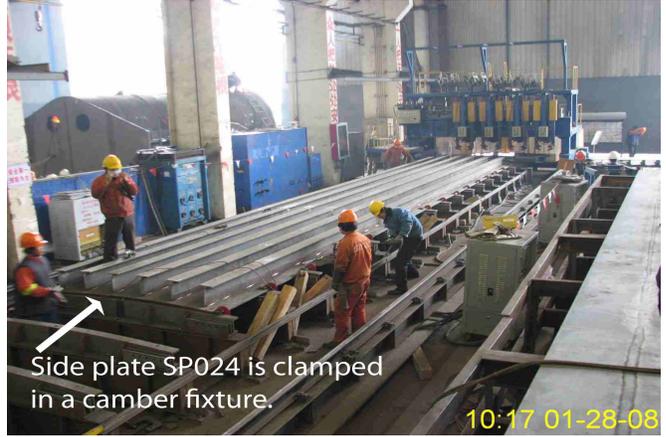
The QA Inspector observed ZPMC personnel using a heavy weight to apply a downward force on side plate SP024 as it is positioned into a "U" shaped camber fixture. See the photographs below for additional information.
