DEPARTMENT OF TRANSPORTATION

Quality Assurance and Source Inspection

Contract #: 04-0120F4Cty: SF/ALA Rte: 80 PM: 13.2/13.9File #: 69.28**WELDING INSPECTION REPORT****Resident Engineer:** Pursell, Gary**Address:** 333 Burma Road**City:** Oakland, CA 94607**Report No:** WIR-001436**Date Inspected:** 04-Jan-2008**Project Name:** SAS Superstructure**OSM Arrival Time:** 700**Prime Contractor:** American Bridge/Fluor Enterprises, a JV**OSM Departure Time:** 1500**Contractor:** Zhenhua Port Machinery Company, Ltd (ZPMC), Changxing Island **Location:** Shanghai, China**CWI Name:** Huong Wei**CWI Present:** Yes No**Inspected CWI report:** Yes No N/A**Rod Oven in Use:** Yes No N/A**Electrode to specification:** Yes No N/A**Weld Procedures Followed:** Yes No N/A**Qualified Welders:** Yes No N/A**Verified Joint Fit-up:** Yes No N/A**Approved Drawings:** Yes No N/A**Approved WPS:** Yes No N/A**Delayed / Cancelled:** Yes No N/A**Bridge No:** 34-0006**Component:** Check Test Samples & PQR #HP200801**Summary of Items Observed:**

WELDING INSPECTION REPORT

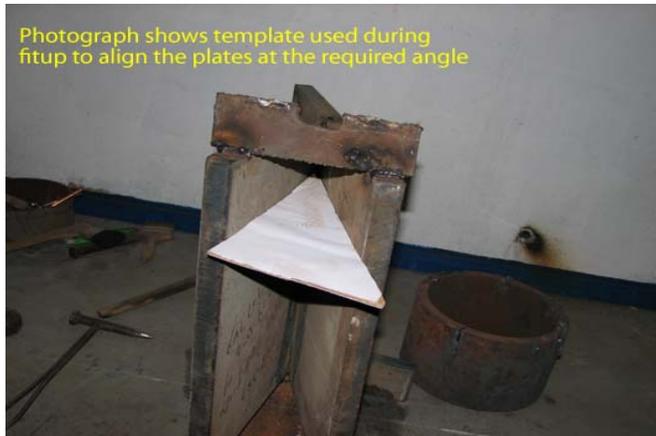
Photograph shows template used during fitup to align the plates at the required angle

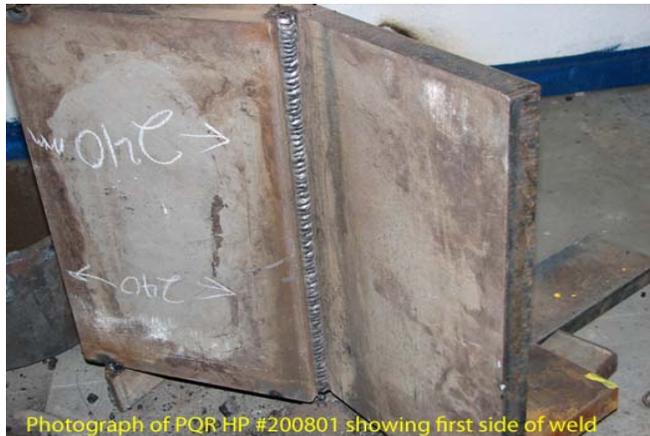
PQR ID #HP200801 QA Inspector observed ZPMC welder Zhu Haiping ID #066424 perform welding for Procedure Qualification Record Test (PQR) #HP200801. Base material specification is ASTM Grade 345, Heat #7300320N and is 26mm thick. Welder is observed welding in the 3G position utilizing the SMAW process. Electrodes used for the PQR is described as the following: diameter 3.2mm and 4.0mm diameter, Classification E7018, Brand TL-508, Specification AWS A5.1. QA observed that a template is used to during fit up to verify that the plates are in position at an angle of 31.07 Degrees per as per the preliminary WPS. QA Inspector observed ZPMC QC Inspector Huong Wei monitor welding parameters per the preliminary WPS. QA Inspector observed interpass cleaning methods by using manual steel wire brush and manual hammer with a chisel. QA Inspector performed random verifications of the welding and parameters for two layers then a back gouge from the second side was performed using a Carbon Arc Air Gouging process and an electric grinder. QA Inspector then continued to observe the welding of weld layers three, four, five and six on the second side of the weld. QA Inspector observed that the welding parameters taken by QC Inspector appear to be accurate and in accordance with the contract documents and AWS D1.5 (2002), Qualification Section 5.13. Craig Knops of ABF is present to observe the PQR. QA Inspector did not observe the final weld layers of the PQR. QA Inspector assigned Caltrans Lot #L17-023-08 to the PQR test plate. See photographs on the following page which show the PQR described above.

Photograph of PQR HP #200801 showing first side of weld

QA Inspector was assigned to witness test samples prior to completing the final layers of the PQR. QA Inspector was informed by QA Task Leader Jim Cochran that welding may continue with out observation by the QA Inspector on conditions that no discrepancies were noted during prior observation. QA Inspector informed Craig Knops of ABF that QA Inspector will not be present during the welding of final layers and directed him to continue his observations during any welding.

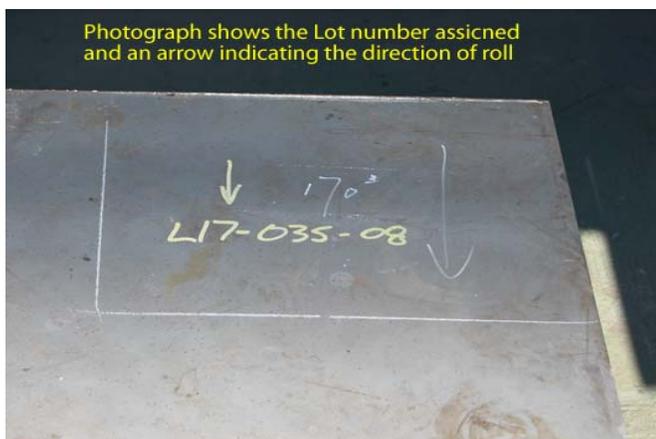
Check Test Samples - QA Inspector observed the lay out and marked Caltrans Check Test Samples that will be removed for testing as specified in the Contract Special Provisions. QA Inspector verified that the heat numbers, batch numbers, grade, thickness and identification number for batch number nine (9), fourteen (14) and eighteen (18) matched the list of material for the Caltrans Check Test Samples provided. QA Inspector observed that all samples are properly marked for removal with the long dimension transverse to the direction of rolling and 355mm wide by 460 mm long. QA Inspector identified each plate and with an arrow indicating the direction of roll and assigned a Caltrans Lot Number for each plate marked for sampling. The following list shows the Caltrans Lot Numbers assigned, heat numbers thickness and grades of the materials sampled. See the photographs on the following page which shows an example of the material identification and marking applied by the QA Inspector.

Photograph shows the Lot number assigned and an arrow indicating the direction of roll

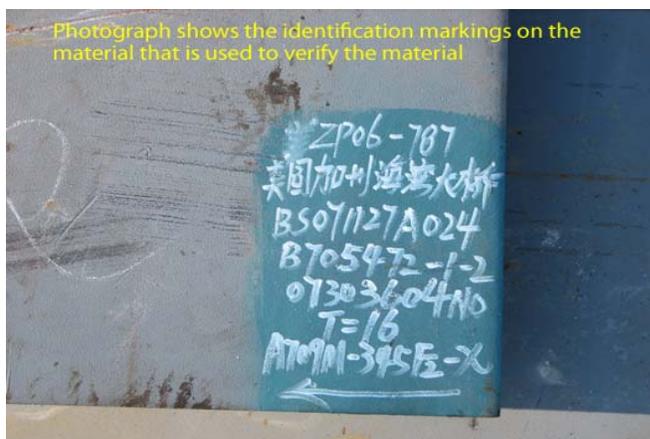
Photograph shows the identification markings on the material that is used to verify the material

QA Inspector informed the QC Inspector Fu Yu Hong that any markings on the edges of the samples will be required to be removed prior to shipping the samples to the testing facility.
