**DEPARTMENT OF TRANSPORTATION**

Caltrans Quality Assurance (QA) Inspector, Larry Viars was present to perform observations of the welding of Orthotropic Box Girder (OBG) U ribs Production Monitoring Test (PMT) and Production Panel, for the San Francisco Oakland Bay Self Anchored Suspension Bridge, at Zhenhua Port Machinery Company (ZPMC) facility on Changxing Island.

# WELDING INSPECTION REPORT

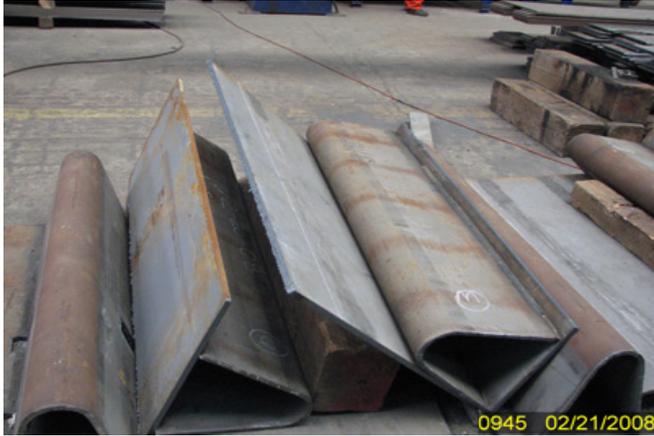
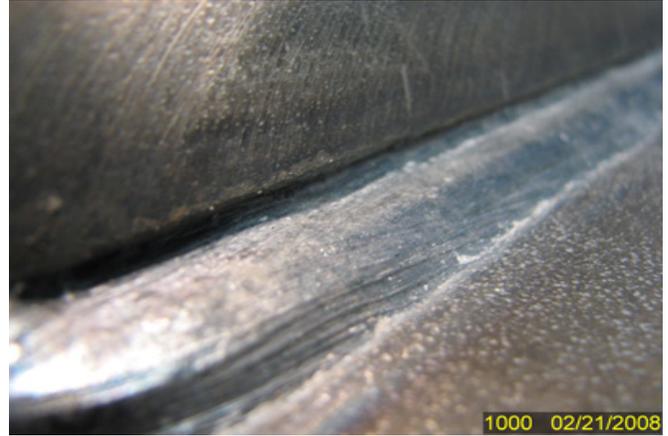
The Caltrans Quality Assurance Inspector observed the U-rib PMT panel for Deck Panel (DP) 014-002 being cut into sections with an oxyfuel torch. The Panel had areas of large areas of incomplete fusion on the u-rib toe of the weld for weld # 6. Please see the attached photo below after oxyfuel cutting and the incomplete fusion mentioned above.
