**DEPARTMENT OF TRANSPORTATION**

Contract #: 04-0120F4Cty: SF/ALA Rte: 80 PM: 13.2/13.9File #: 69.28**WELDING INSPECTION REPORT****Resident Engineer:** Pursell, Gary**Address:** 333 Burma Road**City:** Oakland, CA 94607**Report No:** WIR-001556**Date Inspected:** 26-Oct-2007**Project Name:** SAS Superstructure**OSM Arrival Time:** 630**Prime Contractor:** American Bridge/Fluor Enterprises, a JV**OSM Departure Time:** 1530**Contractor:** Zhenhua Port Machinery Company, Ltd (ZPMC), Changxing Island **Location:** Shanghai, China

# WELDING INSPECTION REPORT

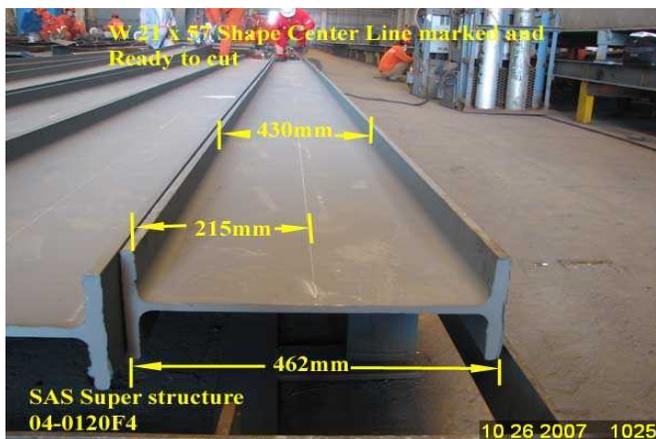
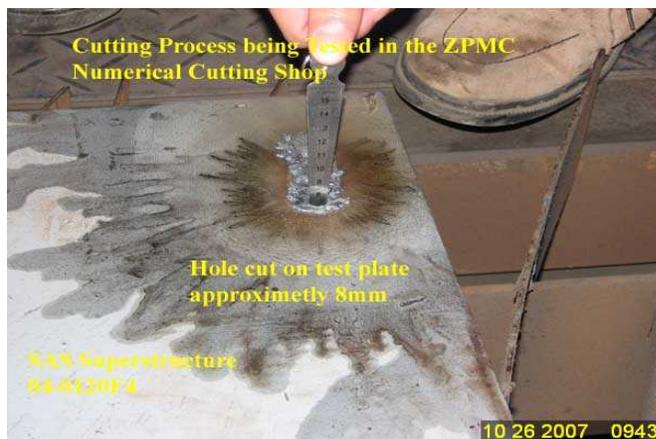
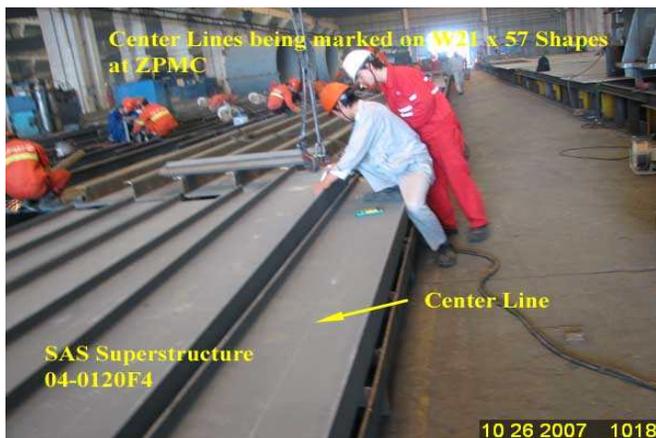
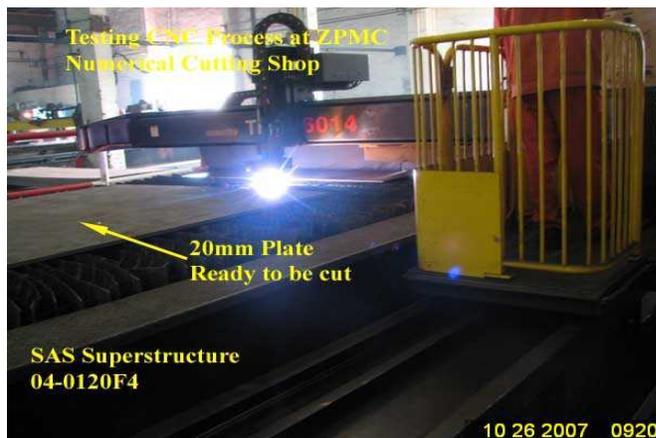
QA Inspector Timothy McClendon accompanied by ZPMC QA Mr. Shen Xue Jun and ZPMC QC Miss Cary Wu Ming went to the ZPMC Numerical Cutting (NC) Shop to observe plate NG070508G221 being cut on CNC machine. QA Inspector Timothy McClendon observed testing of CNC machine on scrap plate before proceeding with actual cutting of plate NG070508G221. It was determined by ZPMC QA Shen Xue Jun and ZPMC QC Miss Cary Wu Ming and shop personal, the CNC cutting machine would produce 8mm kerf. Drawing number MUB-MA21 F/J used to cut plate into shapes indicates kerf would need to be 4mm. At this point cutting operation was stopped until CNC machine could be adjusted in order to meet the requirements of the drawing.

QA Inspector Timothy McClendon accompanied by ZPMC QA Mr. Shen Xue Jun went to observe previously blasted and primed shapes (W21 x 57) being marked to be split by fuel gas cutting process. QA Inspector Timothy McClendon and ZPMC QA Mr. Shen Xue Jun witnessed ZPMC QC Mr. Guo Xang Wei measuring the inside W21 x 57 and it was found to be 430mm. ZPMC QC Mr. Guo Xang Wei proceeded to mark the entire length of W21 x 57, 215mm, with a painted line. This measurement will split W21 x 57 shapes into two equal halves. QA Inspector Timothy McClendon also witnessed ZPMC QC Mr. Guo Xang Wei recording all material information

on both halves of W21 x 57 in order to maintain traceability after the cutting operation is complete. Cutting operation may begin once approval has been given by ZPMC QA department. See attached pictures for additional information.
