**DEPARTMENT OF TRANSPORTATION**

Contract #: 04-0120F4Cty: SF/ALA Rte: 80 PM: 13.2/13.9File #: 69.28**WELDING INSPECTION REPORT****Resident Engineer:** Pursell, Gary**Address:** 333 Burma Road**City:** Oakland, CA 94607**Report No:** WIR-001588**Date Inspected:** 01-Feb-2008**Project Name:** SAS Superstructure**OSM Arrival Time:** 700**Prime Contractor:** American Bridge/Fluor Enterprises, a JV**OSM Departure Time:** 1930**Contractor:** Zhenhua Port Machinery Company, Ltd (ZPMC), Changxing Island **Location:** Shanghai, China**CWI Name:** Sun Wei**CWI Present:** Yes No**Inspected CWI report:** Yes No N/A**Rod Oven in Use:** Yes No N/A**Electrode to specification:** Yes No N/A**Weld Procedures Followed:** Yes No N/A**Qualified Welders:** Yes No N/A**Verified Joint Fit-up:** Yes No N/A**Approved Drawings:** Yes No N/A**Approved WPS:** Yes No N/A**Delayed / Cancelled:** Yes No N/A**Bridge No:** 34-0006**Component:** OBG & 77 Meter Mock-Up**Summary of Items Observed:**

# WELDING INSPECTION REPORT

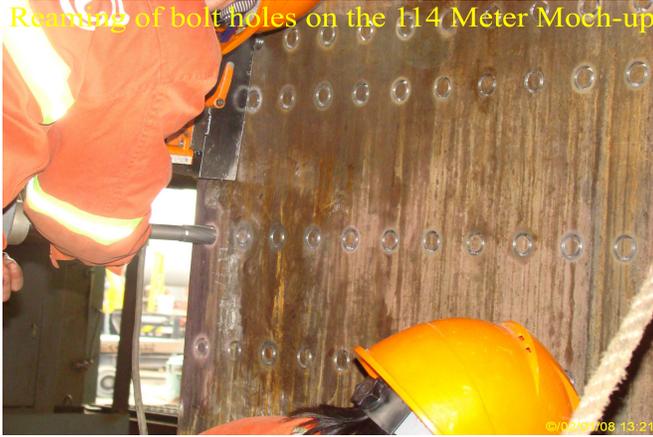
This QA Inspector observed the drilling of bolt holes in the skin plates of the upper and lower Mock-up.

Remains of bolt holes on the 114 Meter Mock-up
