**DEPARTMENT OF TRANSPORTATION**

Contract #: 04-0120F4Cty: SF/ALA Rte: 80 PM: 13.2/13.9File #: 69.28**WELDING INSPECTION REPORT****Resident Engineer:** Pursell, Gary**Address:** 333 Burma Road**City:** Oakland, CA 94607**Report No:** WIR-001638**Date Inspected:** 20-Feb-2008**Project Name:** SAS Superstructure**OSM Arrival Time:** 800**Prime Contractor:** American Bridge/Fluor Enterprises, a JV**OSM Departure Time:** 1730**Contractor:** Zhenhua Port Machinery Company, Ltd (ZPMC), Changxing Island **Location:** Shanghai, China**CWI Name:** See Below**CWI Present:** Yes No**Inspected CWI report:** Yes No N/A**Rod Oven in Use:** Yes No N/A**Electrode to specification:** Yes No N/A**Weld Procedures Followed:** Yes No N/A**Qualified Welders:** Yes No N/A**Verified Joint Fit-up:** Yes No N/A**Approved Drawings:** Yes No N/A**Approved WPS:** Yes No N/A**Delayed / Cancelled:** Yes No N/A**Bridge No:** 34-0006**Component:** Tower and OBG Fabrication**Summary of Items Observed:**

Orthotropic Box Girder (OBG) and Tower Mock Up:

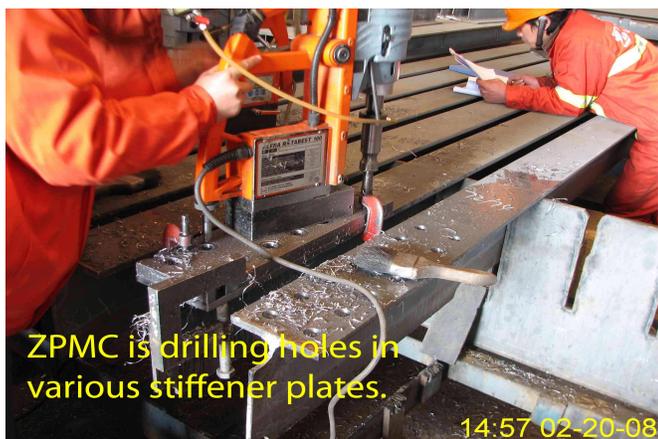
The QA Inspector observed ZPMC personnel drilling holes in various stiffener plates. See the photograph for additional information.
