Quality Assurance and Source Inspection

Contract #: 04-0120F4Cty: SF/ALA Rte: 80 PM: 13.2/13.9File #: 69.28**WELDING INSPECTION REPORT****Resident Engineer:** Pursell, Gary**Address:** 333 Burma Road**City:** Oakland, CA 94607**Report No:** WIR-001650**Date Inspected:** 03-Mar-2008**Project Name:** SAS Superstructure**OSM Arrival Time:** 1830**Prime Contractor:** American Bridge/Fluor Enterprises, a JV**OSM Departure Time:** 630**Contractor:** Zhenhua Port Machinery Company, Ltd (ZPMC), Changxing Island **Location:** Changxing Island**CWI Name:** Sun Wei**CWI Present:** Yes No**Inspected CWI report:** Yes No N/A**Rod Oven in Use:** Yes No N/A**Electrode to specification:** Yes No N/A**Weld Procedures Followed:** Yes No N/A**Qualified Welders:** Yes No N/A**Verified Joint Fit-up:** Yes No N/A**Approved Drawings:** Yes No N/A**Approved WPS:** Yes No N/A**Delayed / Cancelled:** Yes No N/A**Bridge No:** 34-0006**Component:** 77 Mock-up**Summary of Items Observed:**

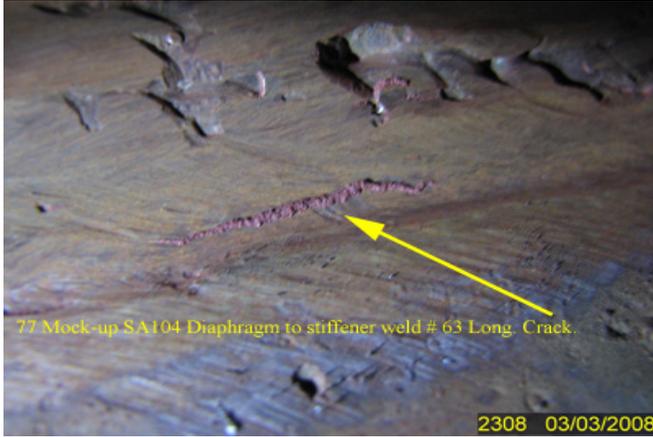
Caltrans QA Inspector Viars performed random MT of the 77 meter Mock-up Partial Joint Penetration (PJP) and fillet welds associated with diaphragm plates SA95 and SA104. A random visual inspection was performed prior to MT inspection. A total of 10 welds were tested and 6 were found to have indications that did not meet the AWS D1.5 (2002) requirements. ZPMC QC Mr. Shen Xue Jun stated that ZPMC had not completed MT of the 77 meter diaphragm PJP and fillet welds. Please the MT report TL-6028, generated on this date for information. The following picture below illustrates indications found during testing.
