DEPARTMENT OF TRANSPORTATION

Contract #: 04-0120F4Cty: SF/ALA Rte: 80 PM: 13.2/13.9File #: 69.28**WELDING INSPECTION REPORT****Resident Engineer:** Pursell, Gary**Address:** 333 Burma Road**City:** Oakland, CA 94607**Report No:** WIR-001687**Date Inspected:** 29-Feb-2008**Project Name:** SAS Superstructure**OSM Arrival Time:** 1830**Prime Contractor:** American Bridge/Fluor Enterprises, a JV**OSM Departure Time:** 730**Contractor:** Zhenhua Port Machinery Company, Ltd (ZPMC), Changxing Island **Location:** Shanghai, China

Caltrans Quality Assurance (QA) Inspector, Mike Hasler was present to observe the fitup, welding and related activities associated with the fabricating of Caltrans Mock-up, 77M, 89M, 114M and orthotropic box girders (OBG), for the San Francisco Oakland Bay Self Anchored Suspension Bridge, at Zhenhua Port Machinery Company (ZPMC) facility on Changxing Island.

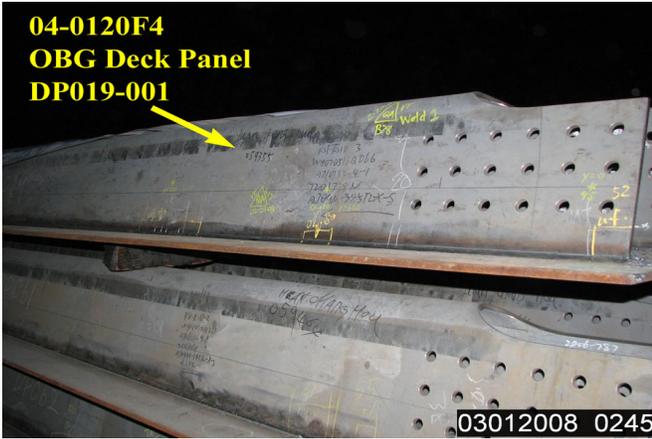
Storage Yard Outside New OBG Fabrication Bays: Caltrans QA Inspector performed visual inspection of the completed submerged arc welding (SAW) cover pass welds; partial joint penetration (PJP) welds joining the closed ribs to deck plate panel DP019-001, u-rib U221, weld 2; u-rib U2176, welds 3 & 4; u-rib U216, welds 5 & 6; u-rib U215, welds 7 & 8 and u-rib U220 weld 9. Caltrans QA observed welding overlap, underfill and incomplete fusion. These indications observed at the weld were marked in yellow paint stick along the distance from the "Y" axis, starting at the weld start to weld completion end. The weld indications observed were recorded on Caltrans spreadsheet for future reference. The following digital picture illustrates deck plate panel DP019-001.
