**DEPARTMENT OF TRANSPORTATION**

Contract #: 04-0120F4Cty: SF/ALA Rte: 80 PM: 13.2/13.9File #: 69.28**WELDING INSPECTION REPORT****Resident Engineer:** Pursell, Gary**Address:** 333 Burma Road**City:** Oakland, CA 94607**Report No:** WIR-001742**Date Inspected:** 07-Mar-2008**Project Name:** SAS Superstructure**OSM Arrival Time:** 1830**Prime Contractor:** American Bridge/Fluor Enterprises, a JV**OSM Departure Time:** 730**Contractor:** Zhenhua Port Machinery Company, Ltd (ZPMC), Changxing Island **Location:** Shanghai, China

Caltrans Quality Assurance (QA) Inspector, Mike Hasler was present to observe the fitup, welding and related activities associated with the fabricating of Caltrans Mock-up, 77M, 89M, 114M and orthotropic box girders (OBG), for the San Francisco Oakland Bay Self Anchored Suspension Bridge, at Zhenhua Port Machinery Company (ZPMC) facility on Changxing Island.

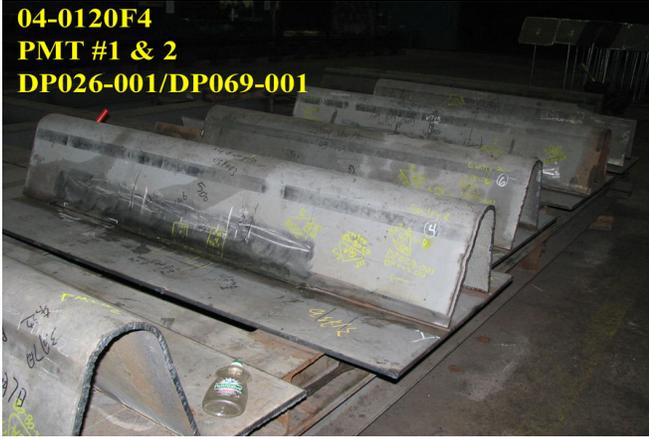
OBG Bay 1: Caltrans QA Inspector performed Visual Test (VT) examination, Production Monitoring Test (PMT #1 & 2) welds, representing the welding of deck plate DP026-001 and DP069-001. The weld inspection results were recorded on the U-Rib PMT Inspection Sheet. Caltrans QA identify locations for macroetch test specimen removal for specimen #1, 2, 3, 4 and 5, welds 1 thru 6 in accordance with Caltrans Special Provisions requirements. The test specimen locations were marked with a paint stick for future removal. The following digital picture illustrates three PMT u-rib test panels representing #1 and two u-rib panels representing #2.
