Contract #: 04-0120F4Cty: SF/ALA Rte: 80 PM: 13.2/13.9File #: 69.28**WELDING INSPECTION REPORT****Resident Engineer:** Pursell, Gary**Address:** 333 Burma Road**City:** Oakland, CA 94607**Report No:** WIR-001744**Date Inspected:** 04-Mar-2008**Project Name:** SAS Superstructure**OSM Arrival Time:** 1830**Prime Contractor:** American Bridge/Fluor Enterprises, a JV**OSM Departure Time:** 730**Contractor:** Zhenhua Port Machinery Company, Ltd (ZPMC), Changxing Island **Location:** Shanghai, China**CWI Name:** Zhao Chen Sun**CWI Present:** Yes No**Inspected CWI report:** Yes No N/A**Rod Oven in Use:** Yes No N/A**Electrode to specification:** Yes No N/A**Weld Procedures Followed:** Yes No N/A**Qualified Welders:** Yes No N/A**Verified Joint Fit-up:** Yes No N/A**Approved Drawings:** Yes No N/A**Approved WPS:** Yes No N/A**Delayed / Cancelled:** Yes No N/A**Bridge No:** 34-0006**Component:** deck panel**Summary of Items Observed:**

WELDING INSPECTION REPORT

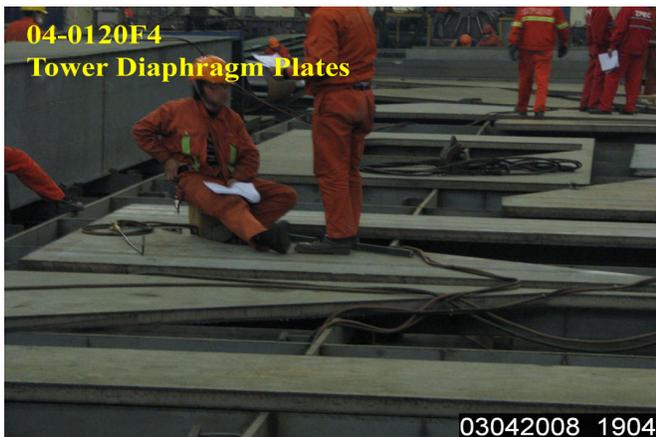
Bay 4: Caltrans QA observed ZPMC shop personnel performing heat straightening of tower diaphragm plates, identified as SA287 (E), Heat Straightening Procedure HSR1 (T) -092, 23M (BTM) P306, Heat Straightening Procedure HSR1 (T) -076 and 23M Top SA333 (S), Heat Straightening Procedure HSR1 (T) -083. Caltrans QA observed QC/ CWI inspector, Mr. Zhao Chen Sun, monitoring the heat straightening activities at the work-station. Caltrans QA met with Mr. Zhao Chen Sun and requested to see the heat straightening procedures, in regards to the work that is being performed at the work-station. Mr. Zhao Chen Sun presented the procedures for review. Caltrans QA observed that the work being

performed is in compliance. The following digital picture illustrates diaphragm plates.
