Contract #: 04-0120F4Cty: SF/ALA Rte: 80 PM: 13.2/13.9File #: 69.28**WELDING INSPECTION REPORT****Resident Engineer:** Pursell, Gary**Address:** 333 Burma Road**City:** Oakland, CA 94607**Report No:** WIR-001806**Date Inspected:** 25-Mar-2008**Project Name:** SAS Superstructure**OSM Arrival Time:** 600**Prime Contractor:** American Bridge/Fluor Enterprises, a JV**OSM Departure Time:** 1800**Contractor:** Zhenhua Port Machinery Company, Ltd (ZPMC), Changxing Island **Location:** Shanghai, China**CWI Name:** Sun Wei and Chen Chih-Ming**CWI Present:** Yes No**Inspected CWI report:** Yes No N/A**Rod Oven in Use:** Yes No N/A**Electrode to specification:** Yes No N/A**Weld Procedures Followed:** Yes No N/A**Qualified Welders:** Yes No N/A**Verified Joint Fit-up:** Yes No N/A**Approved Drawings:** Yes No N/A**Approved WPS:** Yes No N/A**Delayed / Cancelled:** Yes No N/A**Bridge No:** 34-0006**Component:** OBG deck panels and side panels**Summary of Items Observed:**

# WELDING INSPECTION REPORT

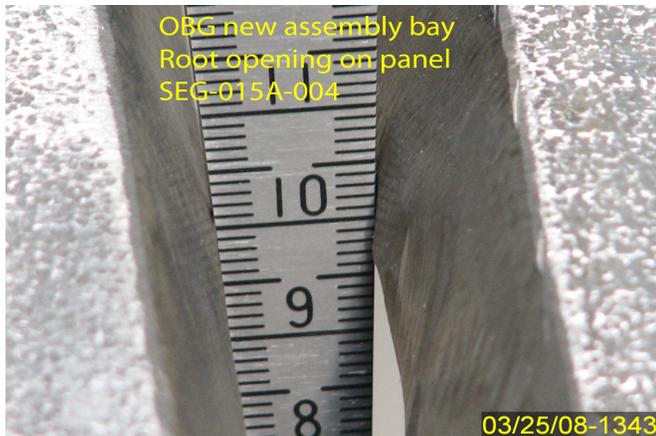
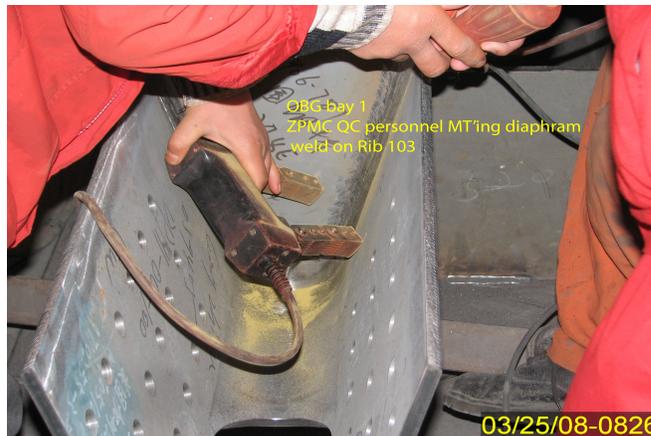
QA randomly inspected root openings on side panels SEG-015A-004 and SEG-015A-002 prior to welding.

They did not appear to comply with the posted WPS which specifies a 6mm root with no +/--tolerance. The “as fit” root openings on both panels varied from 6mm to 10mm. (see attached picture) QA notified ZPMC QC CWI identified as Chen Chih-Ming and American Bridge/Fluor (ABF) inspectors of this condition immediately. QA observed Mr. Craig Knops with ABF and ZPMC QC personnel discussing the issue of the excessive root openings. Mr. Knops recommended that ZPMC pull the panels apart and butter (build up with weld) one edge of one of the panels and grind the buttered areas to bright metal and re-fit the panels. ZPMC stopped work on these two panels and are currently considering Mr. Knops’ recommendation. At the end of this shift QA was unclear as to what ZPMC will propose to do concerning this matter.
