DEPARTMENT OF TRANSPORTATION

Contract #: 04-0120F4Cty: SF/ALA Rte: 80 PM: 13.2/13.9File #: 69.28**WELDING INSPECTION REPORT****Resident Engineer:** Pursell, Gary**Address:** 333 Burma Road**City:** Oakland, CA 94607**Report No:** WIR-001813**Date Inspected:** 17-Mar-2008**Project Name:** SAS Superstructure**OSM Arrival Time:** 600**Prime Contractor:** American Bridge/Fluor Enterprises, a JV**OSM Departure Time:** 430**Contractor:** Zhenhua Port Machinery Company, Ltd (ZPMC), Changxing Island **Location:** Shanghai, China**CWI Name:** Zhang Zhong**CWI Present:** Yes No**Inspected CWI report:** Yes No N/A**Rod Oven in Use:** Yes No N/A**Electrode to specification:** Yes No N/A**Weld Procedures Followed:** Yes No N/A**Qualified Welders:** Yes No N/A**Verified Joint Fit-up:** Yes No N/A**Approved Drawings:** Yes No N/A**Approved WPS:** Yes No N/A**Delayed / Cancelled:** Yes No N/A**Bridge No:** 34-0006**Component:** OBG side panels**Summary of Items Observed:**

New OBG Assembly area

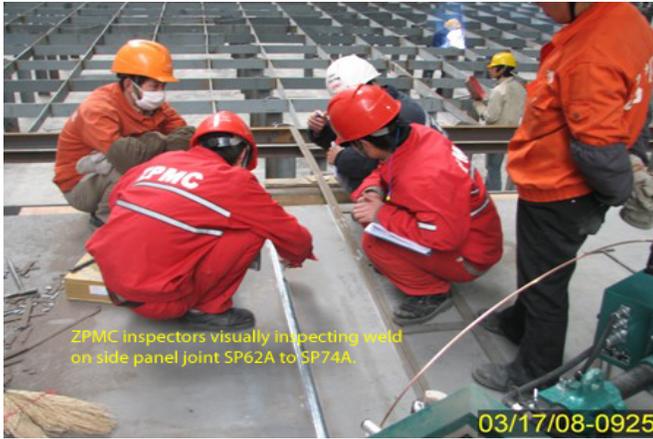
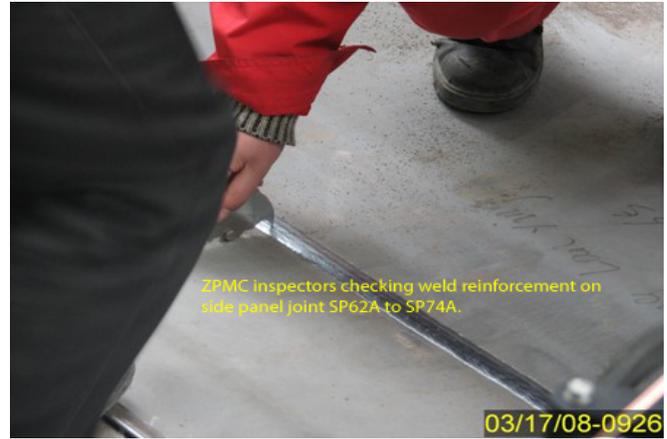
QA observed Zhenhua Port Machinery Company (ZPMC) welding personnel Submerged Arc Welding (SAW) side panels SP62A to SP74A. QA observed ZPMC Quality Control (QC) inspectors randomly monitor the welding parameters. The parameters appeared to be in conformance with the posted WPS. ZPMC's QC inspectors were observed Visually Inspecting (VT) the above mentioned weld for compliance to the contract documents immediately after the completion of the weld. Visual inspection appeared to be in conformance with AWS D1.5 2002 and the contract documents.
