DEPARTMENT OF TRANSPORTATION

Quality Assurance and Source Inspection

Contract #: 04-0120F4Cty: SF/ALA Rte: 80 PM: 13.2/13.9File #: 69.28**WELDING INSPECTION REPORT****Resident Engineer:** Pursell, Gary**Address:** 333 Burma Road**City:** Oakland, CA 94607**Report No:** WIR-001851**Date Inspected:** 18-Mar-2008**Project Name:** SAS Superstructure**OSM Arrival Time:** 600**Prime Contractor:** American Bridge/Fluor Enterprises, a JV**OSM Departure Time:** 1800**Contractor:** Zhenhua Port Machinery Company, Ltd (ZPMC), Changxing Island **Location:** Shanghai, China**CWI Name:** Chen Xi and Xu Le Tong**CWI Present:** Yes No**Inspected CWI report:** Yes No N/A**Rod Oven in Use:** Yes No N/A**Electrode to specification:** Yes No N/A**Weld Procedures Followed:** Yes No N/A**Qualified Welders:** Yes No N/A**Verified Joint Fit-up:** Yes No N/A**Approved Drawings:** Yes No N/A**Approved WPS:** Yes No N/A**Delayed / Cancelled:** Yes No N/A**Bridge No:** 34-0006**Component:** OBG side & deck panels / 89 mockup**Summary of Items Observed:**

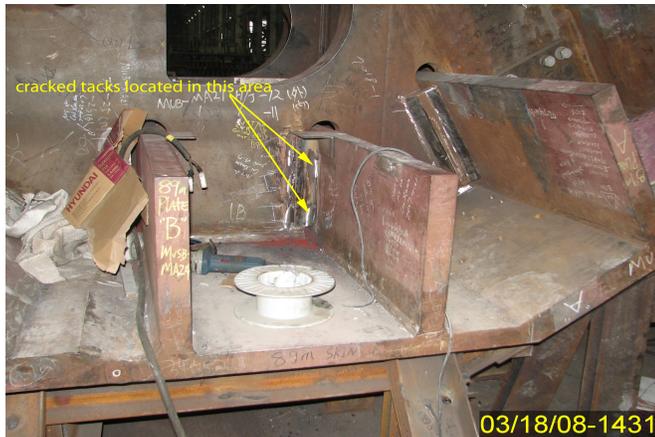
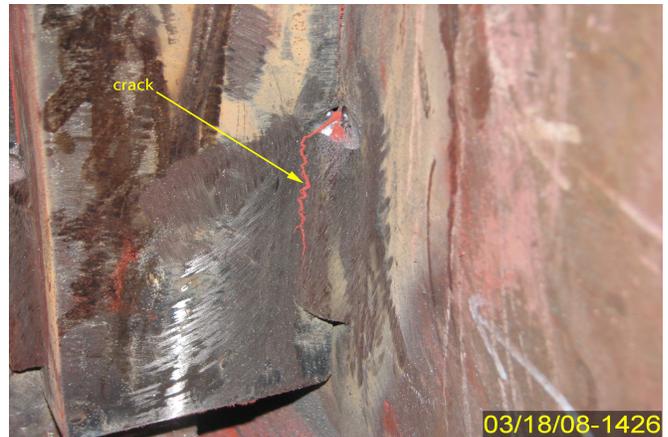
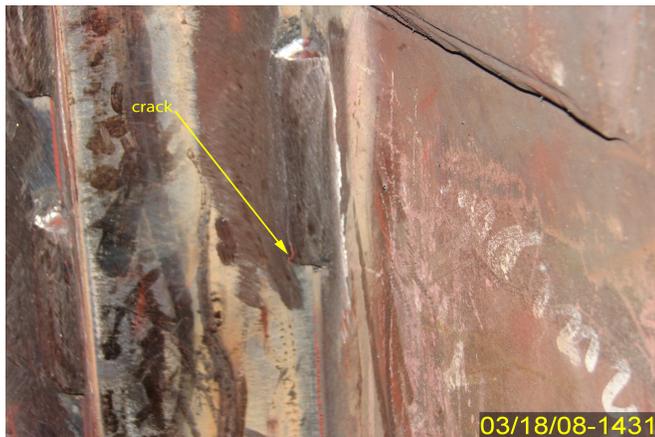
89 mock up

QA arrived in this area at a approximately 1430 hrs to observe the removal and Magnetic particle Testing (MT) of two cracked tacks discovered by ZPMC Quality Control personnel. QA observed two cracked tacks joining part numbers P676-1 to P531-2. QC CWI inspector identified as Xu Le Tong informed QA that ZPMC intended to remove and replace the entire bar (part # P676-1). QA observed ZPMC welding personnel remove the part via carbon arc gouging process. After the part was removed ZPMC's QC MT'ed the material in the effected area. MT appeared to indicate that the material exhibited no signs of any discontinuities. ZPMC welding personnel commenced the preheating process in accordance with the posted WPS's in preparation for re-tacking the new part in position. QA departed the area before ZPMC commenced tack welding. See attached photos for more detail of the effected area.
