DEPARTMENT OF TRANSPORTATION

Contract #: 04-0120F4Cty: SF/ALA Rte: 80 PM: 13.2/13.9File #: 69.28**WELDING INSPECTION REPORT****Resident Engineer:** Pursell, Gary**Address:** 333 Burma Road**City:** Oakland, CA 94607**Report No:** WIR-002000**Date Inspected:** 26-Apr-2008**Project Name:** SAS Superstructure**OSM Arrival Time:** 2300**Prime Contractor:** American Bridge/Fluor Enterprises, a JV**OSM Departure Time:** 730**Contractor:** Zhenhua Port Machinery Company, Ltd (ZPMC), Changxing Island **Location:** Shanghai, China**CWI Name:** Xu Le Feng**CWI Present:** Yes No**Inspected CWI report:** Yes No N/A**Rod Oven in Use:** Yes No N/A**Electrode to specification:** Yes No N/A**Weld Procedures Followed:** Yes No N/A**Qualified Welders:** Yes No N/A**Verified Joint Fit-up:** Yes No N/A**Approved Drawings:** Yes No N/A**Approved WPS:** Yes No N/A**Delayed / Cancelled:** Yes No N/A**Bridge No:** 34-0006**Component:** Tower & OBG**Summary of Items Observed:**

Caltrans Quality Assurance (QA) Inspector, Mike Hasler was present to observe the fitup, welding and related activities associated with the fabricating of Caltrans Mock-up, 77M, 89M, 114M, Orthotropic Box Girders (OBG) and Tower,

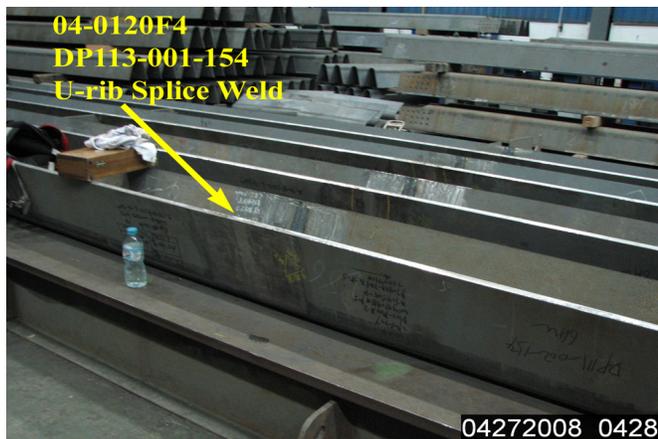
OBG Bay 1: Caltrans QA Inspector performed ultrasonic verification testing of u-rib complete joint penetration butt joint splice weld, identified as DP111-002-154 (U291), DP111-002-155 (U300), DP111-002-156 (U337) and DP111-002-157. The Ultrasonic Testing (UT) was performed to verify that 10% of the weld meets the requirements of the contract documents and AWS D1.5-2002. The weld and base metal were scanned utilizing a Krautkramer Branson USN 60. Caltrans QA Inspector performed a base metal lamination check using a 25mm diameter 2.25 MHz transducer and a shear wave scan was using a 19mm x 16mm 2.25 MHz transducer on a 70 degree angle wedge from face A. Caltrans QA Inspector utilized Scanning patterns A, B, C, and E. Caltrans QA Inspector found the welds inspected to be in compliance with AWS D1.5- 2002 Table 6.3 and the contract documents. See Caltrans Ultrasonic Testing Report (TL-6027), dated April 21, 2008 for additional information. The following digital picture illustrates deck plate u-rib splice weld.

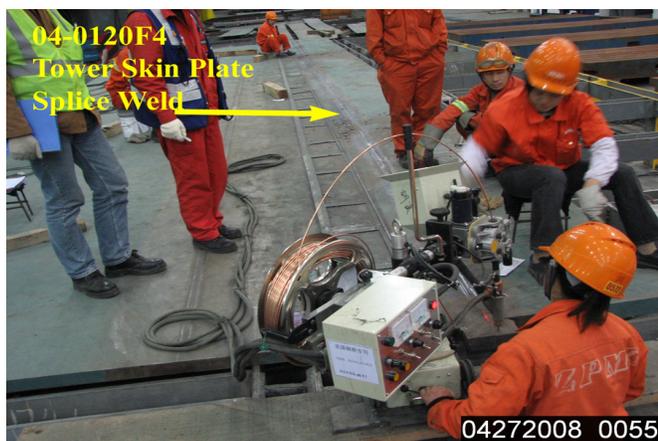
New Tower Shop Bay 1: Caltrans QA Inspector observed ZPMC performing submerged arc welding (SAW), tower skin plate SA16, P149, P151, P150, P123, P124 and P661, root weld pass. The plates are joined to form one continuous weld. That is identified as SSD1-SA16 F/G- 1, SA8, 7A, 3, 109A, 110 and 112A The suffix A letter designates that the weld is a complete joint penetration weld (CJP) and the weld number without the A suffix is a partial joint penetration (PJP) weld. The welder operator is identified as Ms. Chen Hong Xia, welder stamp 040460, welding fill pass weld, weld 110 and 112A, utilizing welding procedure WPS-B-T-2221-B-U3c-S and WPS-B-T-2321-B-P3-S. Caltrans QA measured current welding parameters at approximately 690 amps, 33.0 volts and 630mm/min (millimeters per minute) travel speed. Caltrans QA verified preheat and interpass temperatures during the welding activities. The preheat temperature prior to the start of welding measures more than 110 degrees Celsius but less than 230 degrees Celsius during maximum interpass temperature verification. Caltrans QA observed, American Bridge/Fluor (ABF) inspector, Mr. Li Hanjie and ZPMC QC/CWI inspector, Mr. Xu Le Feng monitoring the activities at the work station. The following digital picture illustrates welding in progress.

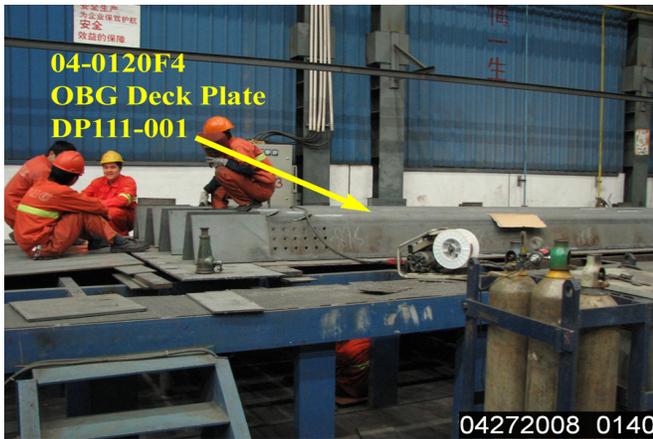
OBG Bay 1: Caltrans QA observed ZPMC shop workers performing fitup and tack welding, closed u-ribs to deck plate, assembly identified as DP111-001. The tack welders were identified as Mr. Liu Xiaomin, welder stamp #059393 and Mr. Xiao Bianbin, welder stamp #059440, utilizing welding procedure WPS-B-T-2342-U2 (rib), revision 0. Caltrans QA also observed the welding the of closed u-rib complete joint penetration (CJP) splice weld, subassembly u-rib identified as DP113-001-157. The welder is identified as Mr. Song Yin Shu, welder stamp #059421, utilizing welding procedure WPS-B-T-2233-B-U2-F, revision 1. Caltrans QA observed ZPMC QC inspector, Mr. Li Yan hua monitoring the welding activities at the workstations.
