Contract #: 04-0120F4Cty: SF/ALA Rte: 80 PM: 13.2/13.9File #: 69.28**WELDING INSPECTION REPORT****Resident Engineer:** Pursell, Gary**Address:** 333 Burma Road**City:** Oakland, CA 94607**Report No:** WIR-002001**Date Inspected:** 24-Apr-2008**Project Name:** SAS Superstructure**OSM Arrival Time:** 2300**Prime Contractor:** American Bridge/Fluor Enterprises, a JV**OSM Departure Time:** 730**Contractor:** Zhenhua Port Machinery Company, Ltd (ZPMC), Changxing Island **Location:** Shanghai, China**CWI Name:** Xu Le Feng**CWI Present:** Yes No**Inspected CWI report:** Yes No N/A**Rod Oven in Use:** Yes No N/A**Electrode to specification:** Yes No N/A**Weld Procedures Followed:** Yes No N/A**Qualified Welders:** Yes No N/A**Verified Joint Fit-up:** Yes No N/A**Approved Drawings:** Yes No N/A**Approved WPS:** Yes No N/A**Delayed / Cancelled:** Yes No N/A**Bridge No:** 34-0006**Component:** Tower**Summary of Items Observed:**

Caltrans Quality Assurance (QA) Inspector, Mike Hasler was present to observe the fitup, welding and related activities associated with the fabricating of Caltrans Mock-up, 77M, 89M, 114M, Orthotropic Box Girder (OBG) and Tower, for the San Francisco Oakland Bay Sel

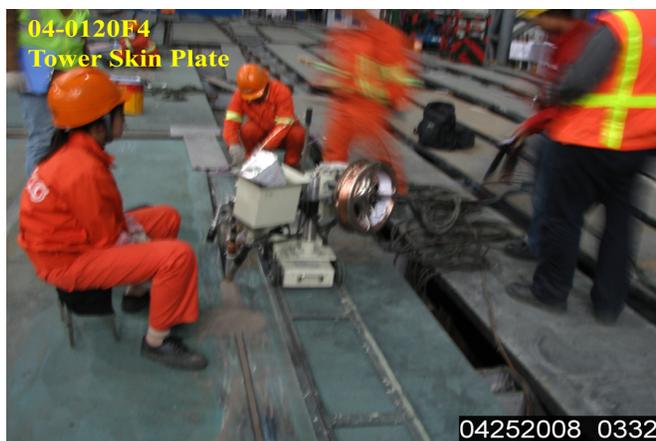
New Tower Shop Bay 1: Caltrans QA Inspector observed ZPMC performing submerged arc welding (SAW), tower skin plate SA16, P149, P151, P150, P123, P124 and P661, root weld pass. The plates are joined to form one continuous weld That is identified as SSD1-SA16 F/G- 1, SA8, 7A, 3, 109A, 110 and 112A The suffix A letter designates that the weld is a complete joint penetration weld (CJP) and the weld number without the A suffix is a partial joint penetration (PJP) weld. The welder operator is identified as Ms. Chen Hong Xia, welder stamp 040460, utilizing welding procedure WPS-B-T-2221-B-U3c-S-1 and WPS-B-T-2321-B-P3-S1. Caltrans QA measured current welding parameters at approximately 510 amps, 30.0 volts and 460mm/min (millimeters per minute) travel speed. Caltrans QA verified preheat and interpass temperatures during the welding activities. The preheat temperature prior to the start of welding measures more than 110 degrees Celsius but less than 230 degrees Celsius during maximum interpass temperature verification. Caltrans QA observed, American Bridge/Fluor (ABF) inspector, Mr. Wei Jian Bo monitoring the activities at the work station. The following digital picture illustrates welding in progress.
