DEPARTMENT OF TRANSPORTATION

Contract #: 04-0120F4Cty: SF/ALA Rte: 80 PM: 13.2/13.9File #: 69.28**WELDING INSPECTION REPORT****Resident Engineer:** Pursell, Gary**Address:** 333 Burma Road**City:** Oakland, CA 94607**Report No:** WIR-002015**Date Inspected:** 17-Apr-2008**Project Name:** SAS Superstructure**OSM Arrival Time:** 930**Prime Contractor:** American Bridge/Fluor Enterprises, a JV**OSM Departure Time:** 1700**Contractor:** Zhenhua Port Machinery Company, Ltd (ZPMC), Changxing Island **Location:** Shanghai, China**CWI Name:** Xu Le Feng, Ye Yong Jun**CWI Present:** Yes No**Inspected CWI report:** Yes No N/A**Rod Oven in Use:** Yes No N/A**Electrode to specification:** Yes No N/A**Weld Procedures Followed:** Yes No N/A**Qualified Welders:** Yes No N/A**Verified Joint Fit-up:** Yes No N/A**Approved Drawings:** Yes No N/A**Approved WPS:** Yes No N/A**Delayed / Cancelled:** Yes No N/A**Bridge No:** 34-0006**Component:** OBG**Summary of Items Observed:**

Production Monitoring Tests Macro Etches

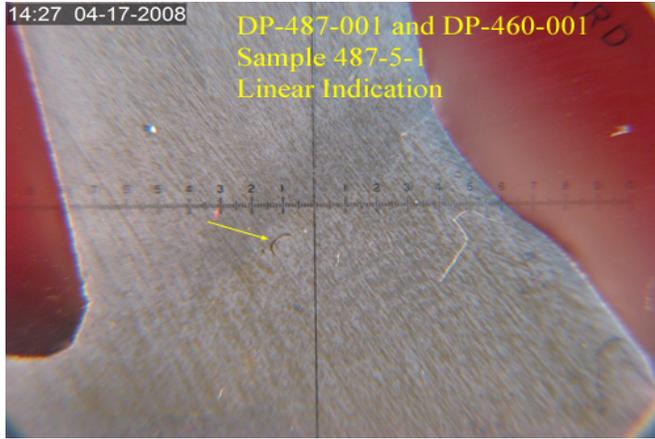
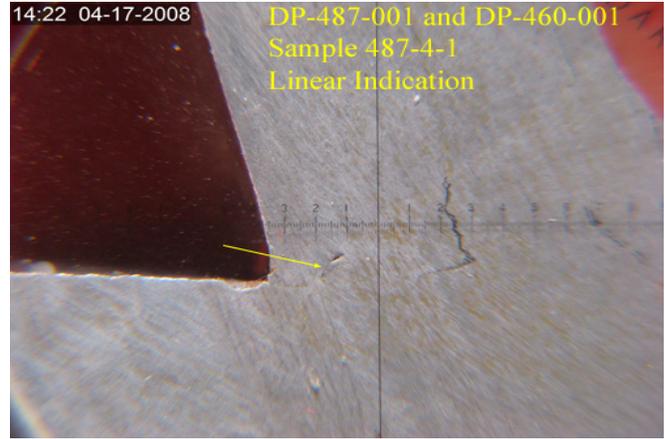
The Quality Assurance Inspector performed a visual inspection of the only set of production monitoring tests (PMT) macro etch samples available, identified as DP-487-001/DP-460-001. The PMT was welded on the previous day (4-16-08). All samples appeared to contain penetration greater than 80 percent. The Quality Assurance Inspector observed two samples that contained linear indications. All the data from the review was recorded in a tracking log and forwarded to Quality Assurance Task Leaders and Structural Materials Representatives. The Samples were digitally photographed and placed on the internal server for future review. Below are two digital photographs illustrating the linear indications observed.
