Contract #: 04-0120F4Cty: SF/ALA Rte: 80 PM: 13.2/13.9File #: 69.28**WELDING INSPECTION REPORT****Resident Engineer:** Pursell, Gary**Address:** 333 Burma Road**City:** Oakland, CA 94607**Report No:** WIR-002095**Date Inspected:** 07-Apr-2008**Project Name:** SAS Superstructure**OSM Arrival Time:** 1545**Prime Contractor:** American Bridge/Fluor Enterprises, a JV**OSM Departure Time:** 100**Contractor:** Zhenhua Port Machinery Company, Ltd (ZPMC), Changxing Island **Location:** Shanghai, China

WELDING INSPECTION REPORT

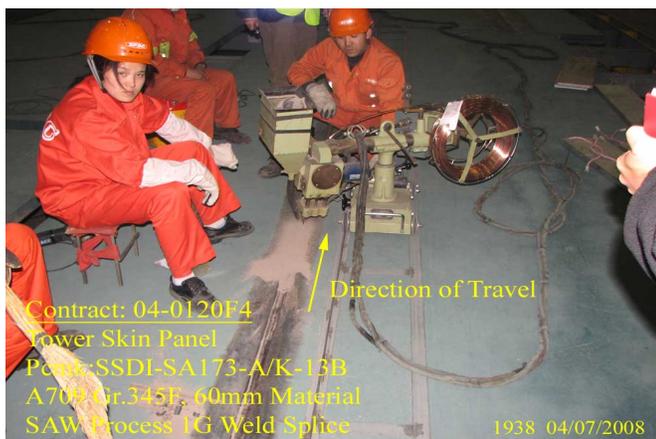
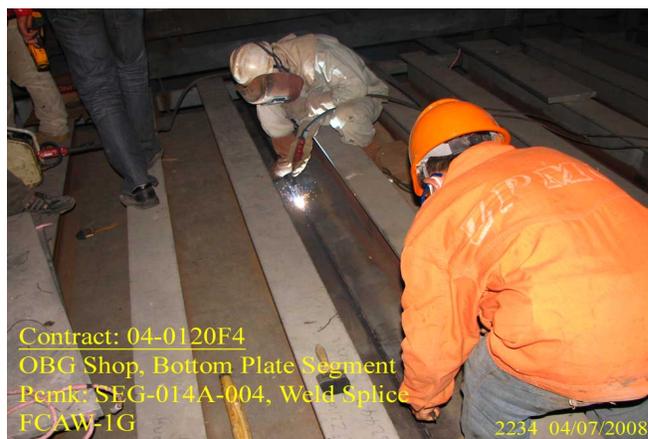
The QA Inspector observed the welding was being performed at three locations on 60mm and 90mm thick A709M grade 345F material. At the time of this observation the QA Inspector also noted that subsequent filler passes were being deposited at the various locations. The QA Inspector was also informed by ZPMC QC personnel Zhu Zhong Hai that welding procedure specification (WPS)-B-T-2221-B-U3C-5 is being used at these locations. The QA Inspector noted a copy of this WPS was posted in the shop. Based on the observations above it appeared that the work in progress was in general compliance with the contract specifications.

thickness. The QA Inspector performed a random verification of the welding current and voltage observing approximately 280 amperes and 28.2 volts. The QA Inspector was informed by ZPMC QC personnel Jiang Jun Lin that the welding is being performed to the requirements of WPS-B-T-223(2)1T. The QA Inspector referenced a copy of this procedure and noted that the welding parameters mentioned above appeared to comply with this procedure. The QA Inspector also reviewed the information on the daily welding inspection report provided by ZPMC QC personnel Jiang Jun Lin. At the time of this observation it appeared that the work in progress was in general compliance with the contract specifications.

The following pictures below detail the work in progress in the tower and OBG shops.
