DEPARTMENT OF TRANSPORTATION

Quality Assurance and Source Inspection

Contract #: 04-0120F4Cty: SF/ALA Rte: 80 PM: 13.2/13.9File #: 69.28**WELDING INSPECTION REPORT****Resident Engineer:** Pursell, Gary**Address:** 333 Burma Road**City:** Oakland, CA 94607**Report No:** WIR-002137**Date Inspected:** 28-Apr-2008**Project Name:** SAS Superstructure**OSM Arrival Time:** 2300**Prime Contractor:** American Bridge/Fluor Enterprises, a JV**OSM Departure Time:** 800**Contractor:** Zhenhua Port Machinery Company, Ltd (ZPMC), Changxing Island **Location:** Shanghai, China**CWI Name:** Wang Nan & Chen Xi**CWI Present:** Yes No**Inspected CWI report:** Yes No N/A**Rod Oven in Use:** Yes No N/A**Electrode to specification:** Yes No N/A**Weld Procedures Followed:** Yes No N/A**Qualified Welders:** Yes No N/A**Verified Joint Fit-up:** Yes No N/A**Approved Drawings:** Yes No N/A**Approved WPS:** Yes No N/A**Delayed / Cancelled:** Yes No N/A**Bridge No:** 34-0006**Component:** OBG**Summary of Items Observed:**

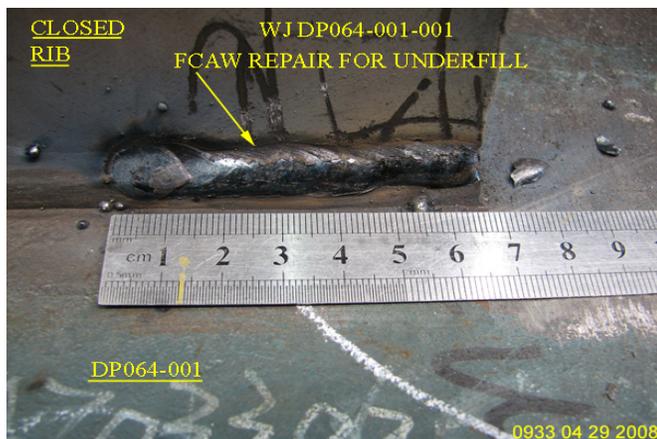
The QA Inspector randomly observed ZPMC welder Xiang Jie ID Number 059378, utilizing the Flux Cored Arc Welding (FCAW) Process in the 2F (Horizontal Fillet) Position, with ZPMC WPS WPS-345-FCAW-2G(2F)-Repair-1, to repair underfill in WJ DP064-001-001 attaching Closed Rib U-222 to Deck Plate DP064-001. The QA Inspector randomly observed ZPMC CWI Wang Nan monitoring weld parameters. The weld parameters appeared to comply with contract requirements. The QA Inspector also randomly observed ZPMC welding personnel utilizing grinders to blend and feather welds after weld repair and to remove overlap and reduce oversized welds. The attached photograph provides additional detail on the weld repair to WJ DP064-001-001.
