Contract #: 04-0120F4Cty: SF/ALA Rte: 80 PM: 13.2/13.9File #: 69.28**WELDING INSPECTION REPORT****Resident Engineer:** Pursell, Gary**Address:** 333 Burma Road**City:** Oakland, CA 94607**Report No:** WIR-002149**Date Inspected:** 28-Apr-2008**Project Name:** SAS Superstructure**OSM Arrival Time:** 700**Prime Contractor:** American Bridge/Fluor Enterprises, a JV**OSM Departure Time:** 1700**Contractor:** Zhenhua Port Machinery Company, Ltd (ZPMC), Changxing Island **Location:** Shanghai, China**CWI Name:** Xu Le Feng, Ye Yong Jun**CWI Present:** Yes No**Inspected CWI report:** Yes No N/A**Rod Oven in Use:** Yes No N/A**Electrode to specification:** Yes No N/A**Weld Procedures Followed:** Yes No N/A**Qualified Welders:** Yes No N/A**Verified Joint Fit-up:** Yes No N/A**Approved Drawings:** Yes No N/A**Approved WPS:** Yes No N/A**Delayed / Cancelled:** Yes No N/A**Bridge No:** 34-0006**Component:** OBG**Summary of Items Observed:**

Production Monitoring Tests Macro Etches

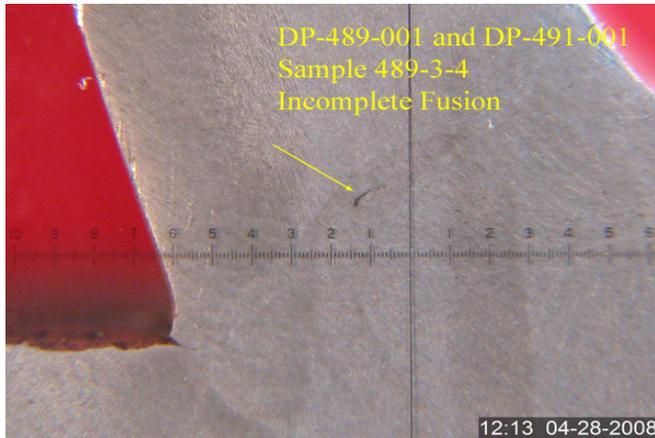
The Quality Assurance Inspector performed a visual inspection of two sets of production monitoring tests (PMT) macro etch samples, identified as DP-329-001 and DP-489-001/DP-491-001. The PMT's were welded on 4-25-2008 and 4-26-2008. All samples appeared to contain penetration greater than 80 percent. The Quality Assurance Inspector observed one sample that contained Incomplete fusion. All the data from the review was recorded in a tracking log and forwarded to Quality Assurance Task Leaders and Structural Materials Representatives. The Samples were digitally photographed and placed on the internal server for future review. Below is digital photograph of sample 489-3-4.
