Contract #: 04-0120F4Cty: SF/ALA Rte: 80 PM: 13.2/13.9File #: 69.28**WELDING INSPECTION REPORT****Resident Engineer:** Pursell, Gary**Address:** 333 Burma Road**City:** Oakland, CA 94607**Report No:** WIR-002159**Date Inspected:** 17-Apr-2008**Project Name:** SAS Superstructure**OSM Arrival Time:** 630**Prime Contractor:** American Bridge/Fluor Enterprises, a JV**OSM Departure Time:** 1530**Contractor:** Zhenhua Port Machinery Company, Ltd (ZPMC), Changxing Island **Location:** Shanghai, China**CWI Name:** Fu Yu Hong**CWI Present:** Yes No**Inspected CWI report:** Yes No N/A**Rod Oven in Use:** Yes No N/A**Electrode to specification:** Yes No N/A**Weld Procedures Followed:** Yes No N/A**Qualified Welders:** Yes No N/A**Verified Joint Fit-up:** Yes No N/A**Approved Drawings:** Yes No N/A**Approved WPS:** Yes No N/A**Delayed / Cancelled:** Yes No N/A**Bridge No:** 34-0006**Component:** OBG**Summary of Items Observed:**

CALTRANS Quality Assurance (QA) Inspector, Alfredo Acuna was present for the fabrication scheduled for this project at the ZPMC facility in Shanghai, China for the San Francisco Oakland Bay Self Anchored Suspension Bridge.

WELDING INSPECTION REPORT

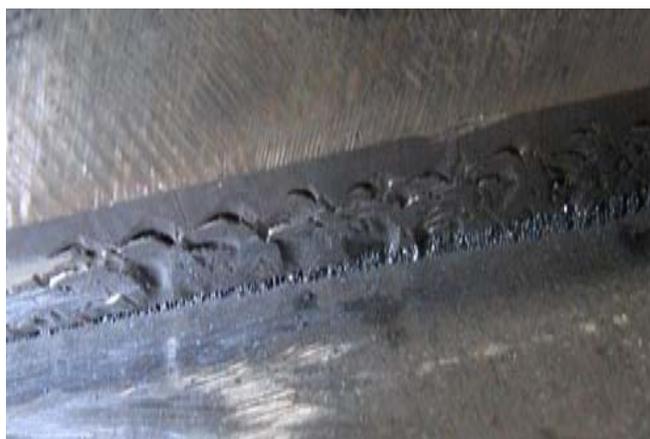
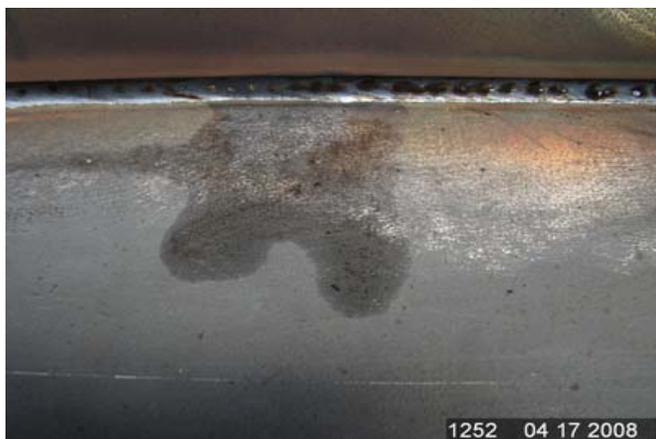
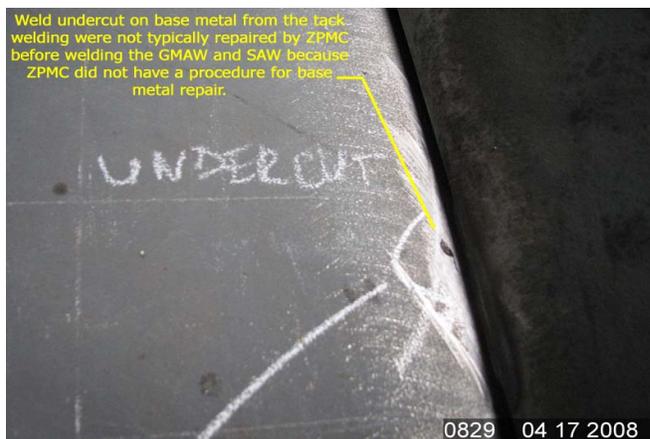
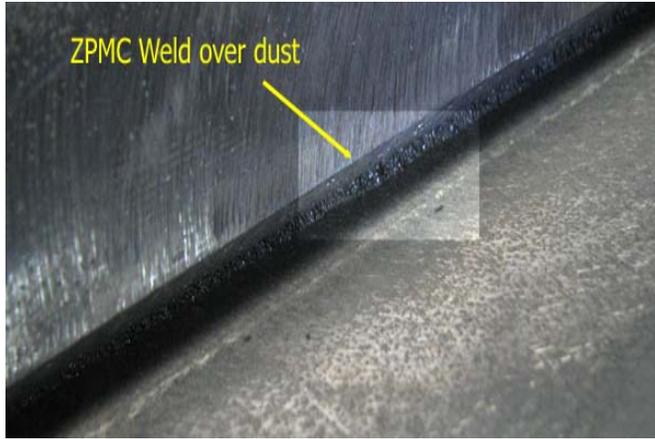
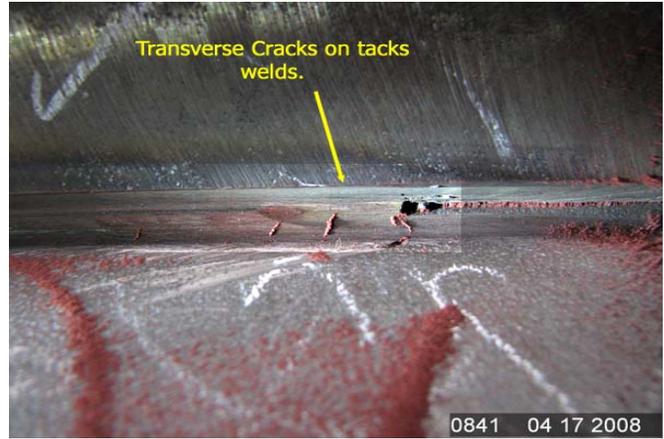
ZPMC started welding operations approximately 1240 hours on the deck panel DP-275-001. The QA inspector performed fit-up verifications to the deck panel DP-275-001 weld joints 2 to 5. The QA inspector observed the following discrepancies:

1. Oil on the weld joint # 2, 4 and 5 before and after welding.
2. Tears on the bevel faces
3. Large accumulation of dust at the weld joint.

The photographs below show the non compliance conditions.

The QA inspector attended to correct the above listed discrepancies before welding but the time the QA inspector informed ABF and ZPMC representatives Peter Saw, Lay Tao and Sun Wei. The QA inspector asked who performed the fit-up verifications. ZPMC representative relayed that ZPMC representative Meng Lin Nan. The QA inspector issued an incident report addressing ZPMC welding over oil. The QA was informed by Caltrans representative Ady Velasco that welding over Tears on the bevel have been already reported since the start of welding on the deck panel and it should not be included on the incident report.
